Shadow Lake

Phase 1 Lake Watershed Action Plan

March 12, 2024

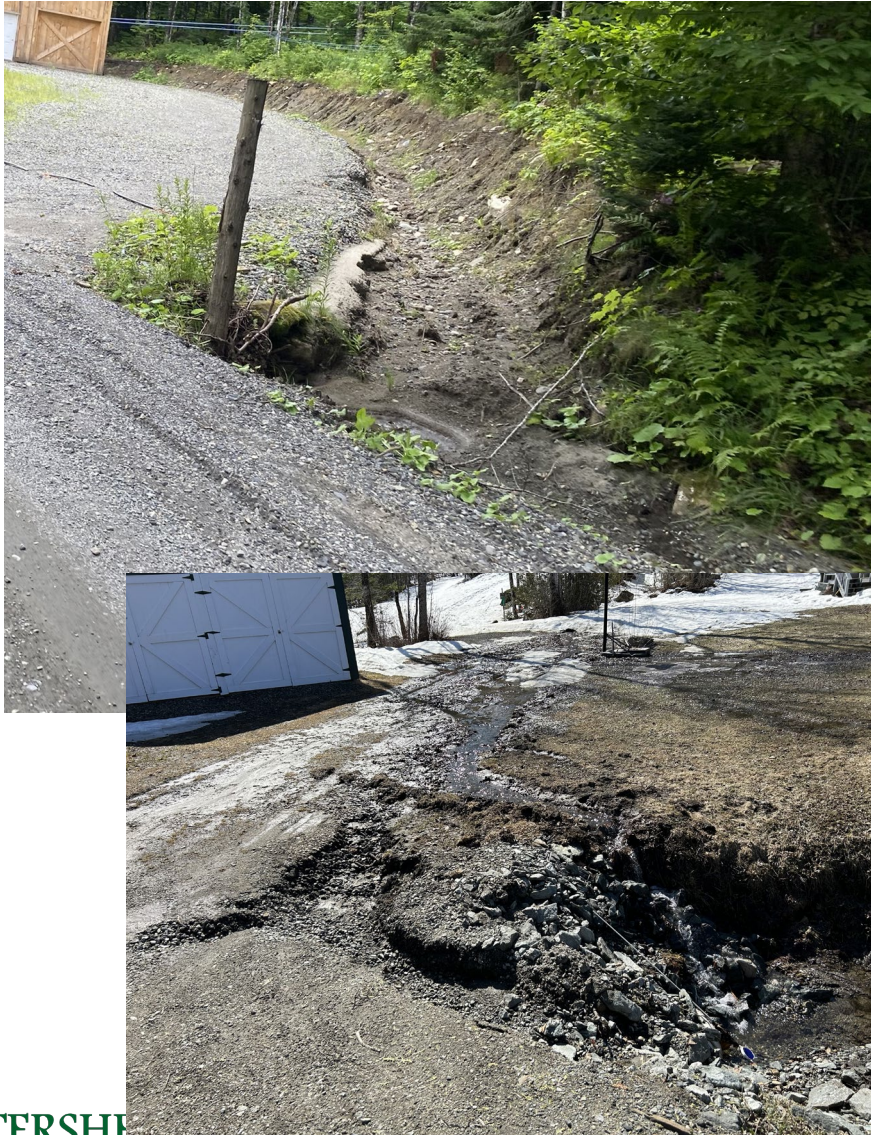
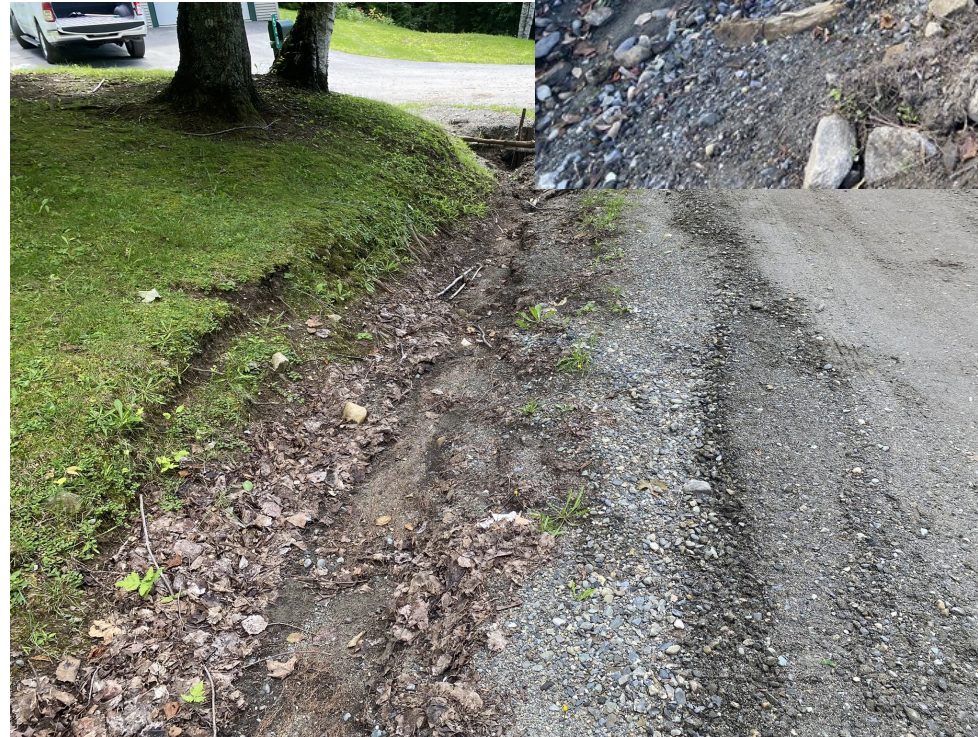
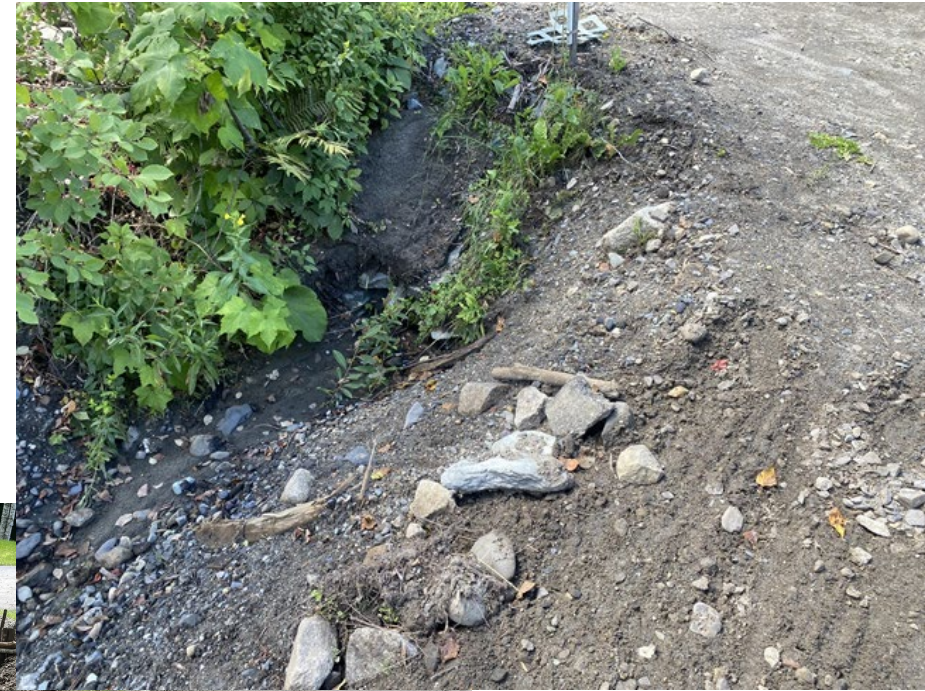
Unstable ditches and uncompacted ditch slopes leading to sediment transport

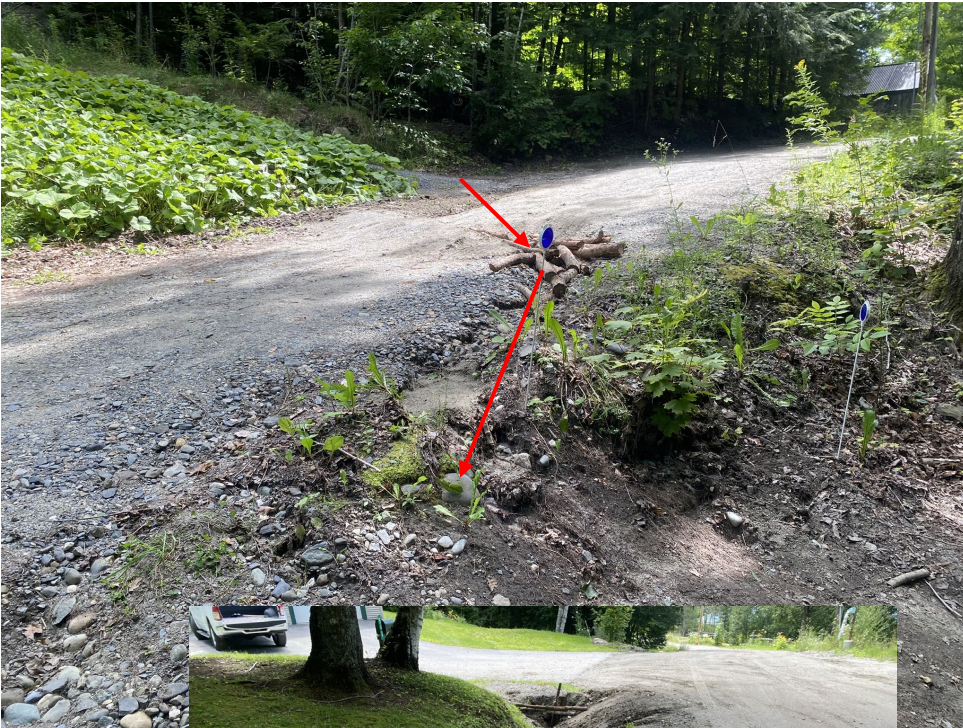
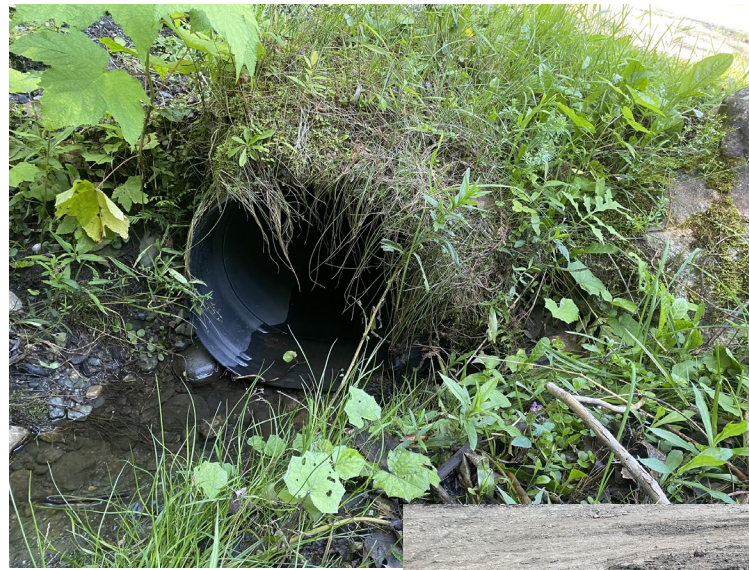
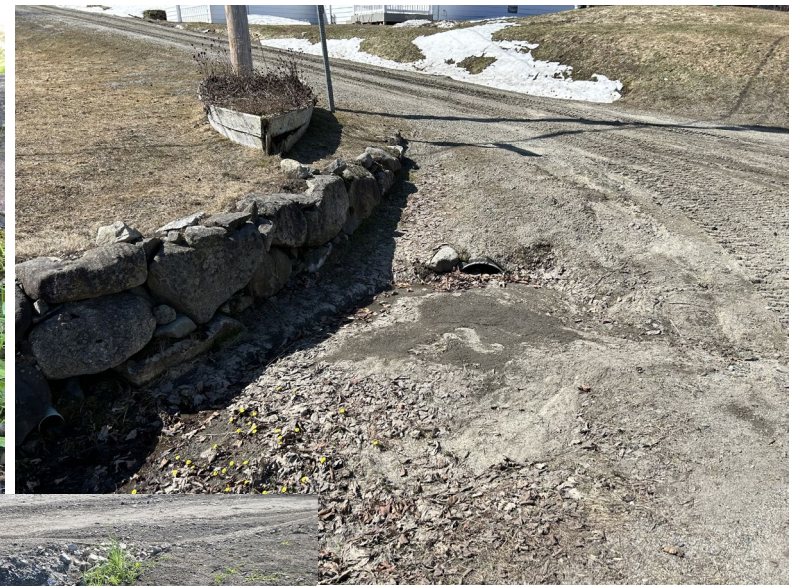
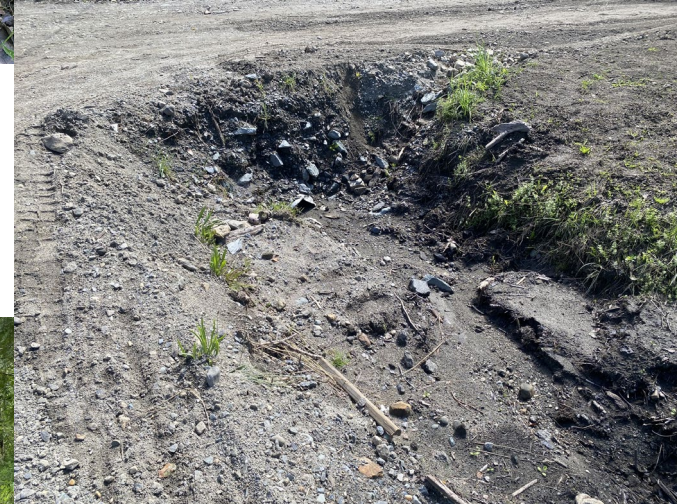
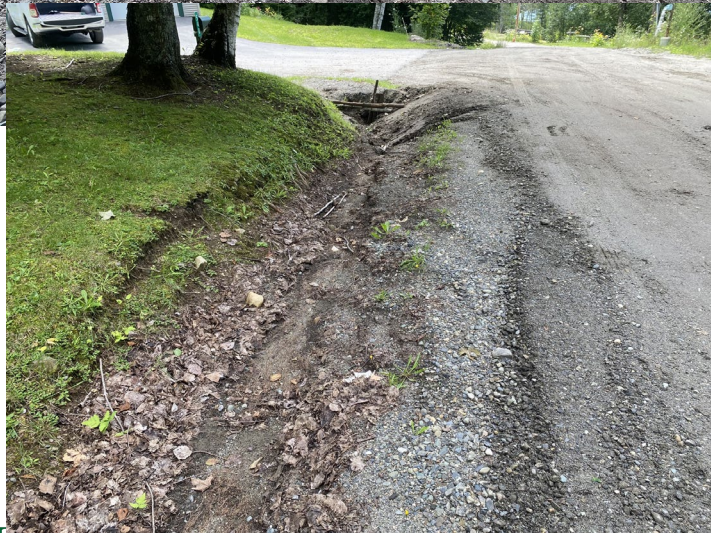
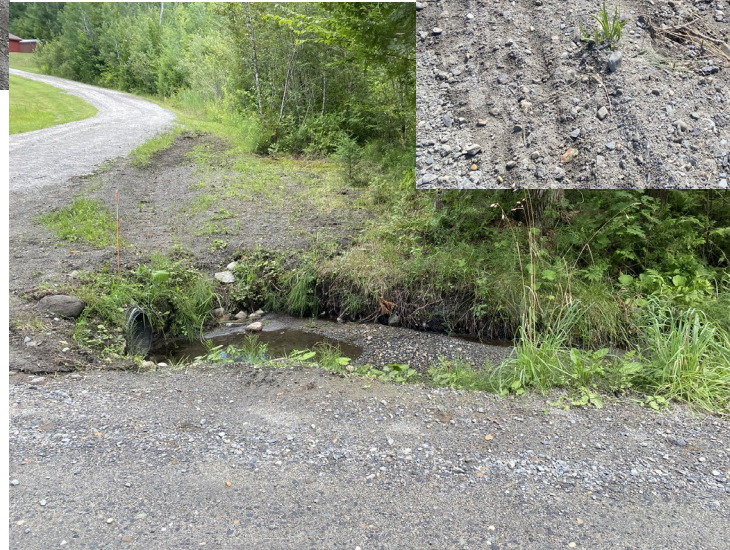
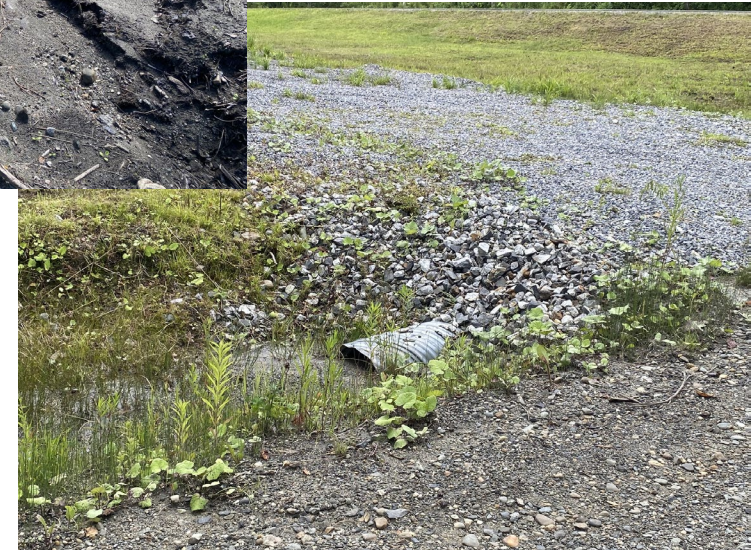
Undersized, absent, or clogged culverts

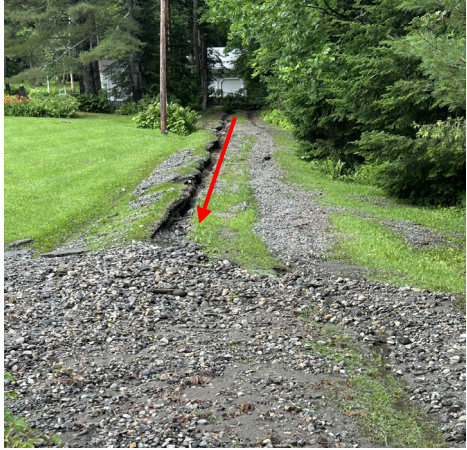
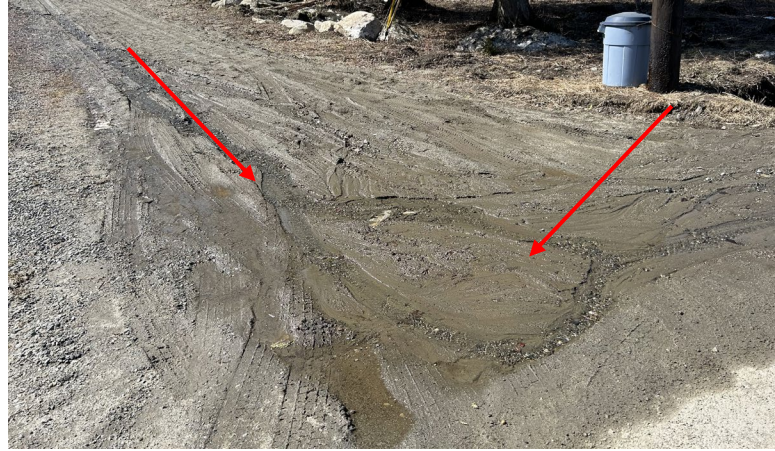
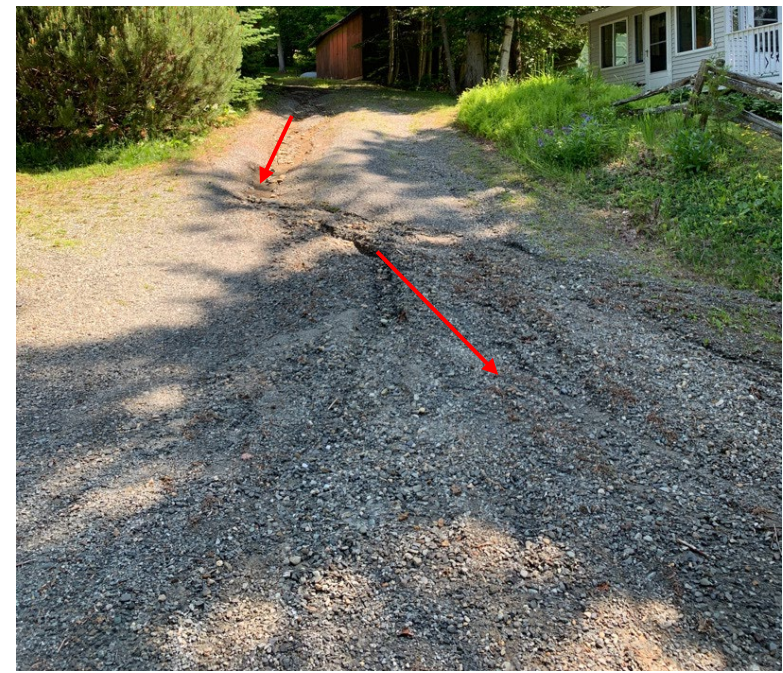
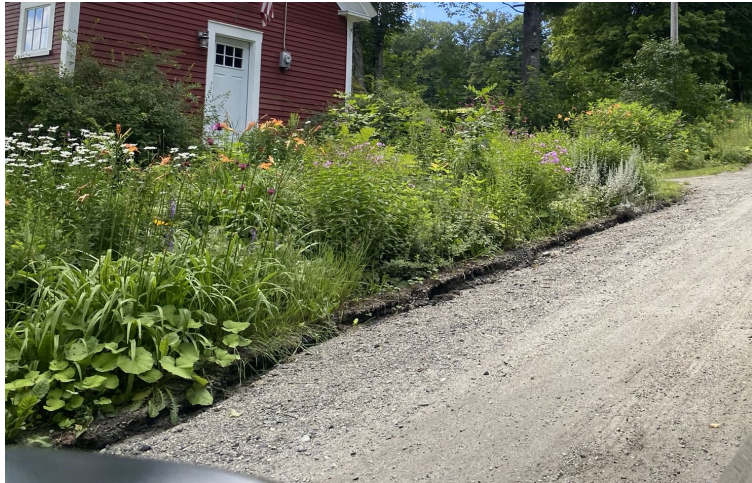
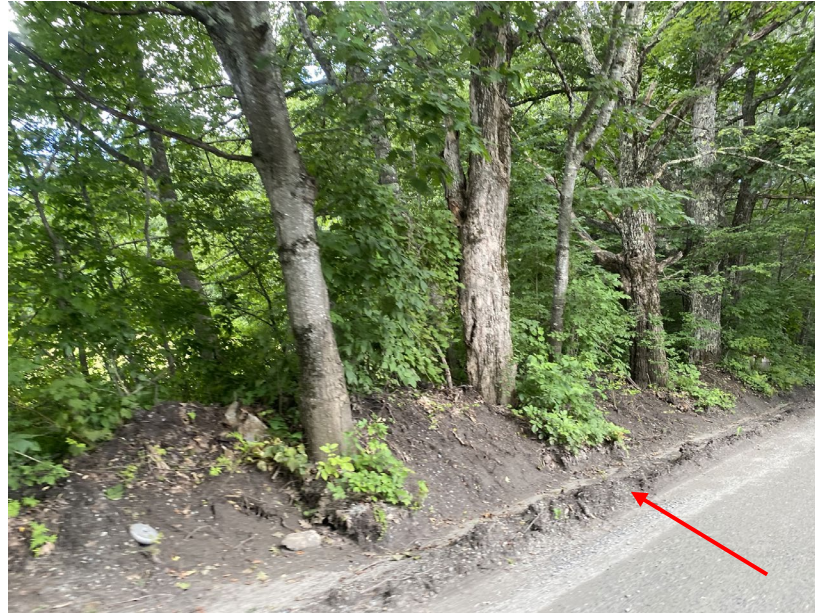
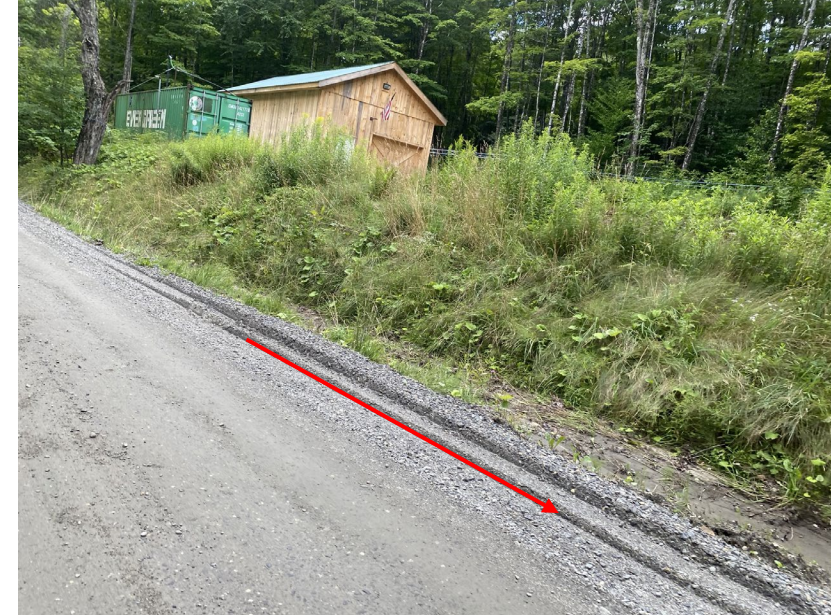
Improper grading, grader berms, piled loose materials near culverts and streams

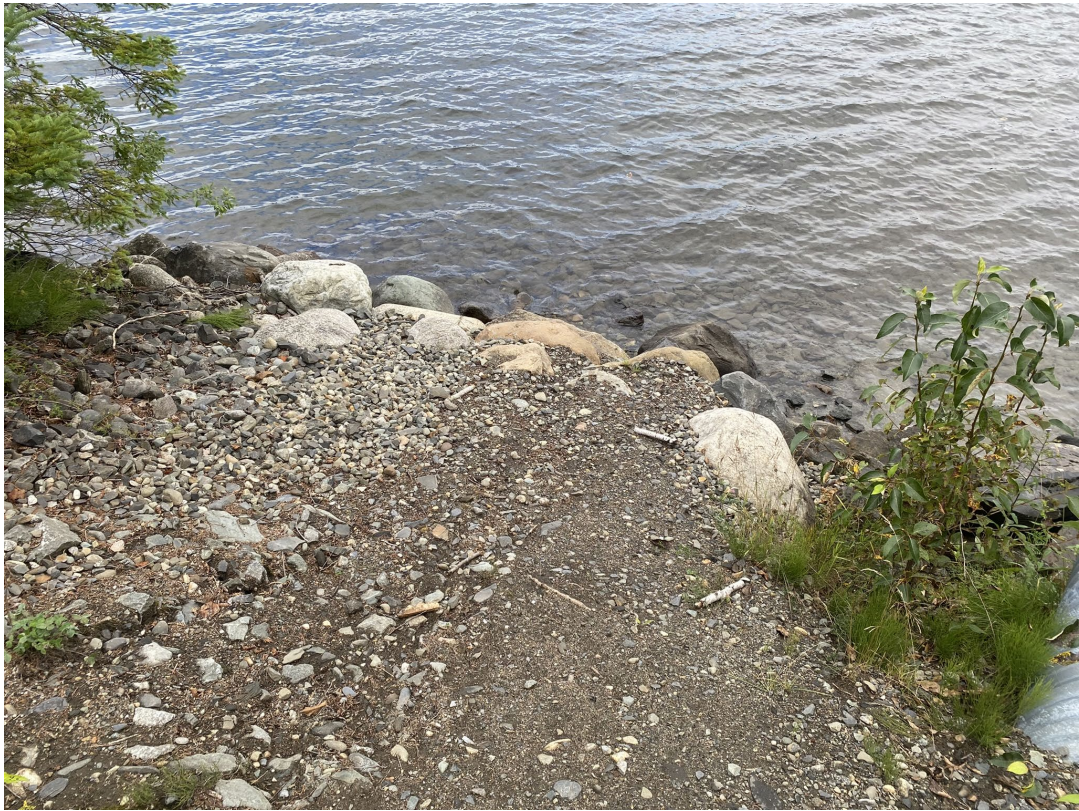
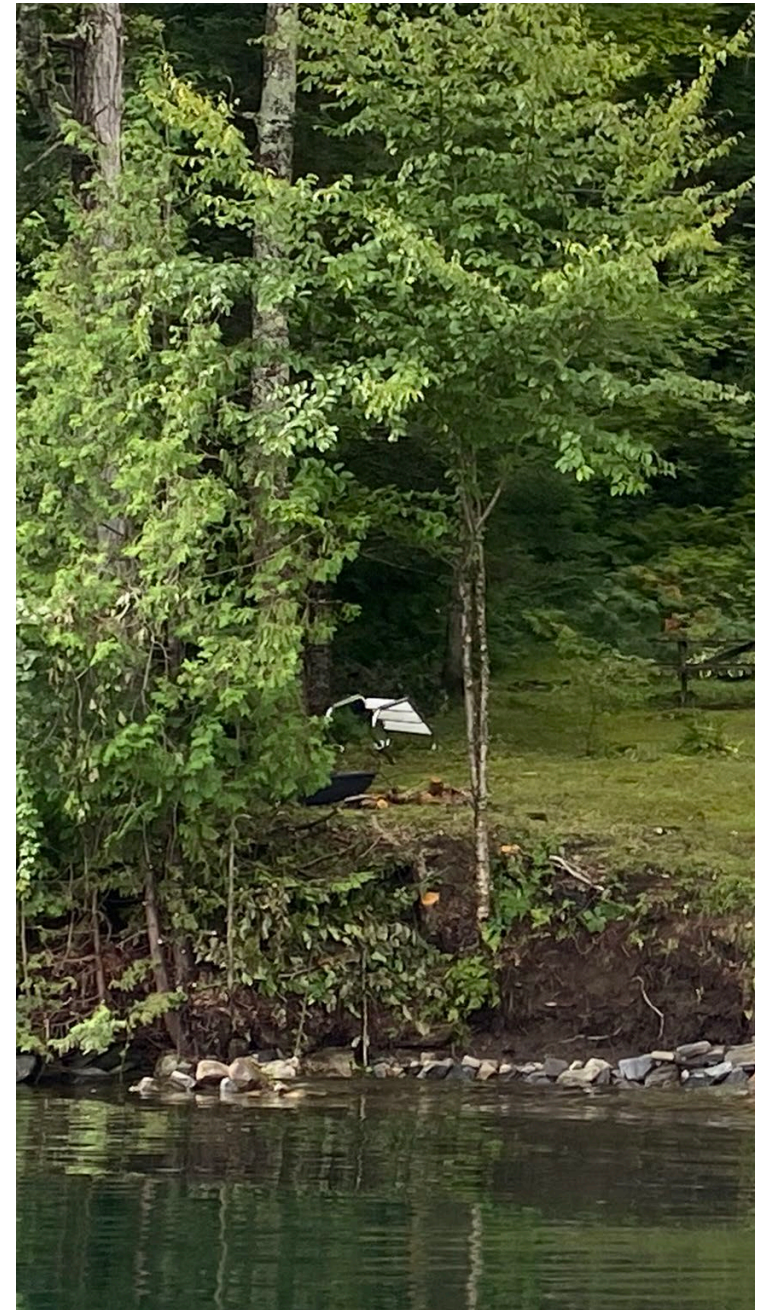
Lakeshores lacking robust native buffers can contribute higher nutrient loads. Shorelines can become unstable.

Bare soils, especially on a slope, are very prone to erosion.

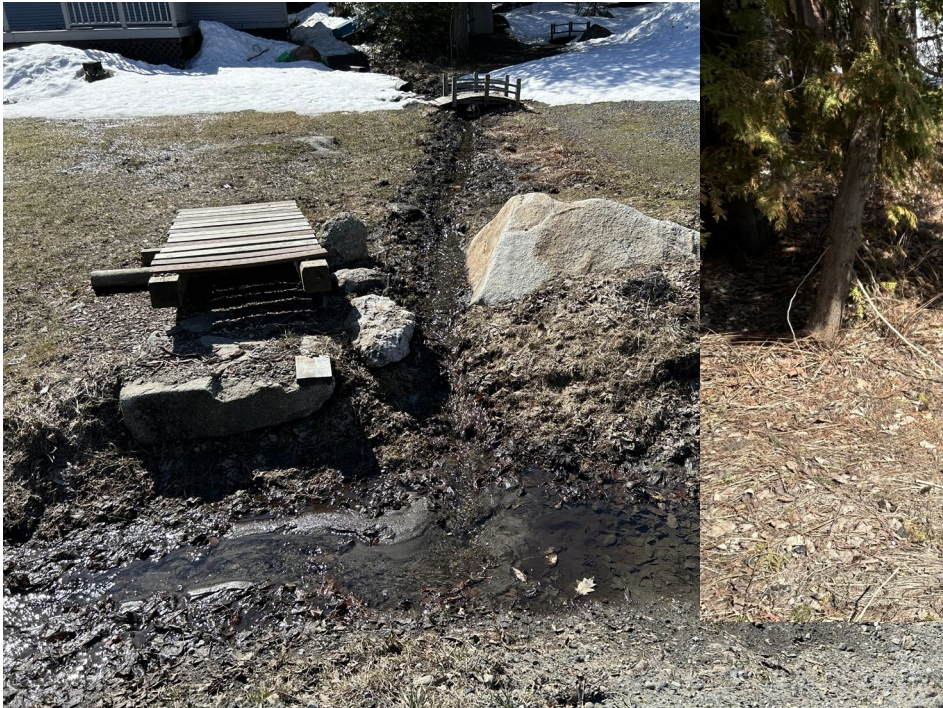
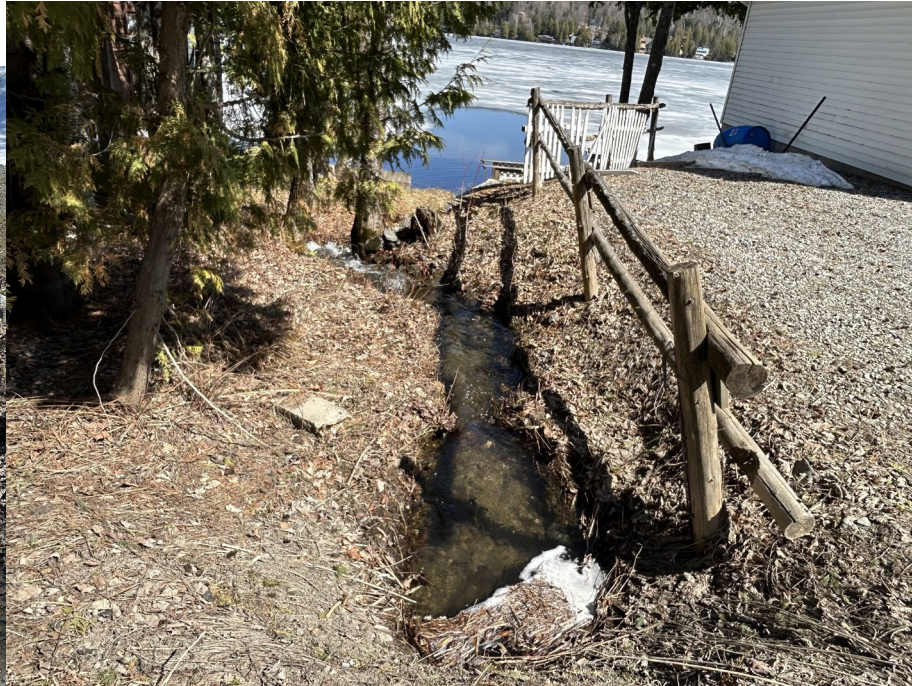
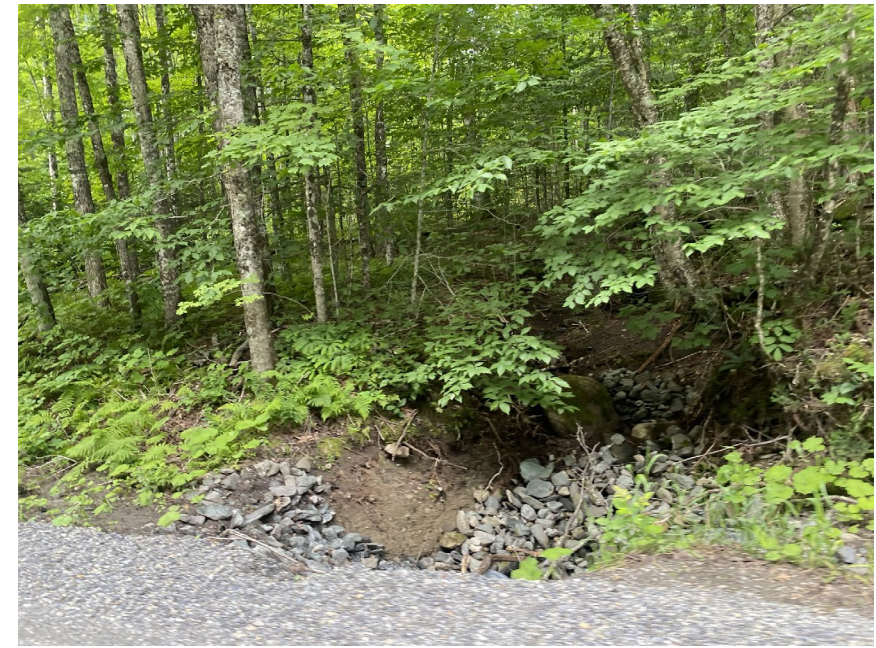
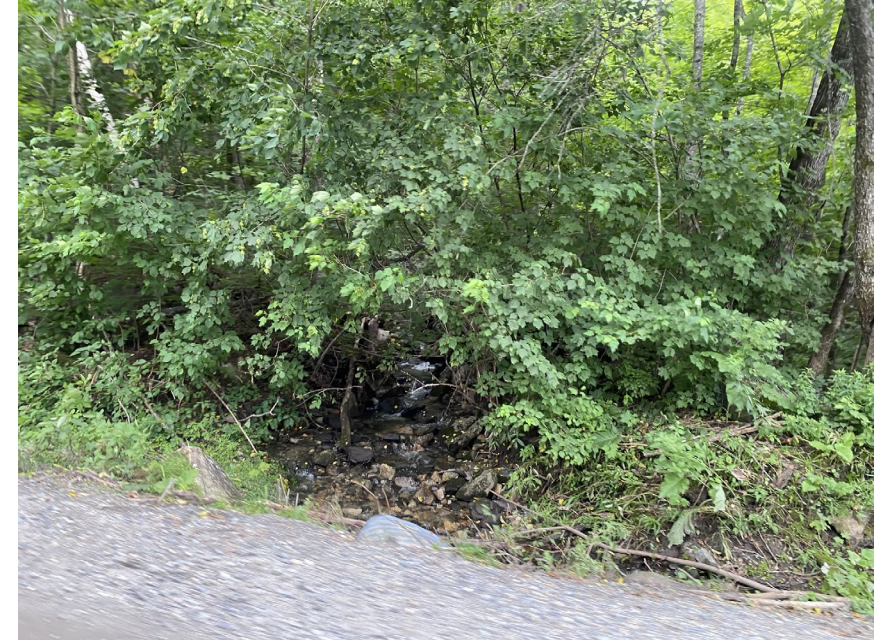
- Unstable streambanks
- Scour / erosion near stream culverts
- Lack of robust vegetated buffer
- Unfiltered channelized stormwater inputs into streams

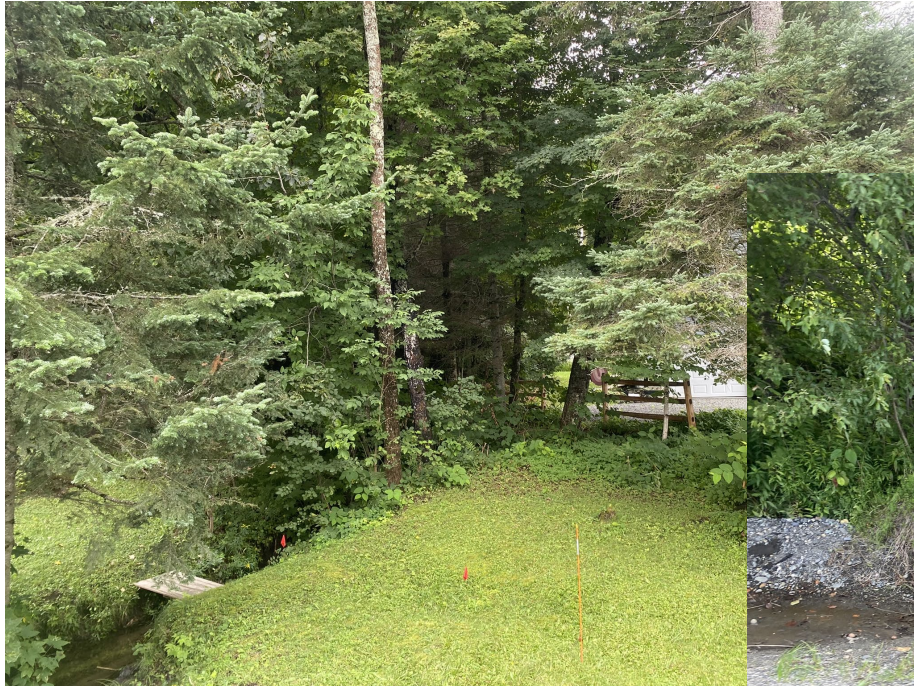
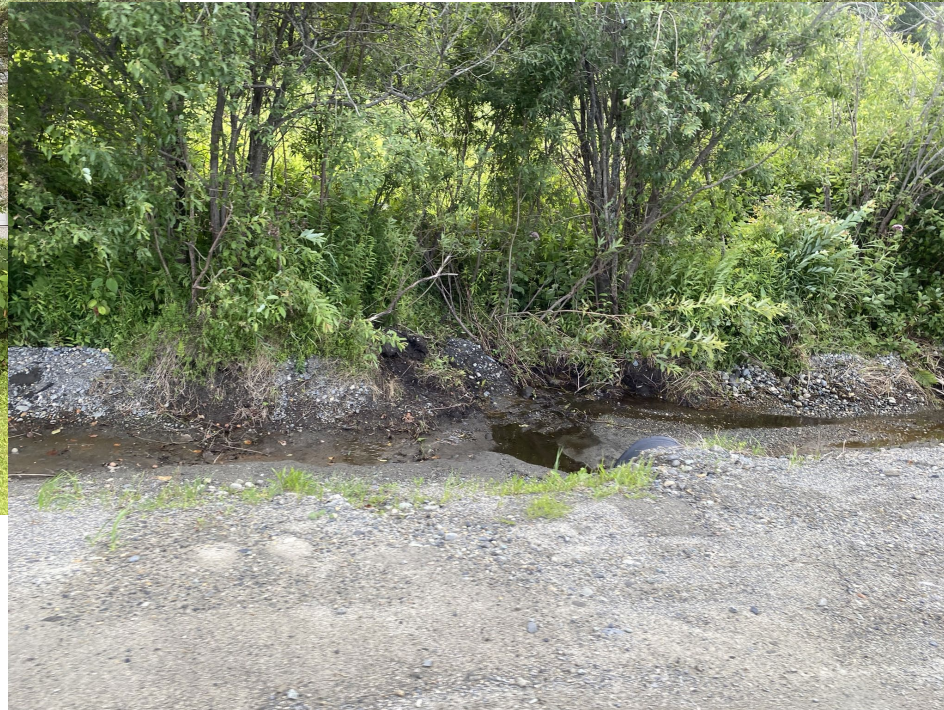
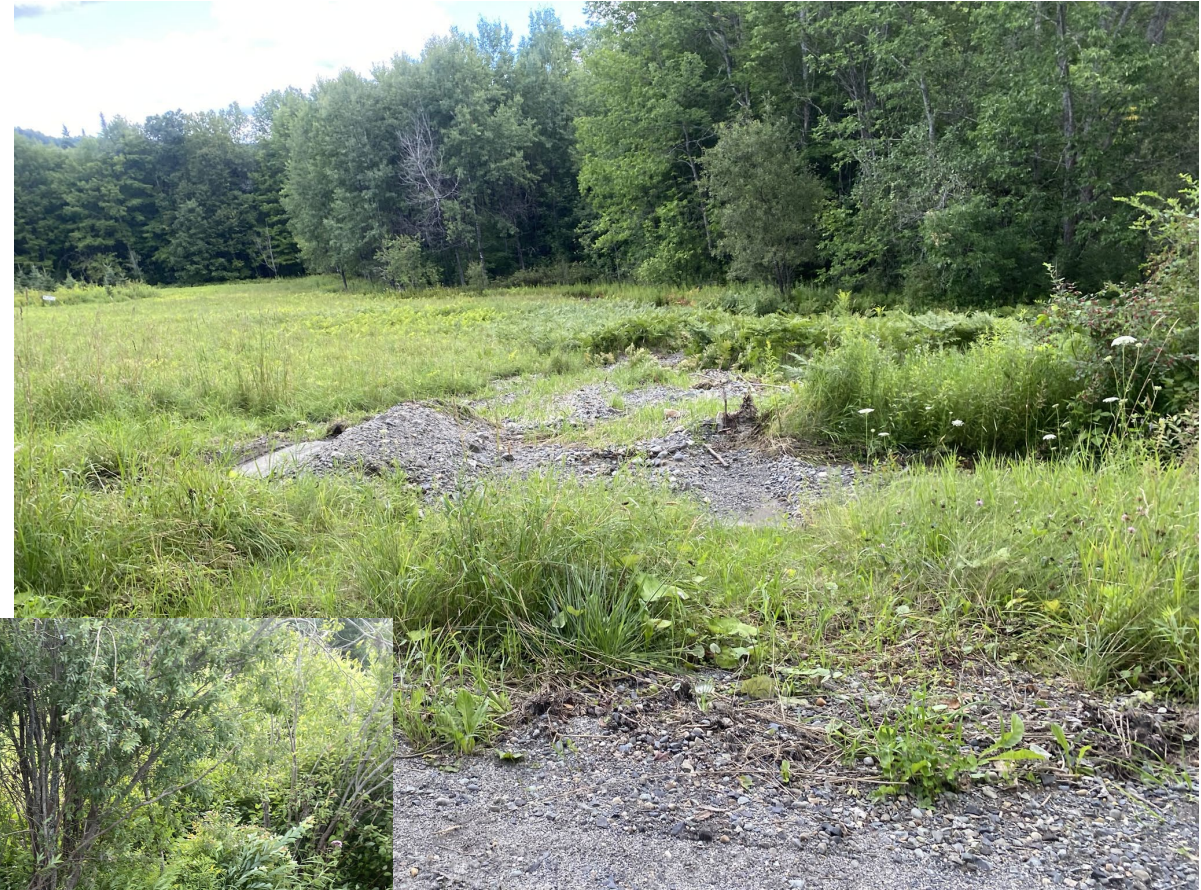
- Unstable streambanks
- Scour / erosion near stream culverts
- Lack of robust vegetated buffer
- Unfiltered channelized stormwater inputs into streams

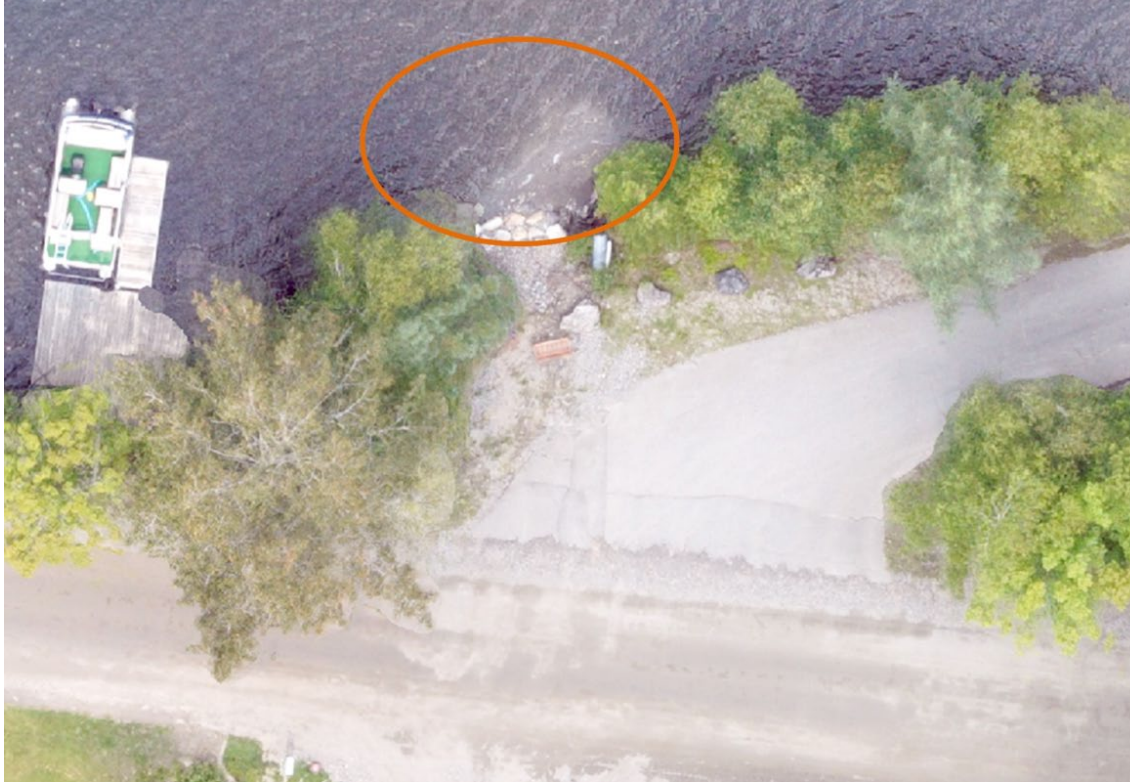
The Fish and Wildlife Access area - stormwater is flowing c
vegetated and eroding shoreline and depositing sediment

Shadow Lake LWAP Phase 1 – Public Roads Summary Sheet		Project rank by sector: 4
Site name:	Fish and Wildlife Parking	
Approximate address:	1504 Shadow Lake Rd, Glover, VT 05839	
Sector type(s):	Public Areas including Roads	
Proposed BMP Description:	Proposed BMP details	
Provide a vegetated buffer along stream; upsize stream culvert and improve drainage in this area; culvert undersized; culvert by Shadow Lake Rd is partially clogged with sediment. This area should be stabilized and cleaned of sediment. A bioretention is recommended in low area of parking lot. Add vegetated buffer along lake side of boat ramp and stabilize area around existing bench.	Current site type	Parking Lot
	Drainage area size	Medium
Site Description Stream jumped banks and eroded parking area in July storm. Benefits: water quality improvements, stormwater management, and shoreline improvements (habitat, shading, stabilization).	Water Quality Concern	High
