Restoring Water Quality in the Lake Memphremagog Basin: Evaluating Project Effectiveness along Nine Tributaries in 2018

24 January 2019

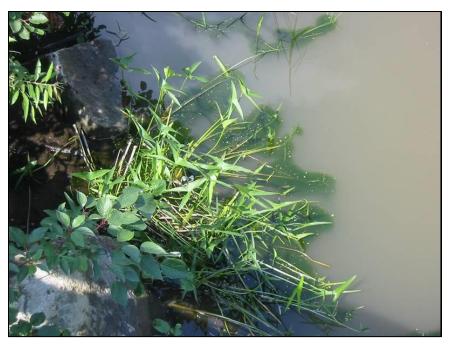
Figure 1. Turbid water and algae near the mouth of the Johns River in Derby, Vermont in 2006. Excessive nutrients and sediment increase plant and algal growth and decrease water quality.

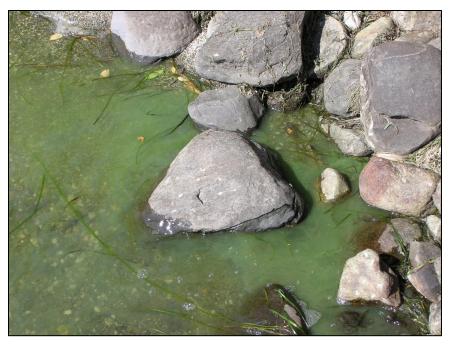
Figure 2. Cyanobacterial bloom along the north shore of Derby Bay in Derby, Vermont on 23 September 2008 (photograph courtesy of Karen Lippens). Cyanobacterial blooms are exacerbated by high nutrient and sediment levels and indicate that water quality is declining in Lake Memphremagog.

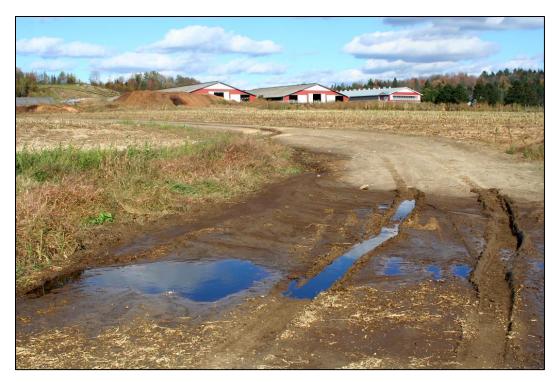
Figure 6. Mortality compost pile (to front and left of barns) and agricultural production area on a large farm operation along the northern branch of Brighton Brook in Irasburg, Vermont on 8 October 2013. Note the darkened ground where leachate from the mortality compost pile flowed along and puddled at the bottom of the farm road.

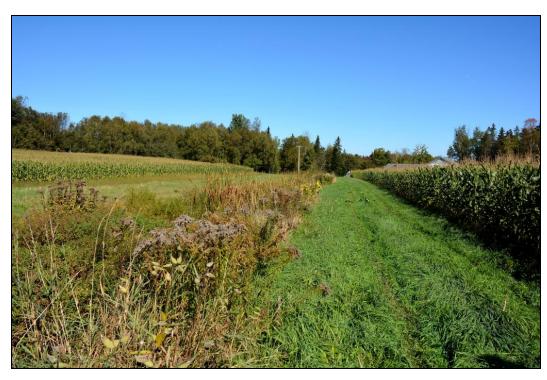
Figure 11. Agricultural improvement projects, such as this filter strip along a small, ditched stream, have the potential to greatly improve water quality in the Lake Memphremagog Basin. Photographed in Irashurg, Vermont on 2 October 2017.

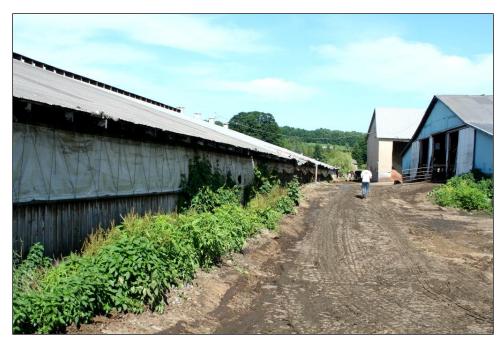
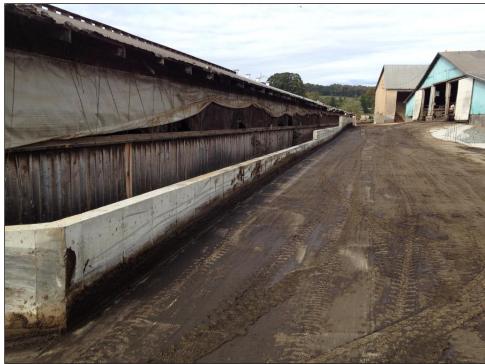
Figure 15. The large farm along the Tributary of Stearns Brook undertook numerous clean water diversion and runoff control projects during 2015-2018 to improve water quality conditions in the Tributary of Stearns Brook. The top photograph shows a barnyard area on 3 July 2015, and the bottom photograph shows the same area during construction of a barrier to separate clean and contaminated water on 28 September 2015 (bottom photograph courtesy of Ben Copans).

County Natural Resources Conservation District, the owners of this farm developed and implemented a number of water quality improvement projects and practices during 2015-2018 to divert runoff from driveways into hay fields, to divert clean water away from the barnyards and laneways, to collect contaminated runoff from the barnyards and laneways into the manure pits, and to add filter strips and cover-cropping to many of the corn fields (Figure 15).
