# Shadow Lake

## Phase 1 Lake Watershed Action Plan

Glover, VT  
August 23, 2023

# Shadow Lake Phase 1 LWAP

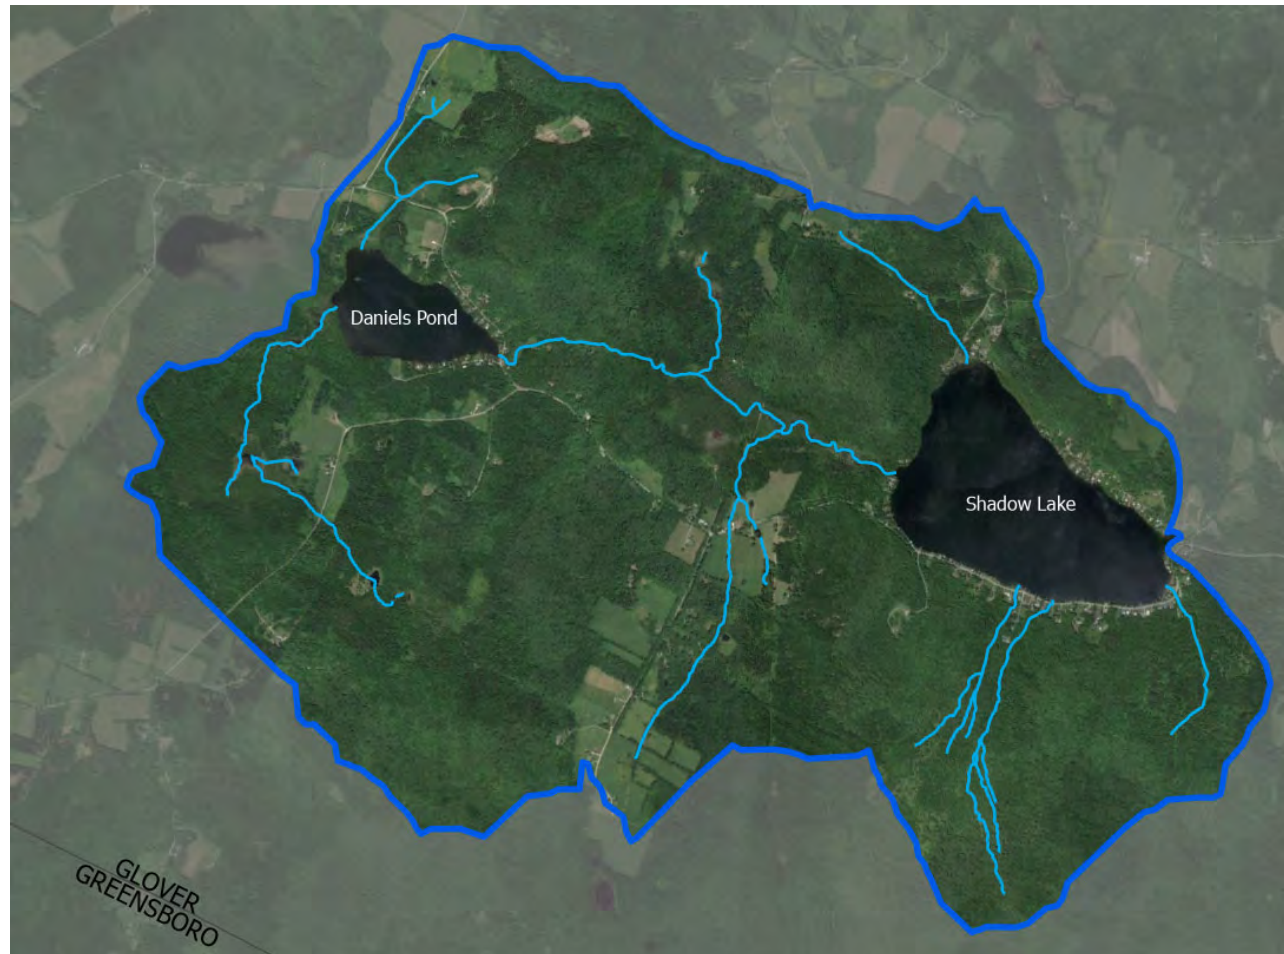
217-acre lake area

3,413-acre drainage area  
(dark blue line)

5 tributaries (light blue lines)  
9.46 miles of tributaries

Daniels Pond flows to Shadow  
Lake

Residence Time: 1.758 years

Lake Volume: 115.5 acre-feet

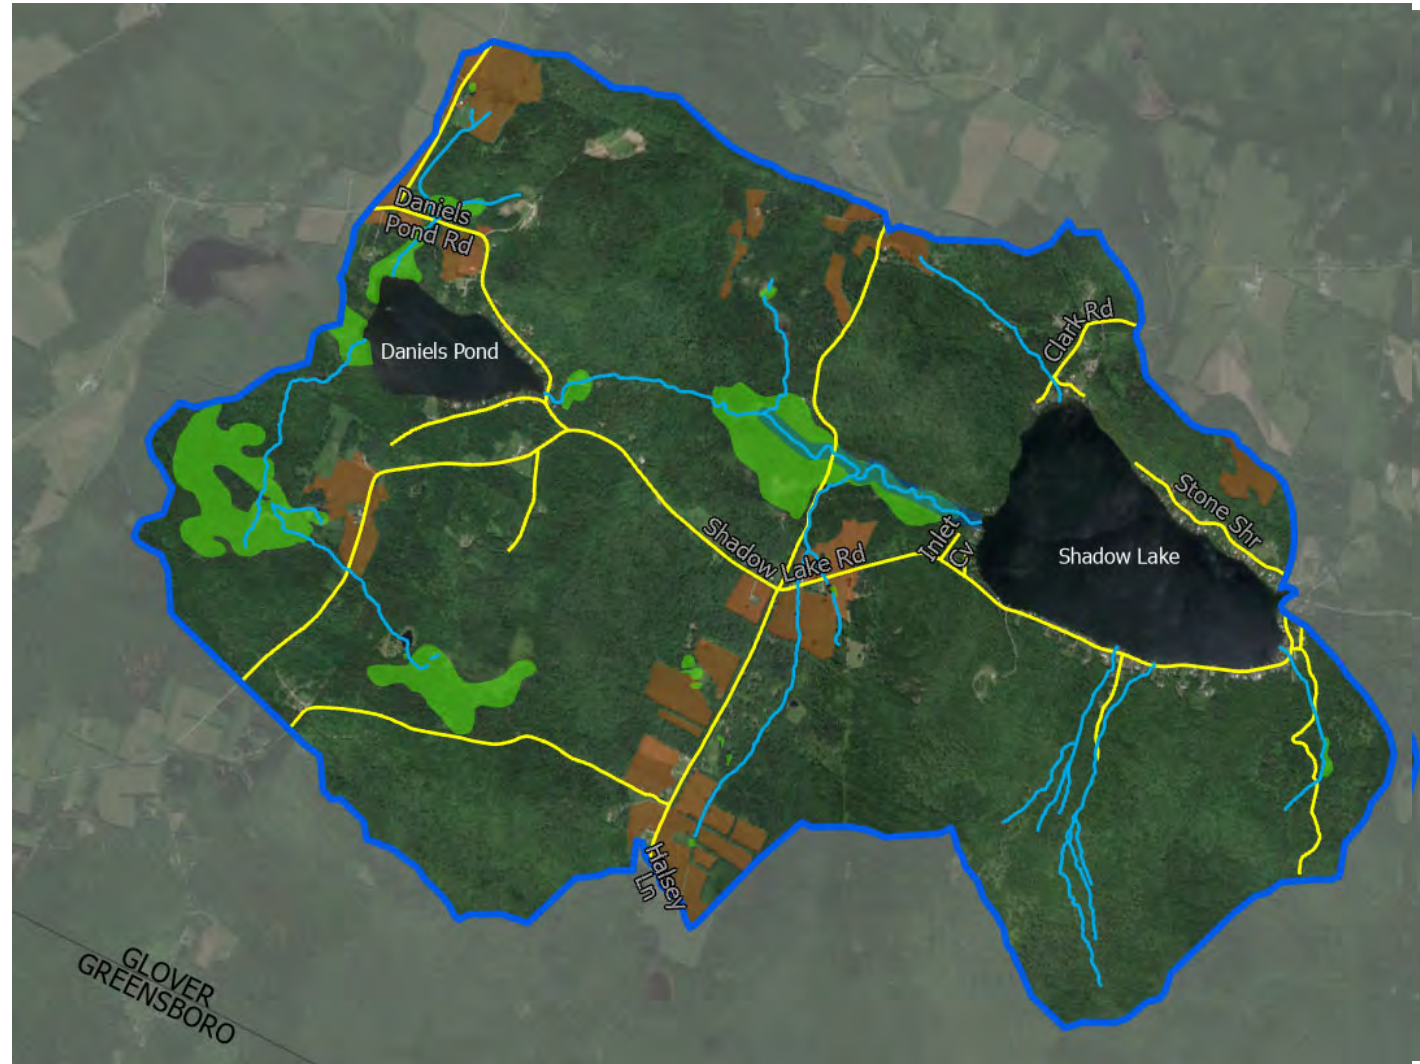
217-acre lake area

178 acres of mapped wetlands

200 acres of agricultural lands  
(brown)

121 mapped culverts,  
conveying water across roads  
or driveways (red dots)

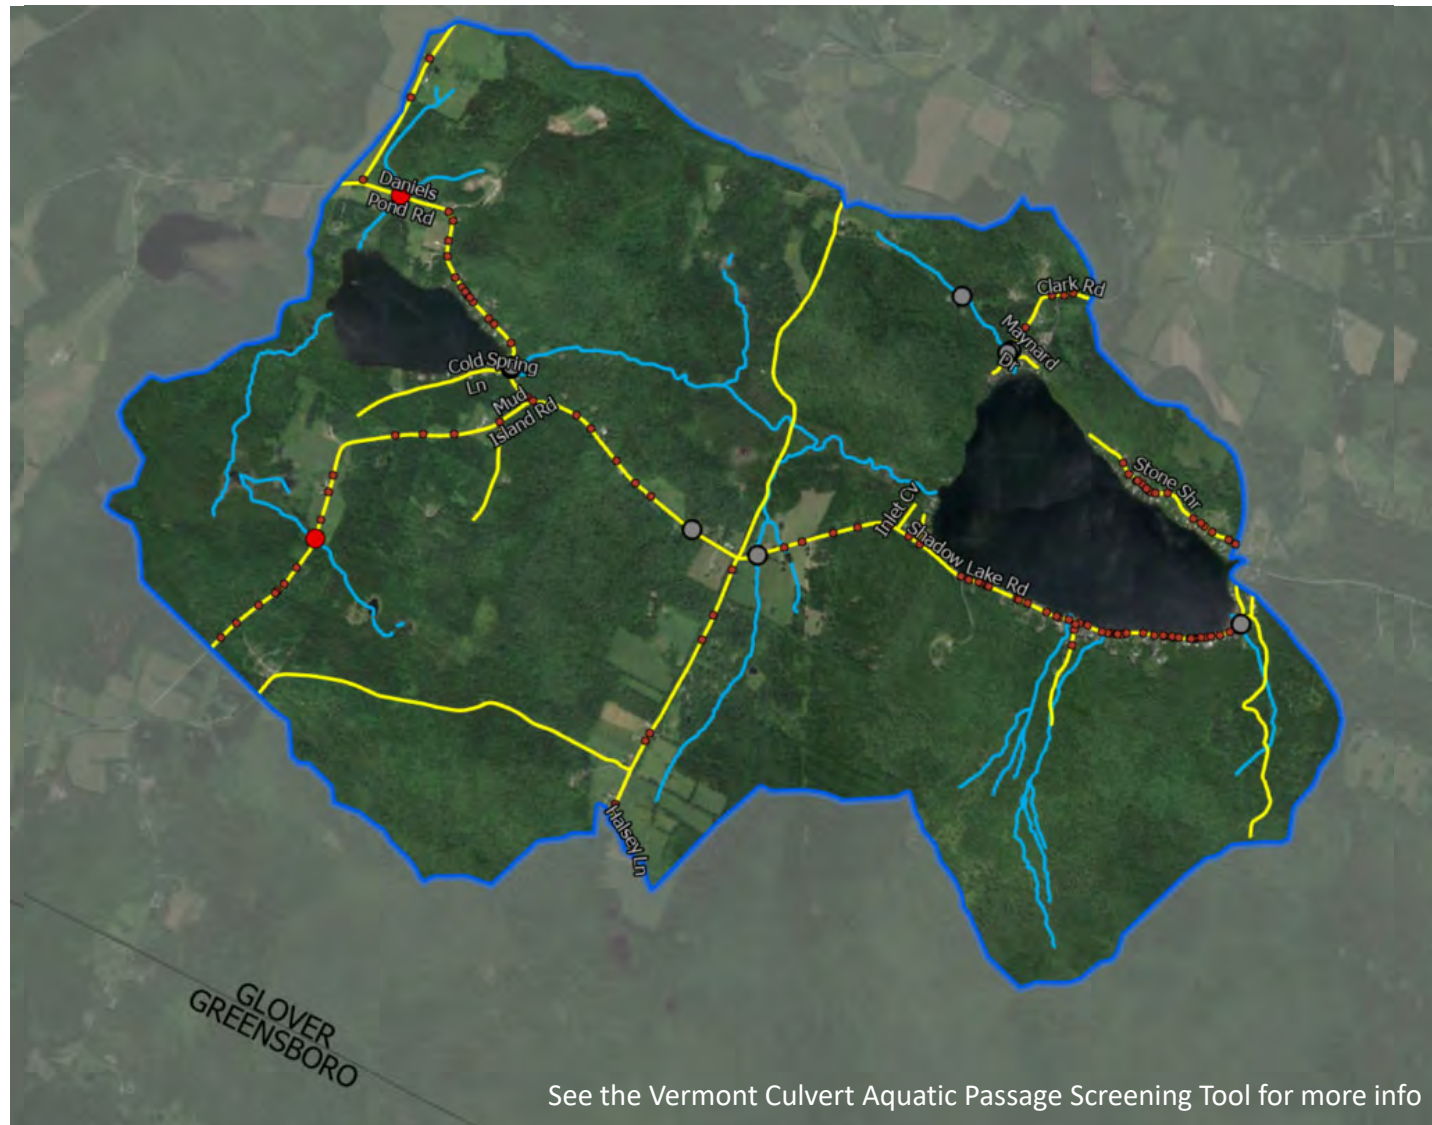
10 mapped stream crossing culverts, scored for Aquatic Organism Passage (AOP)

Red = No AOP for all aquatic organisms including adult salmonids

Grey = Reduced AOP for all aquatic organisms

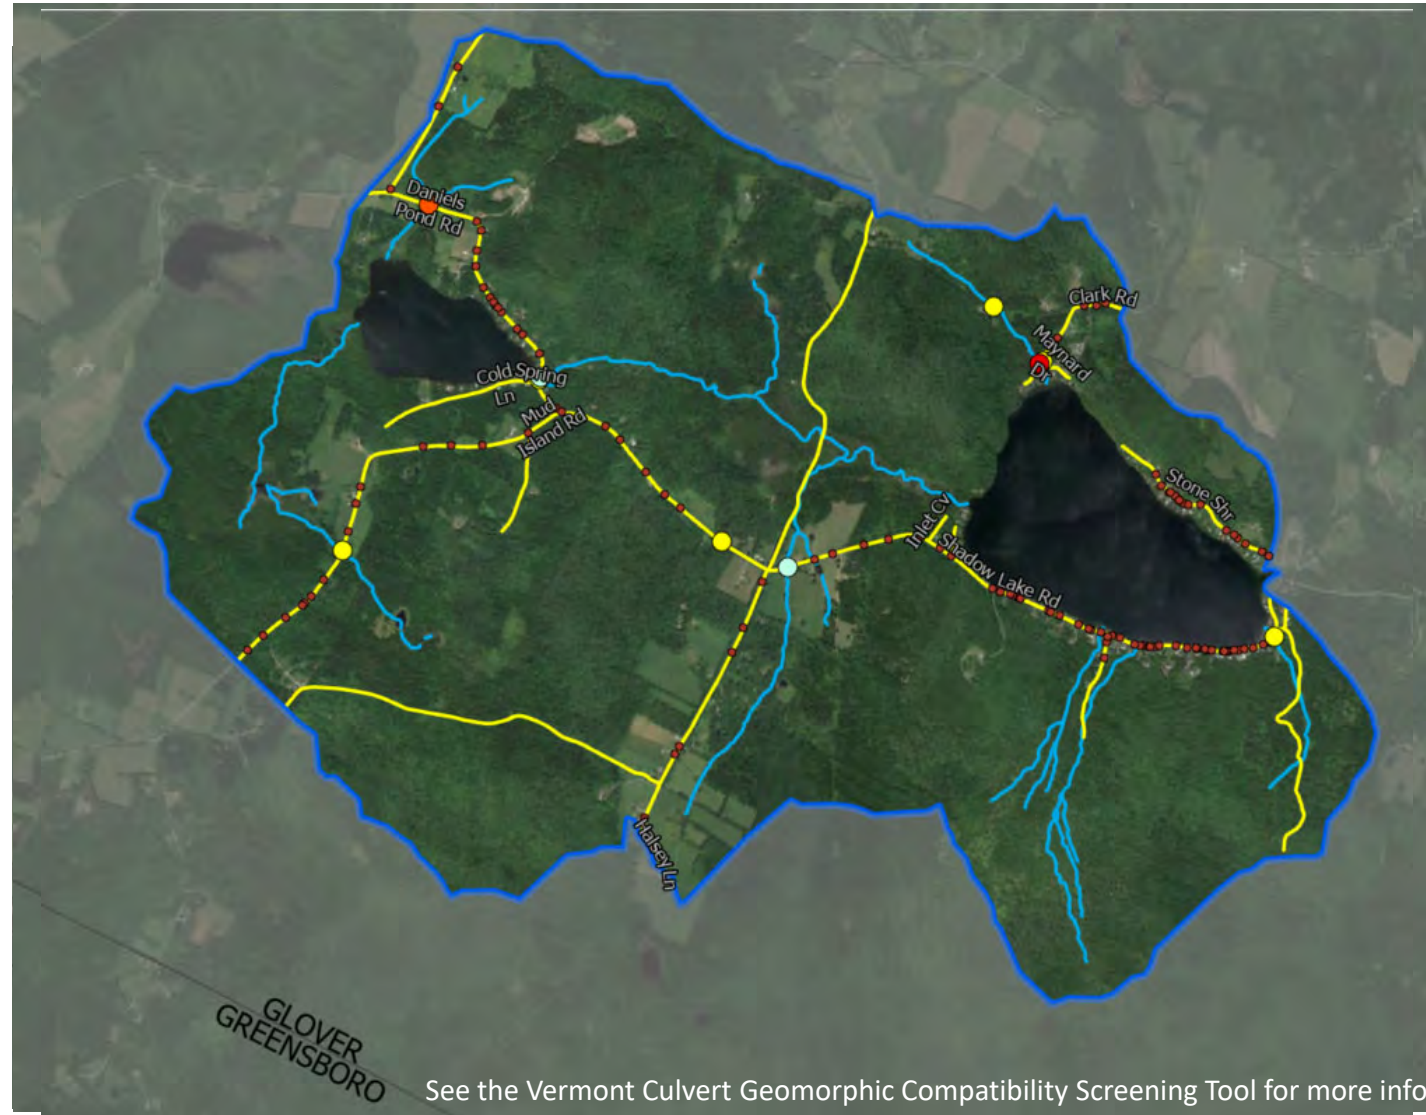
10 mapped stream crossing culverts, scored for  
Geomorphic Compatibility

Teal = Mostly Compatible

Yellow = Partially Compatible

Orange = Mostly Incompatible

Red = Fully Incompatible

- Structure fully incompatible with channel and high risk of failure.
- Re-design and replacement performed ASAP

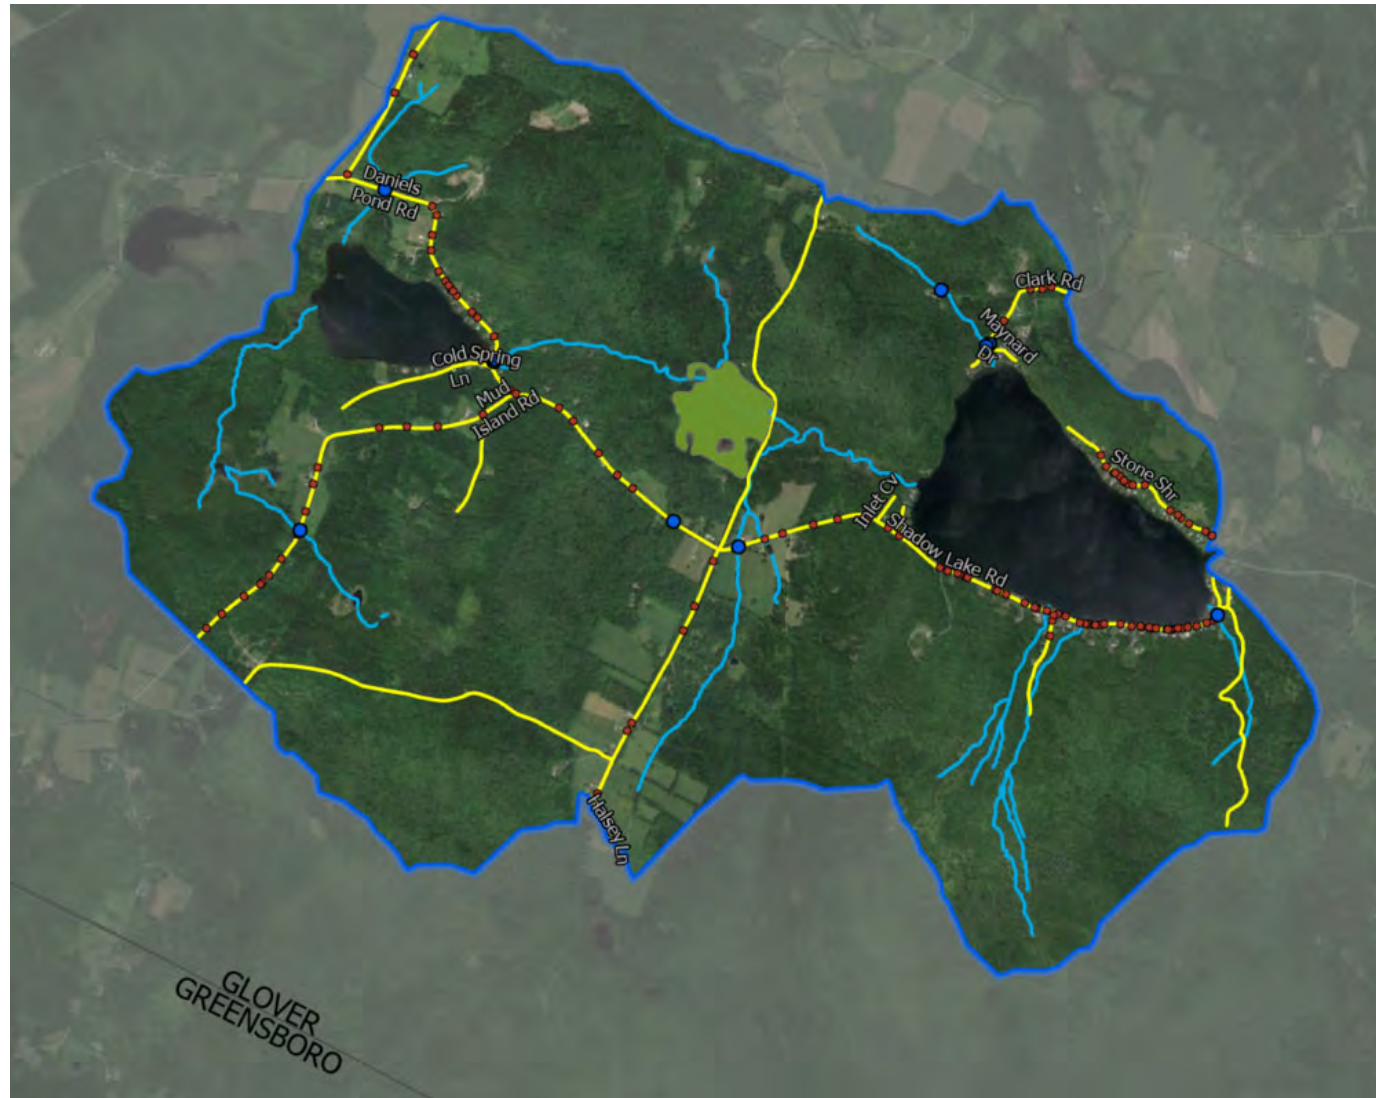
**393 Potentially Erosive Features  
(red) totaling 6 acres**

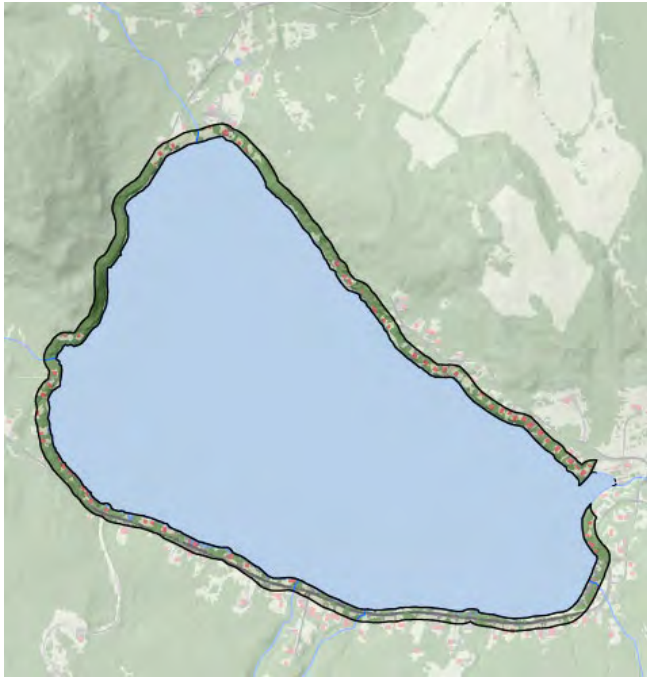
Greater percentage of impervious surface within the 100 ft buffer than in the entire watershed

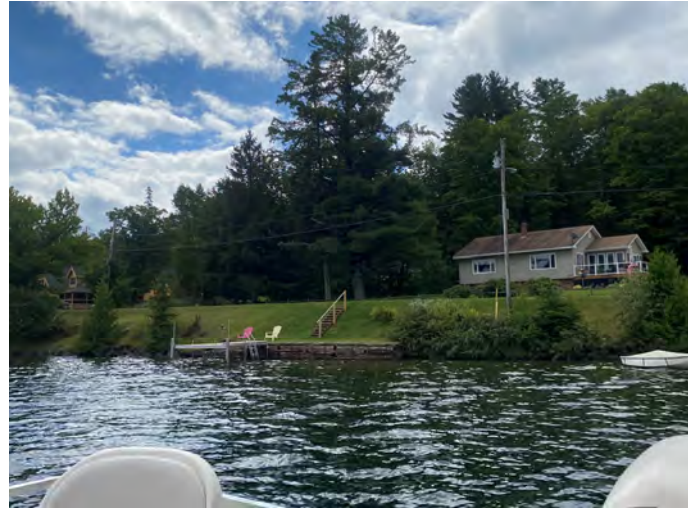
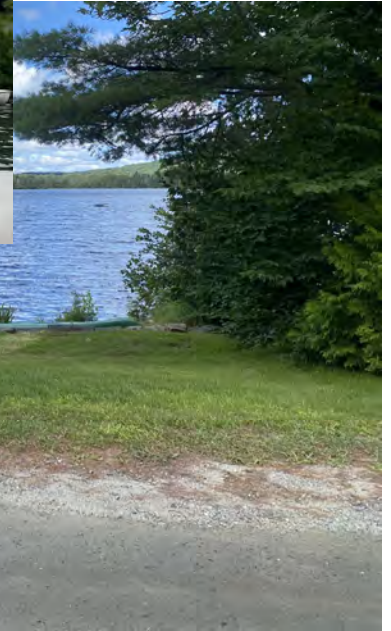
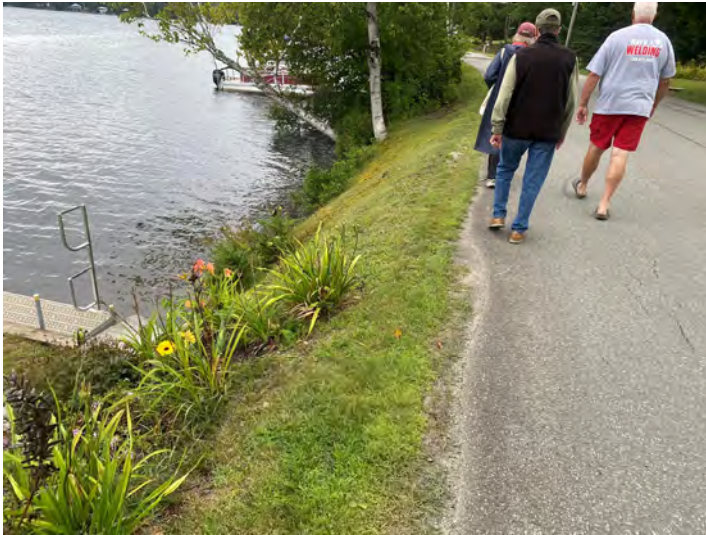
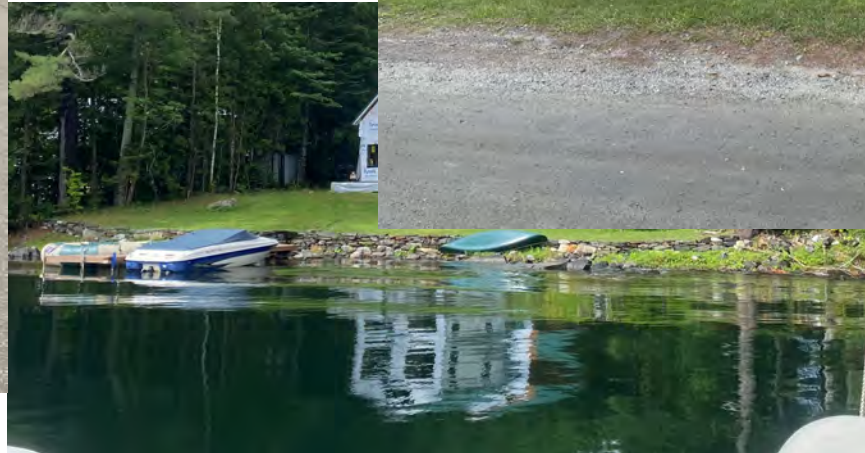
# Shoreland - Erosion

Lakeshores lacking robust native buffers can contribute higher nutrient loads. Shorelines can become unstable.

Turf grass has very shallow roots that does not stabilize the shoreline.

- Reassess road segments post-July storm and plan for safe passage of larger storm events
- Implement site-specific BMPs to capture and filter sediment and provide detention
- Apply unpaved driveway BMPs
- Preserve and protect large undeveloped parcels
- Illicit discharge survey
- Stabilize trails and prevent future damage from ATVs
- Complete Lakewise assessments and implement site-specific recommendations
- Improve lake buffers
- Stabilize roadside ditches and ensure they are cleaned out regularly

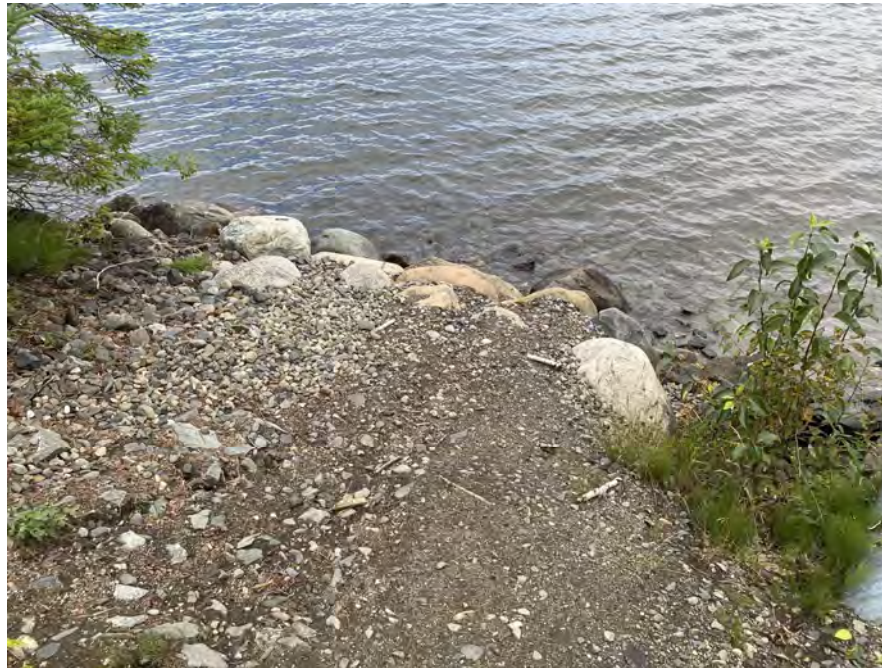
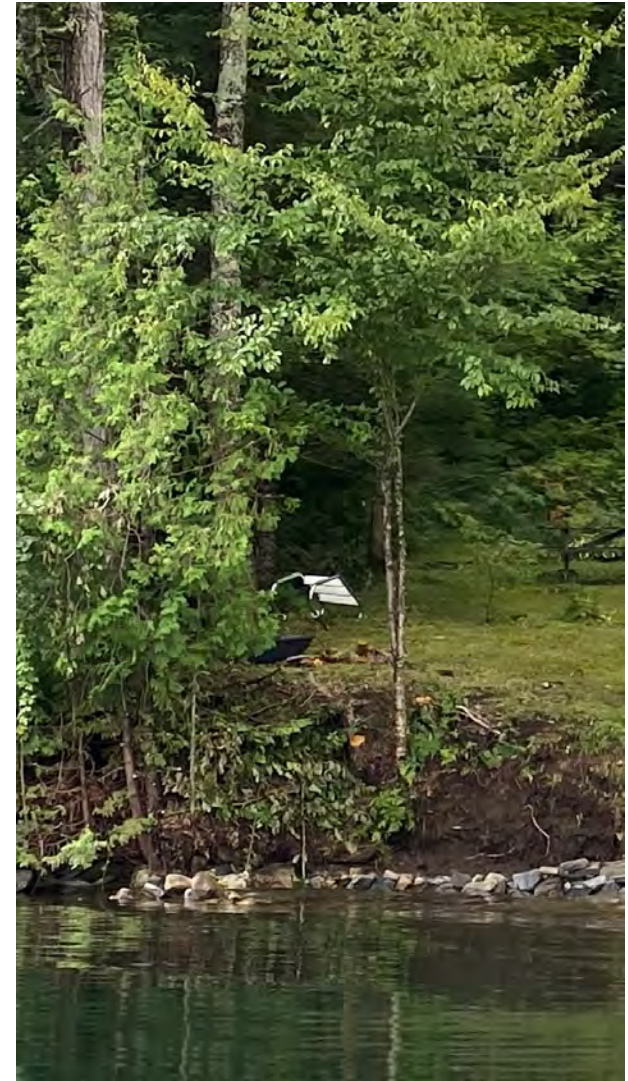
Bare soils, especially on a slope, are very prone to erosion.

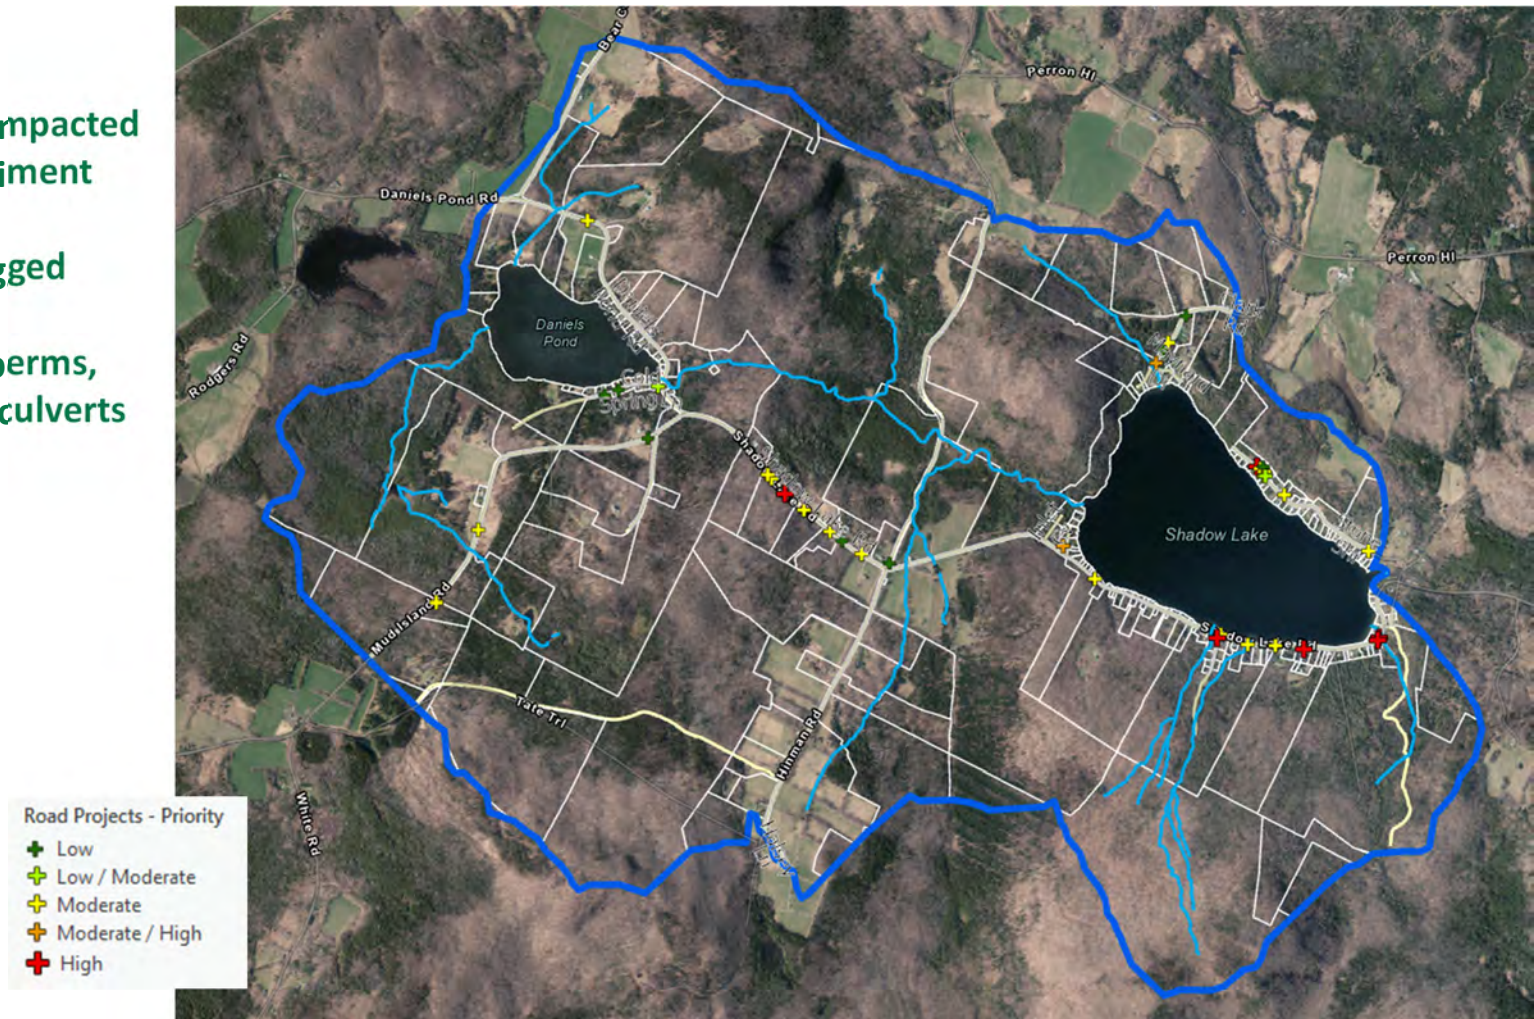
# Roadways

- Unstable ditches and uncompacted ditch slopes leading to sediment transport
- Undersized, absent, or clogged culverts
- Improper grading, grader berms, piled loose materials near culverts and streams

Unstable ditches and uncompacted ditch slopes leading to sediment transport

Improper grading, grader berms, piled loose materials near culverts and streams

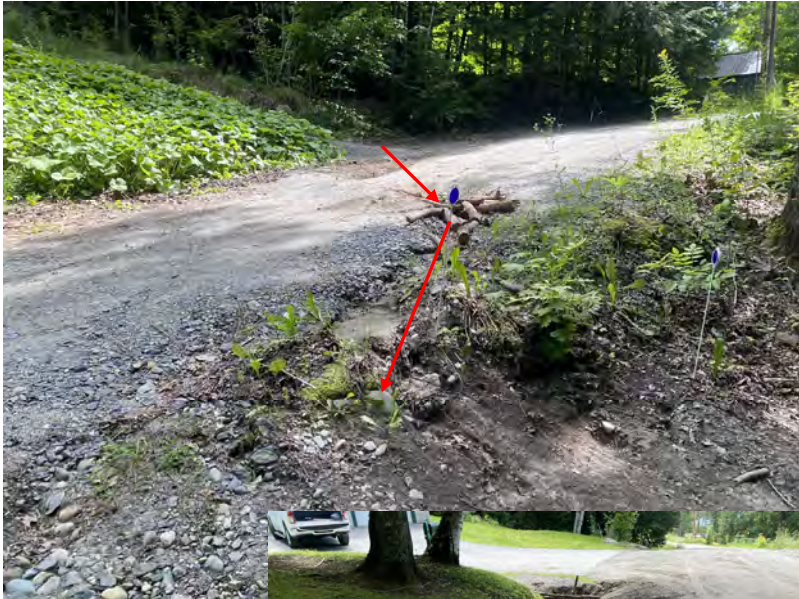
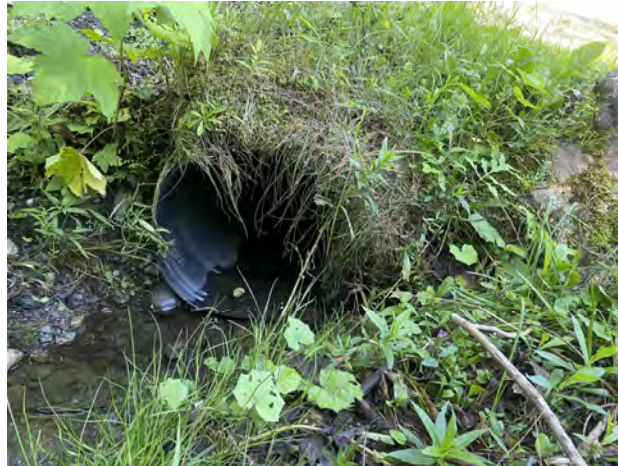
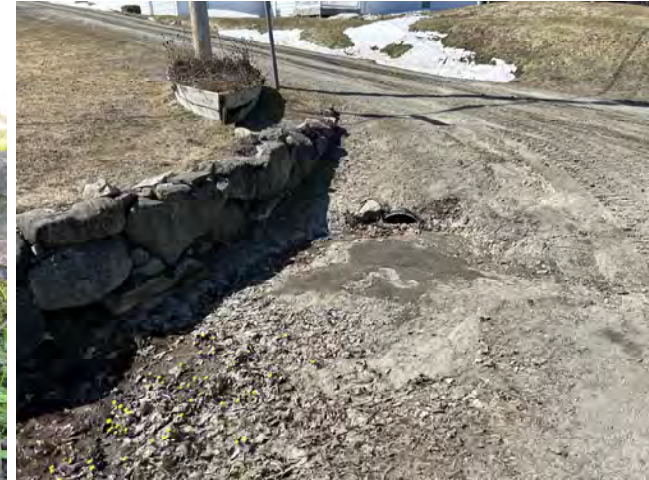
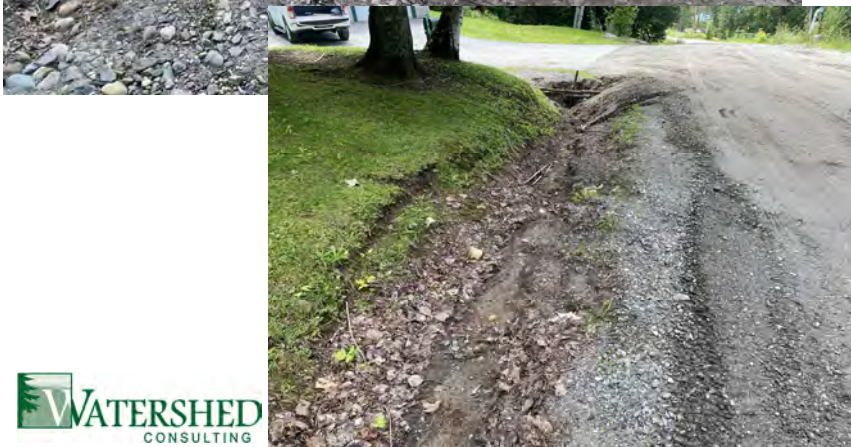
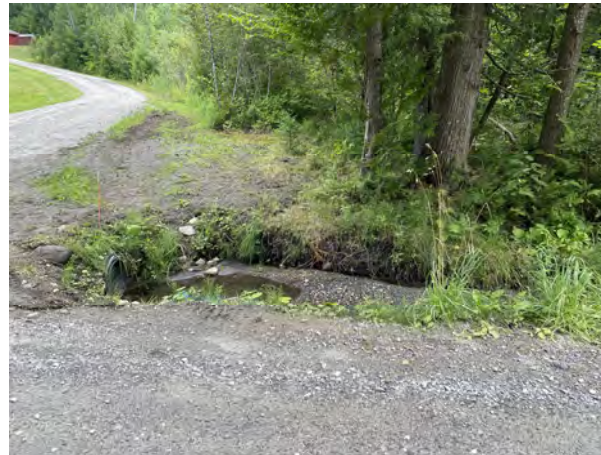
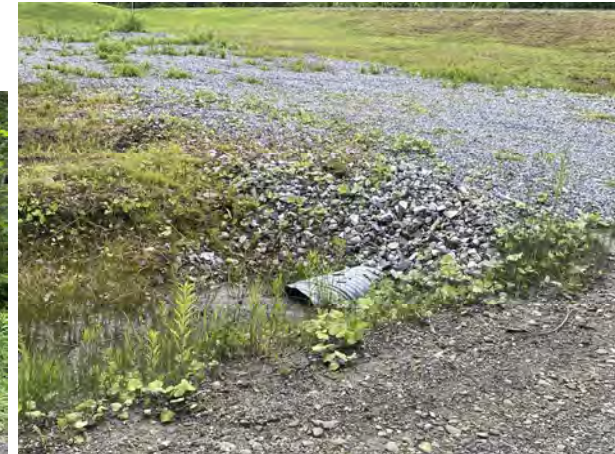
Undersized, absent, or clogged culverts

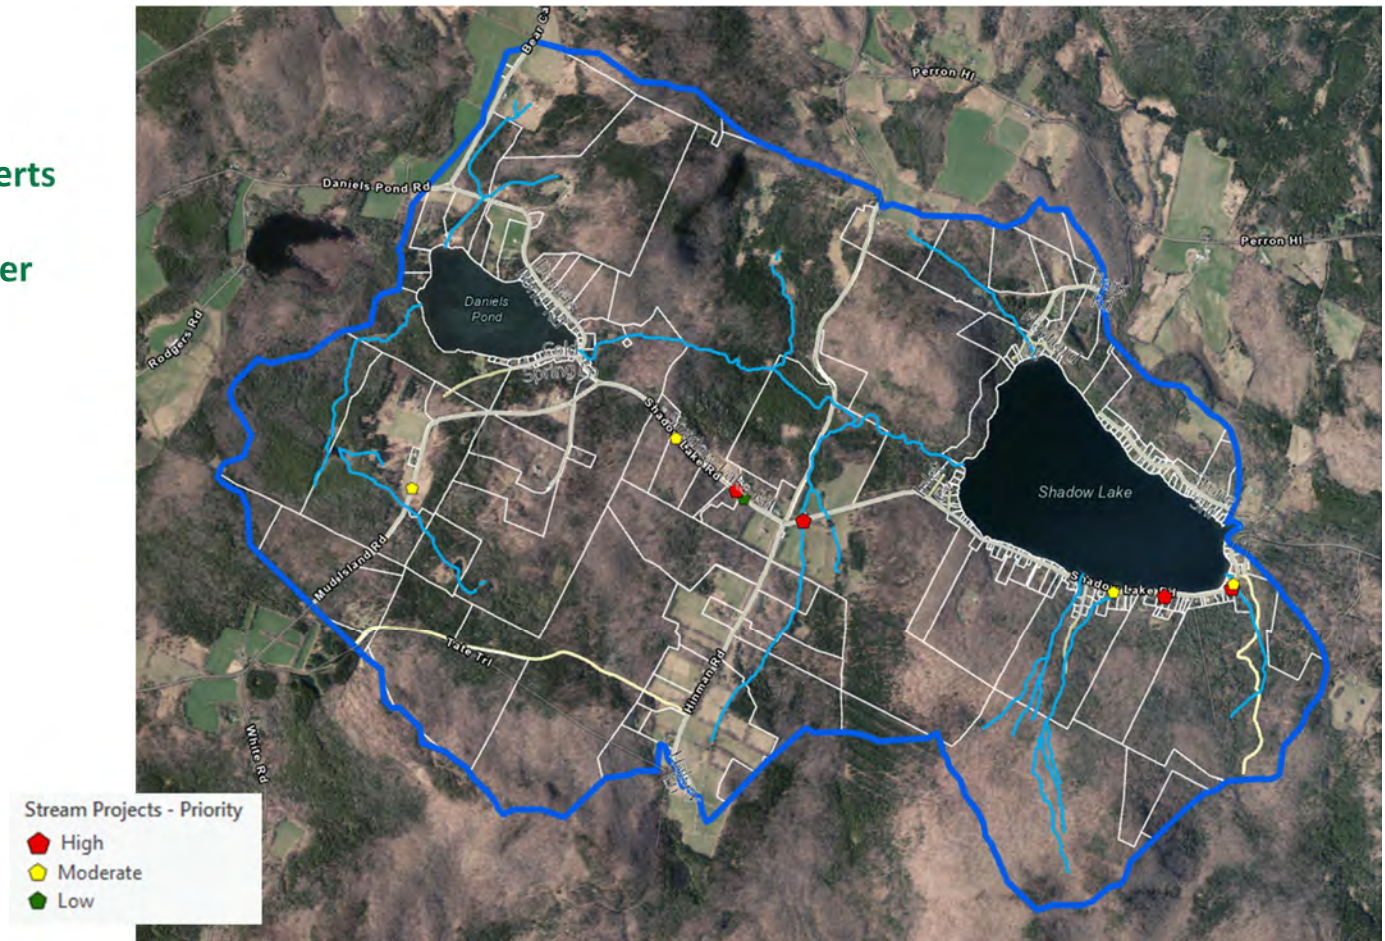
# Streams

- Unstable streambanks
- Scour / erosion near stream culverts
- Lack of robust vegetated buffer
- Unfiltered channelized stormwater inputs into streams

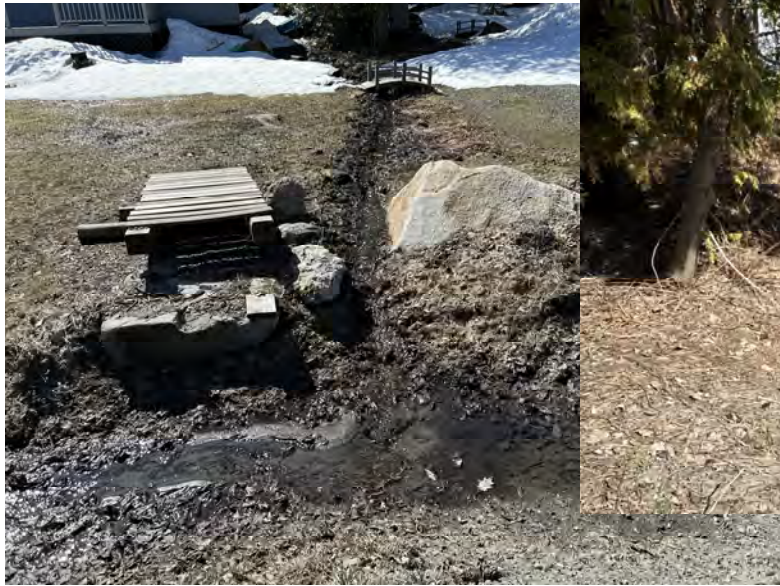
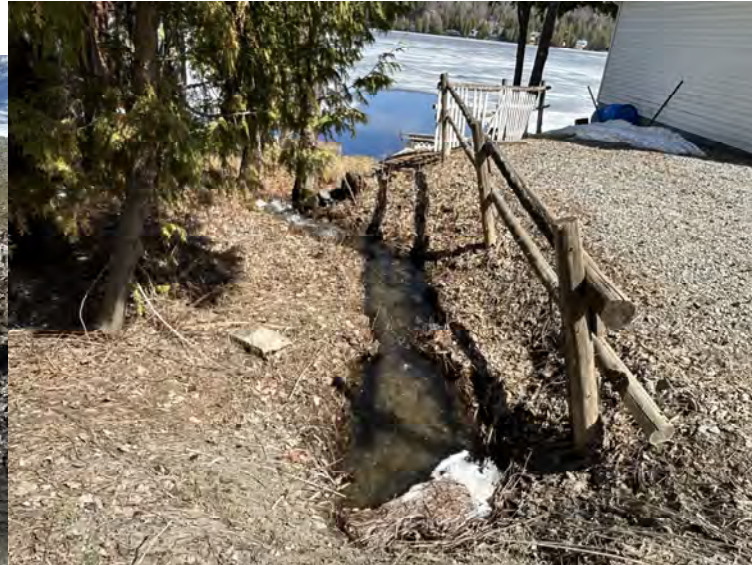
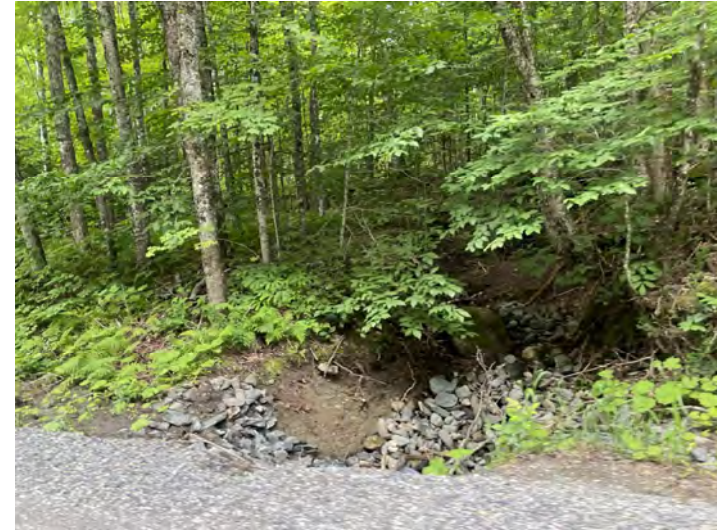
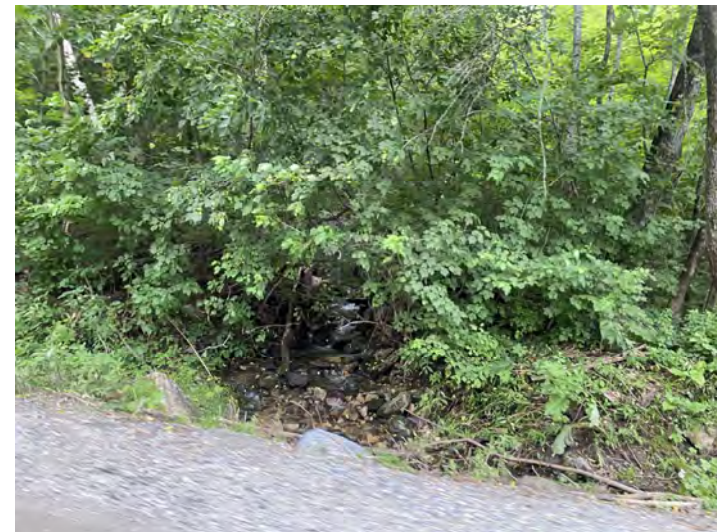
- Unstable streambanks
- Scour / erosion near stream culverts
- Lack of robust vegetated buffer
- Unfiltered channelized stormwater inputs into streams

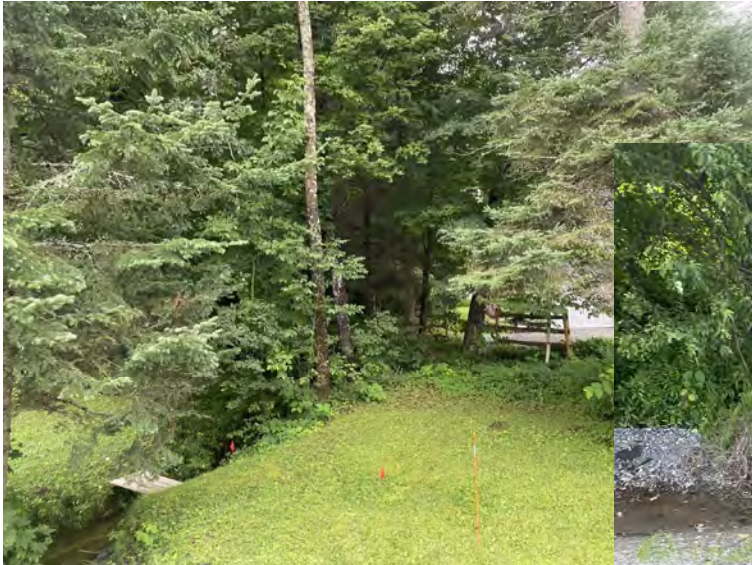
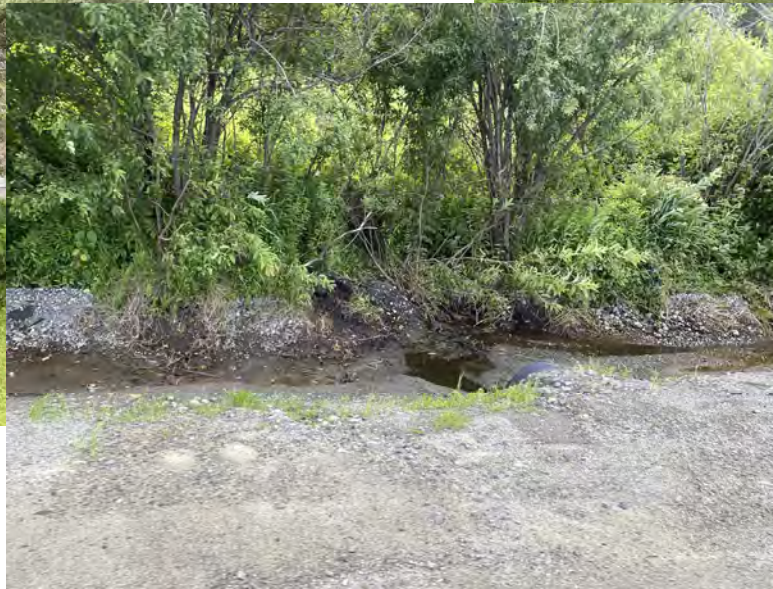
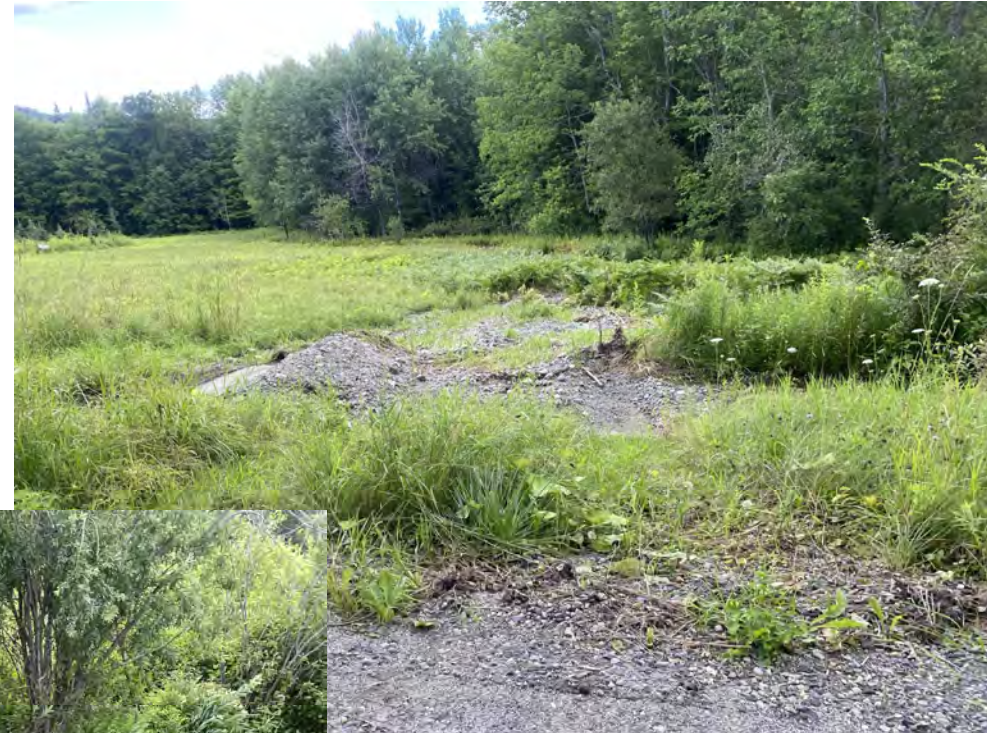
- Unstable streambanks
- Scour / erosion near stream culverts
- Lack of robust vegetated buffer
- Unfiltered channelized stormwater inputs into streams

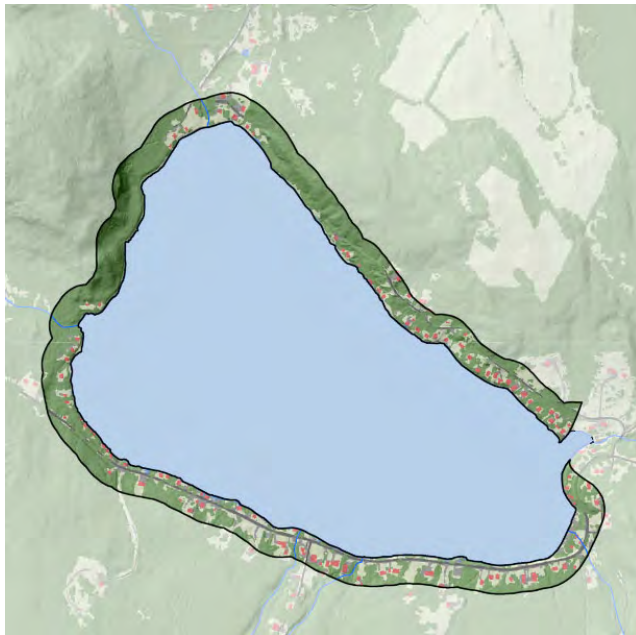
# Land Cover: Lake 250ft buffer

More forested percentage of land cover within 250 ft of Shadow Lake than 100 ft, but still much higher percent impervious than overall watershed
