Shadow Lake

Phase 1 Lake Watershed Action Plan

Data Library Summary

Glover, VT

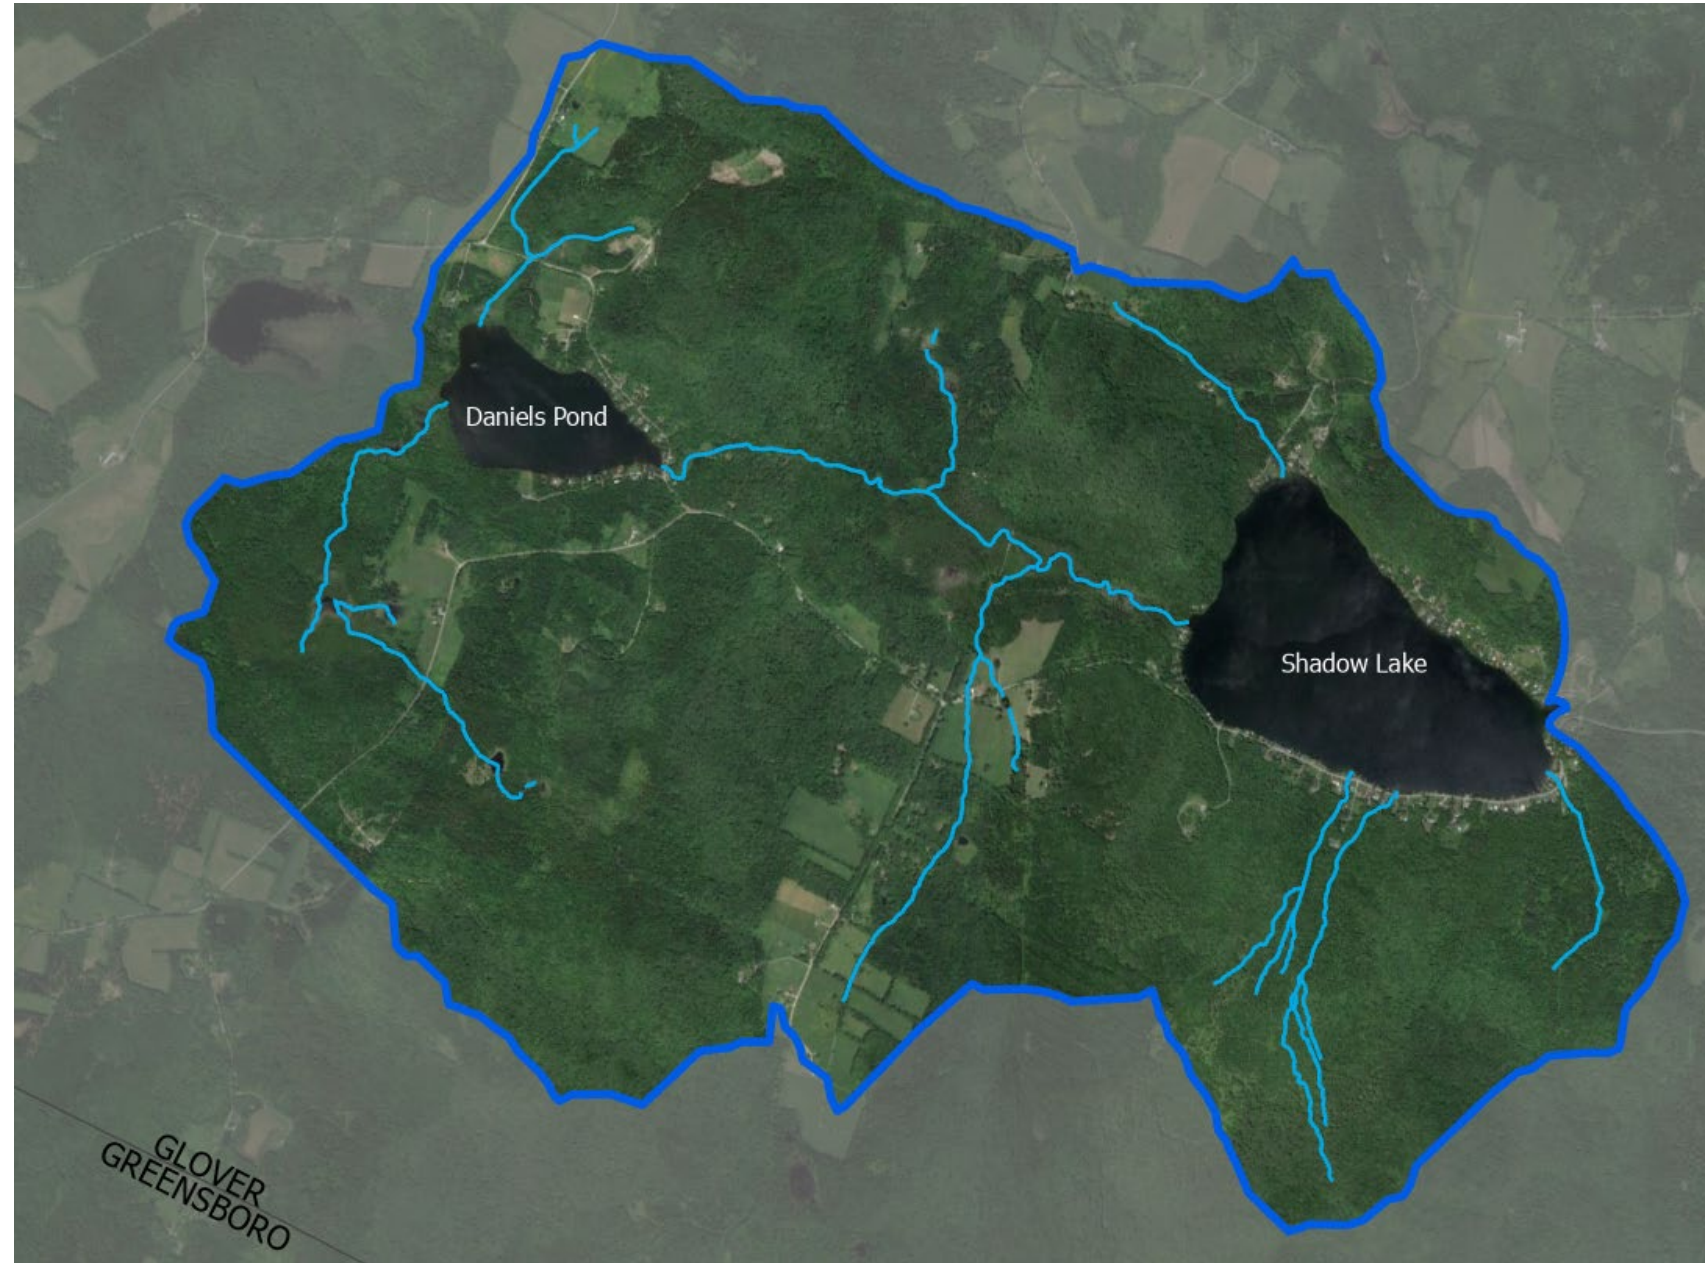
217-acre lake area

3,413-acre drainage area
(dark blue line)

5 tributaries (light blue lines)
9.46 miles of tributaries

Daniels Pond flows to Shadow
Lake

Residence Time: 1.758 years

Lake Volume: 115.5 acre-feet

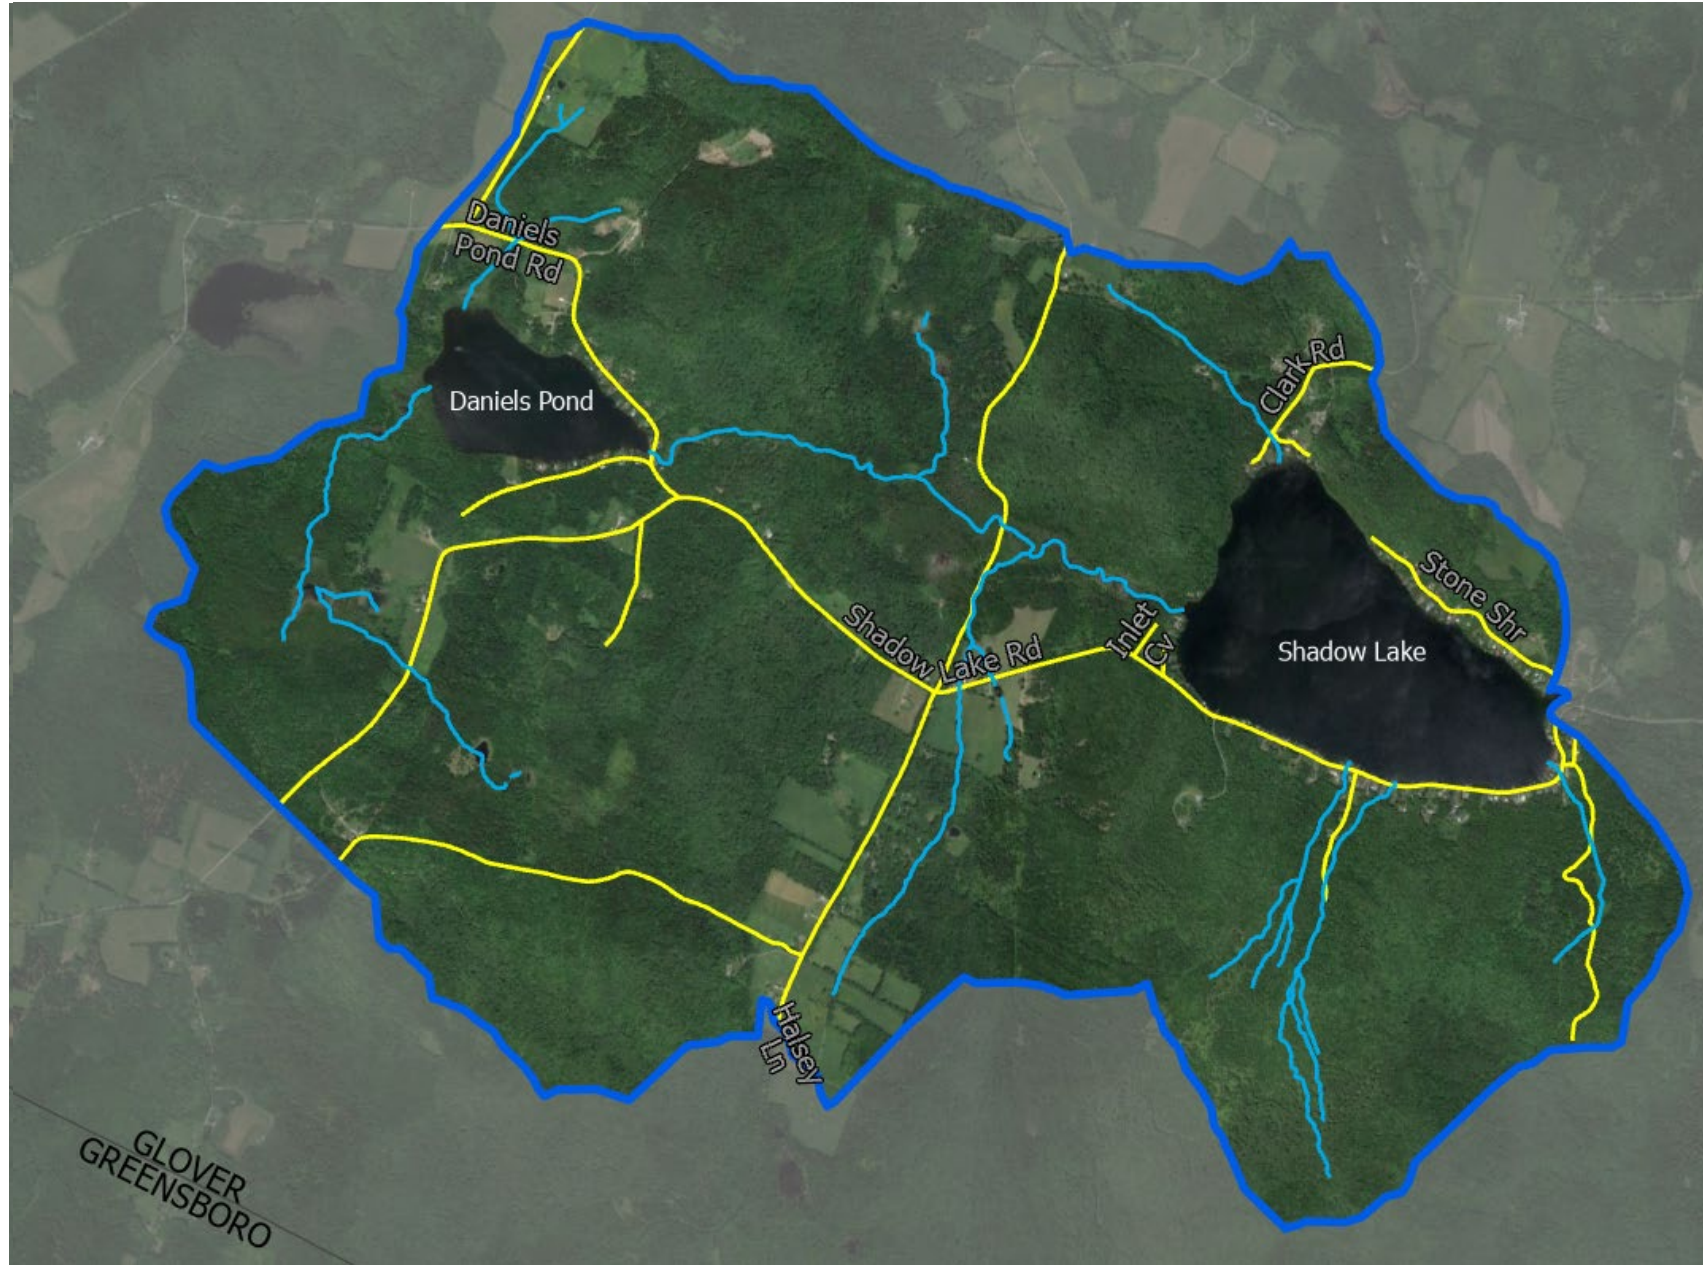
217-acre lake area

3,413-acre drainage area

Main roads shown in yellow

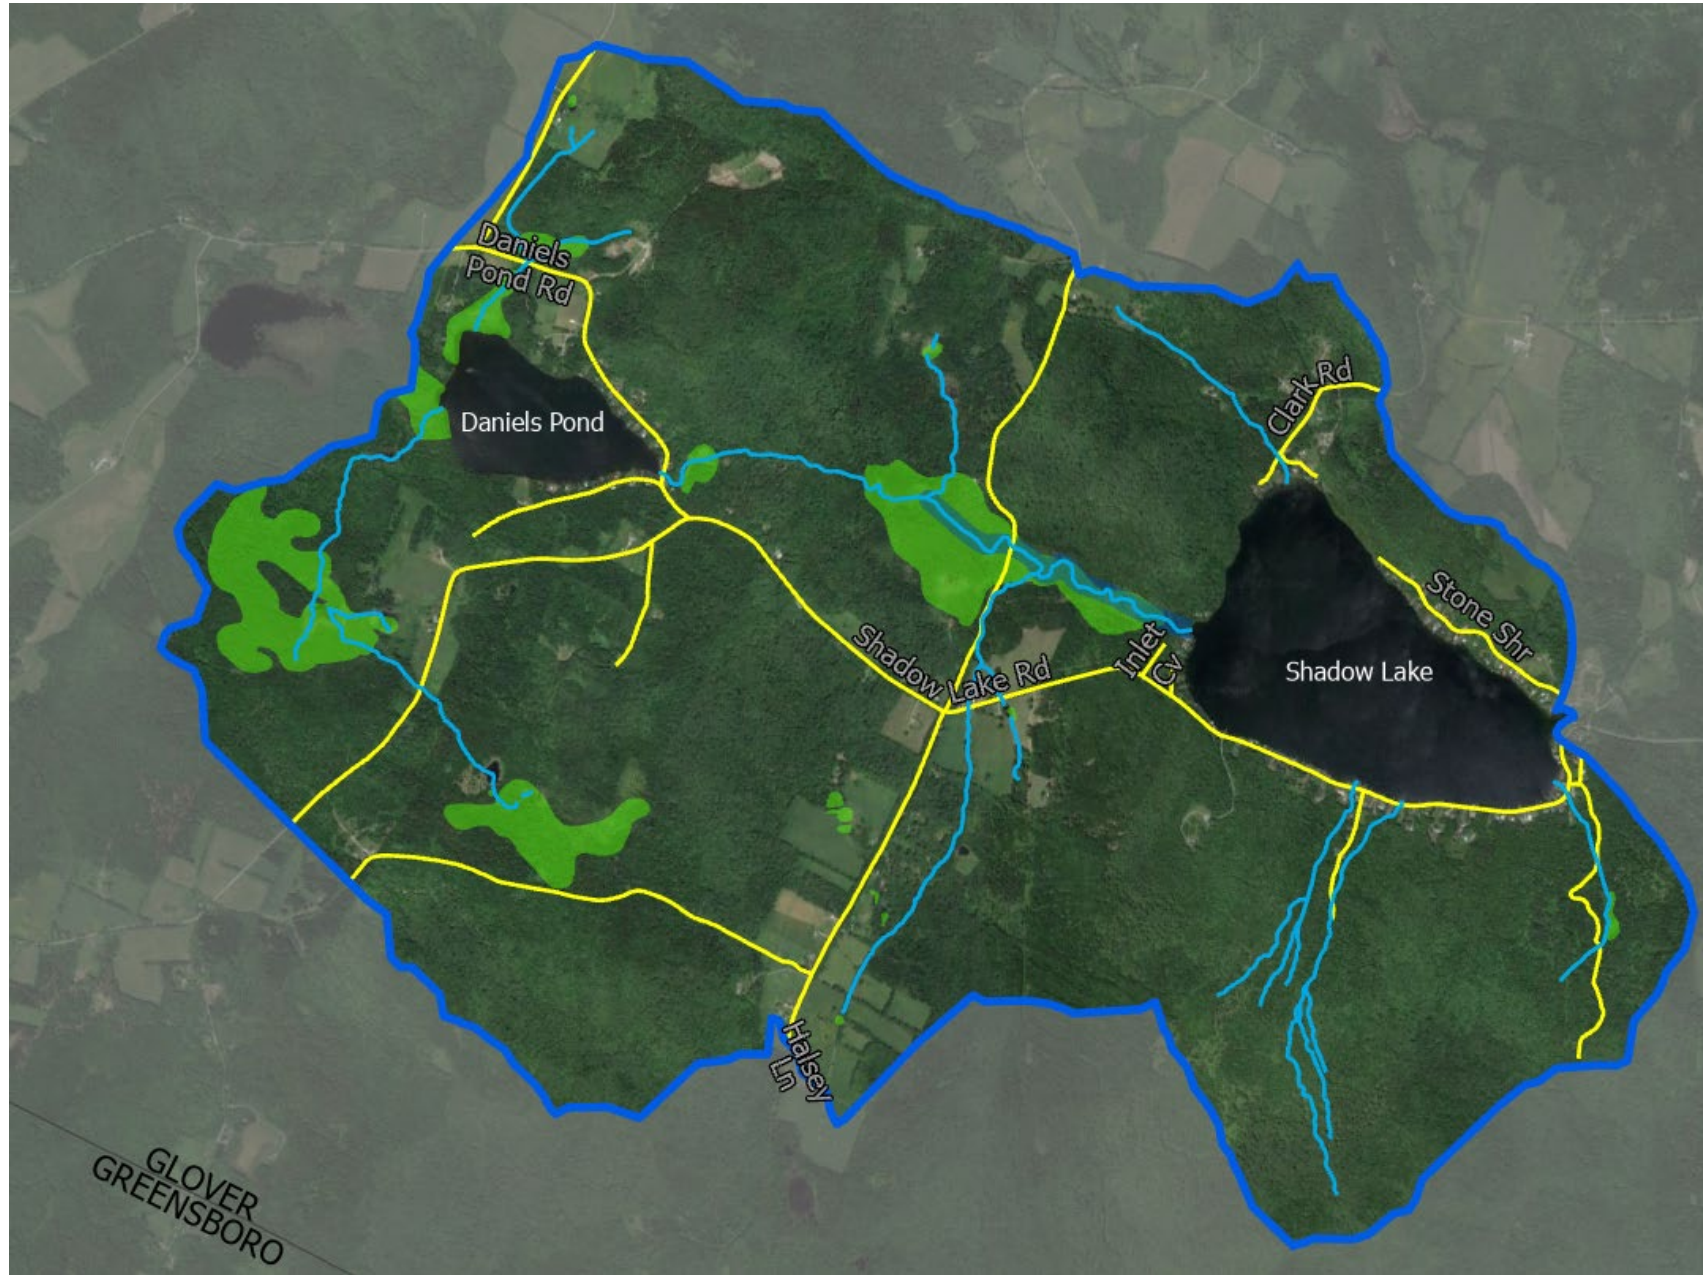
178 acres of mapped wetlands
(green)

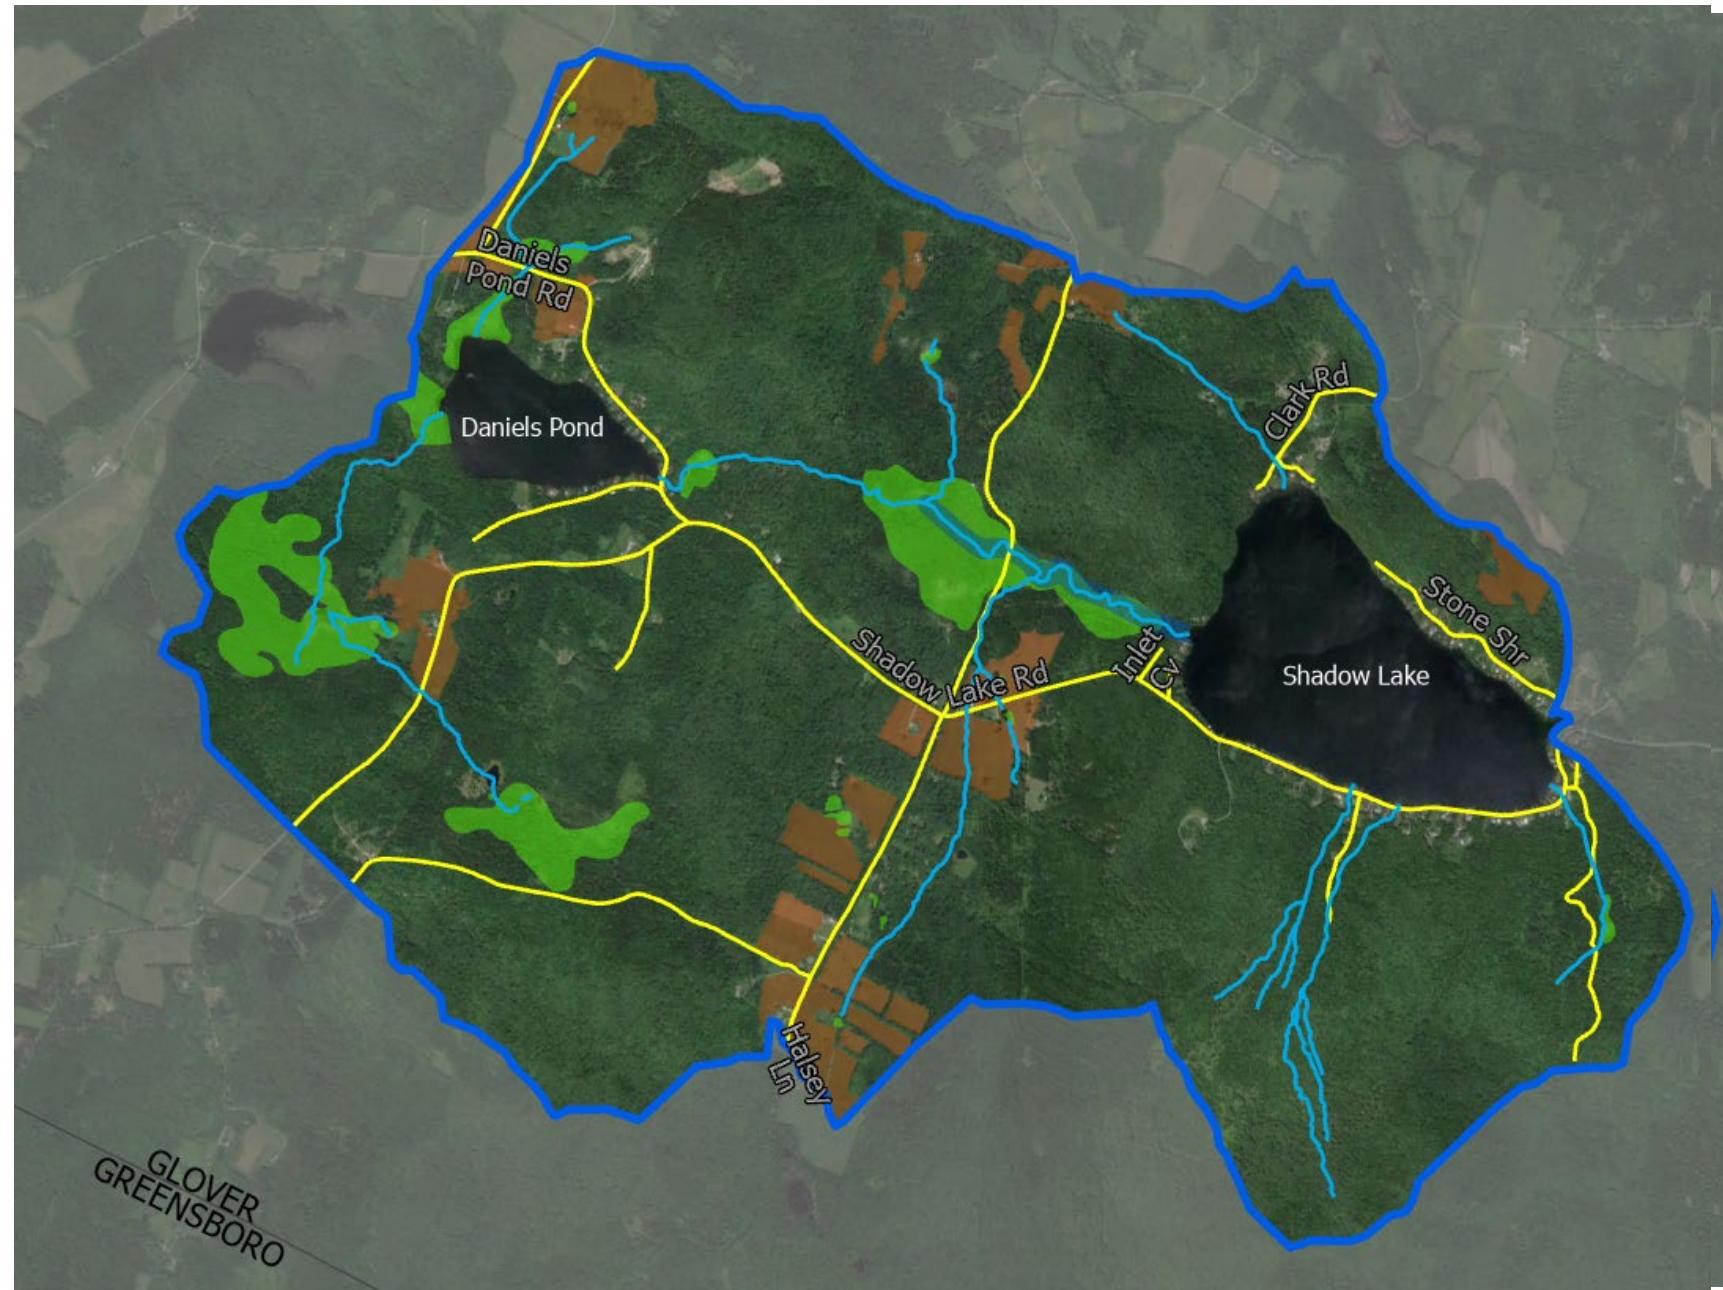
178 acres of mapped wetlands
(green)

200 acres of agricultural lands
(brown)

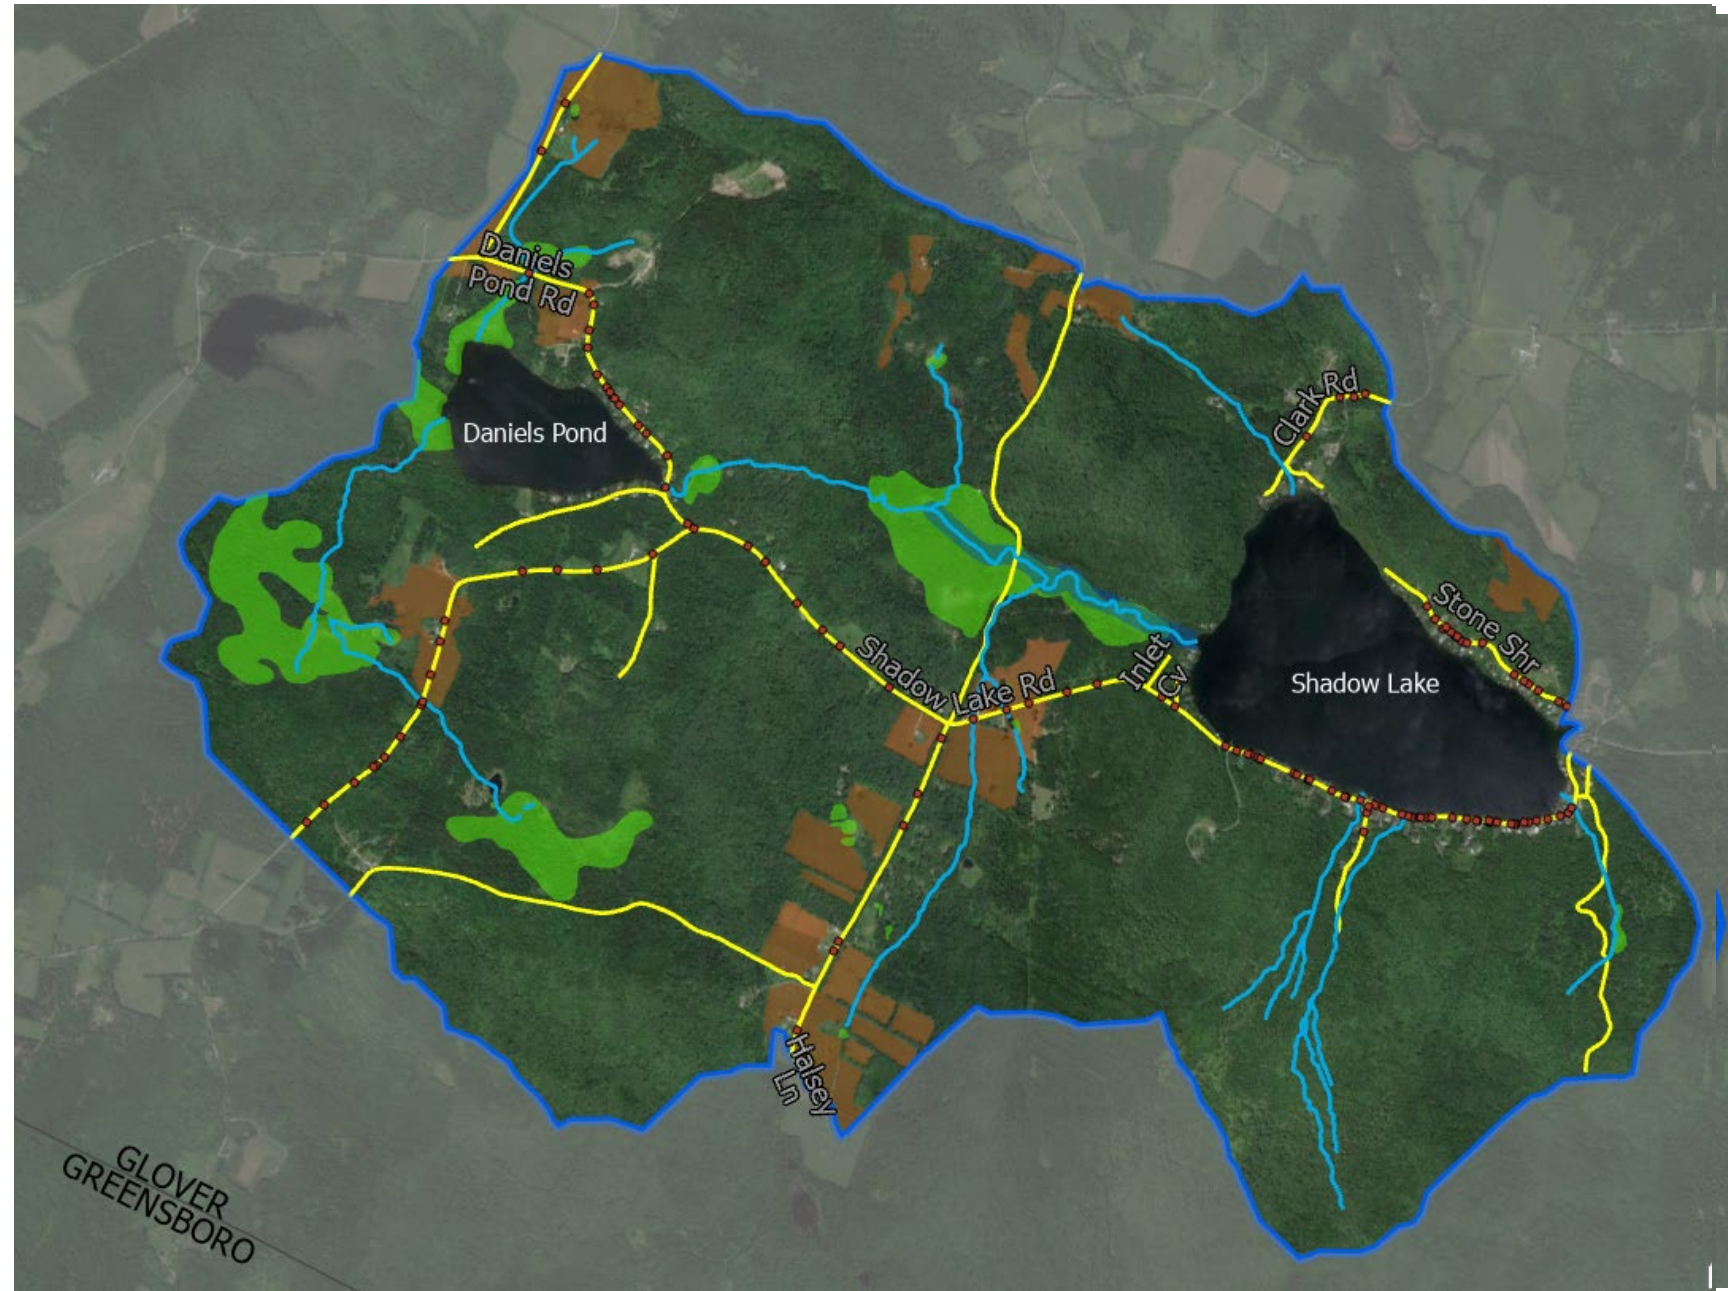
178 acres of mapped wetlands

200 acres of agricultural lands
(brown)

121 mapped culverts,
conveying water across roads
or driveways (red dots)

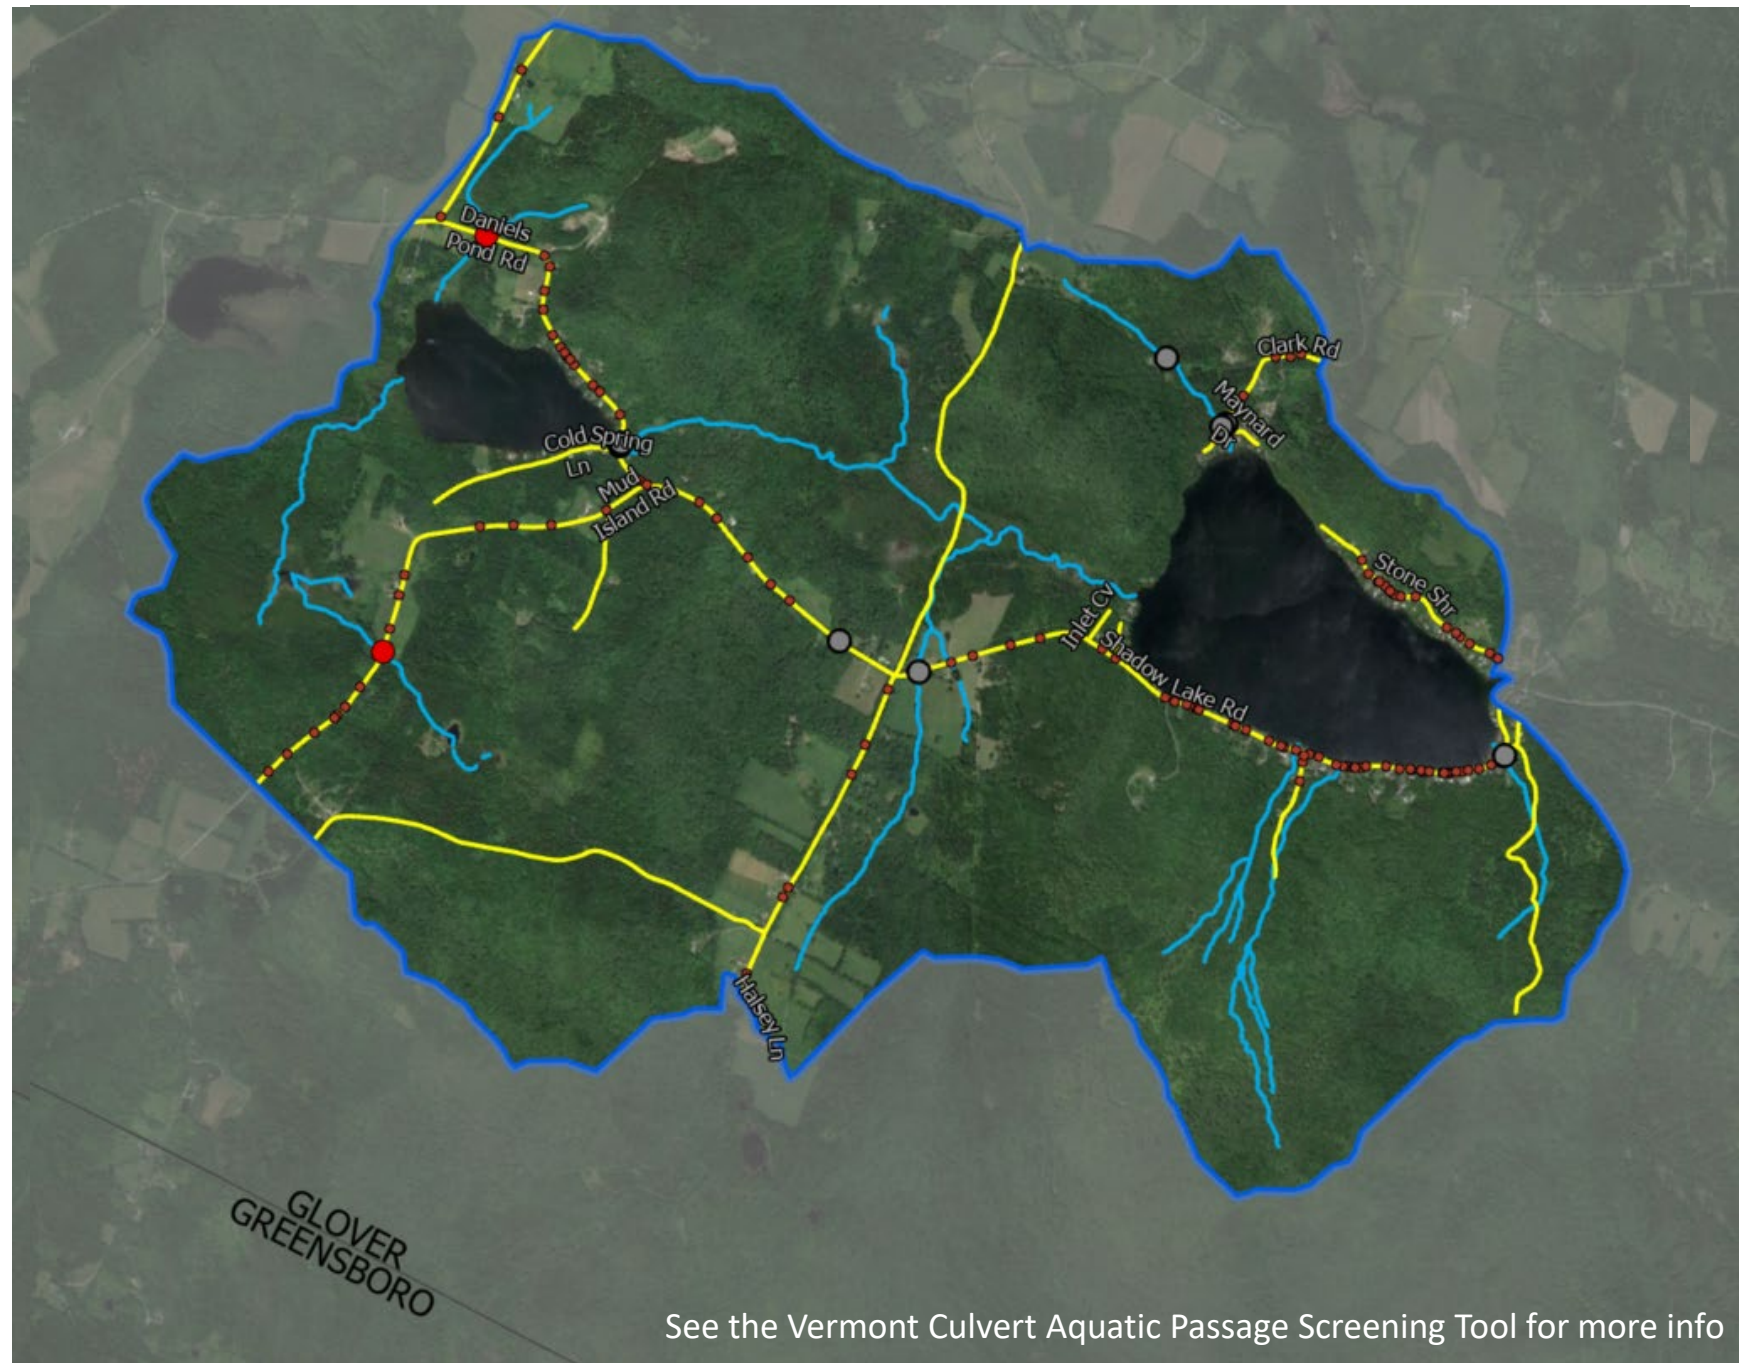
10 mapped stream crossing culverts, scored for Aquatic Organism Passage (AOP)

Red = No AOP for all aquatic organisms including adult salmonids

Grey = Reduced AOP for all aquatic organisms

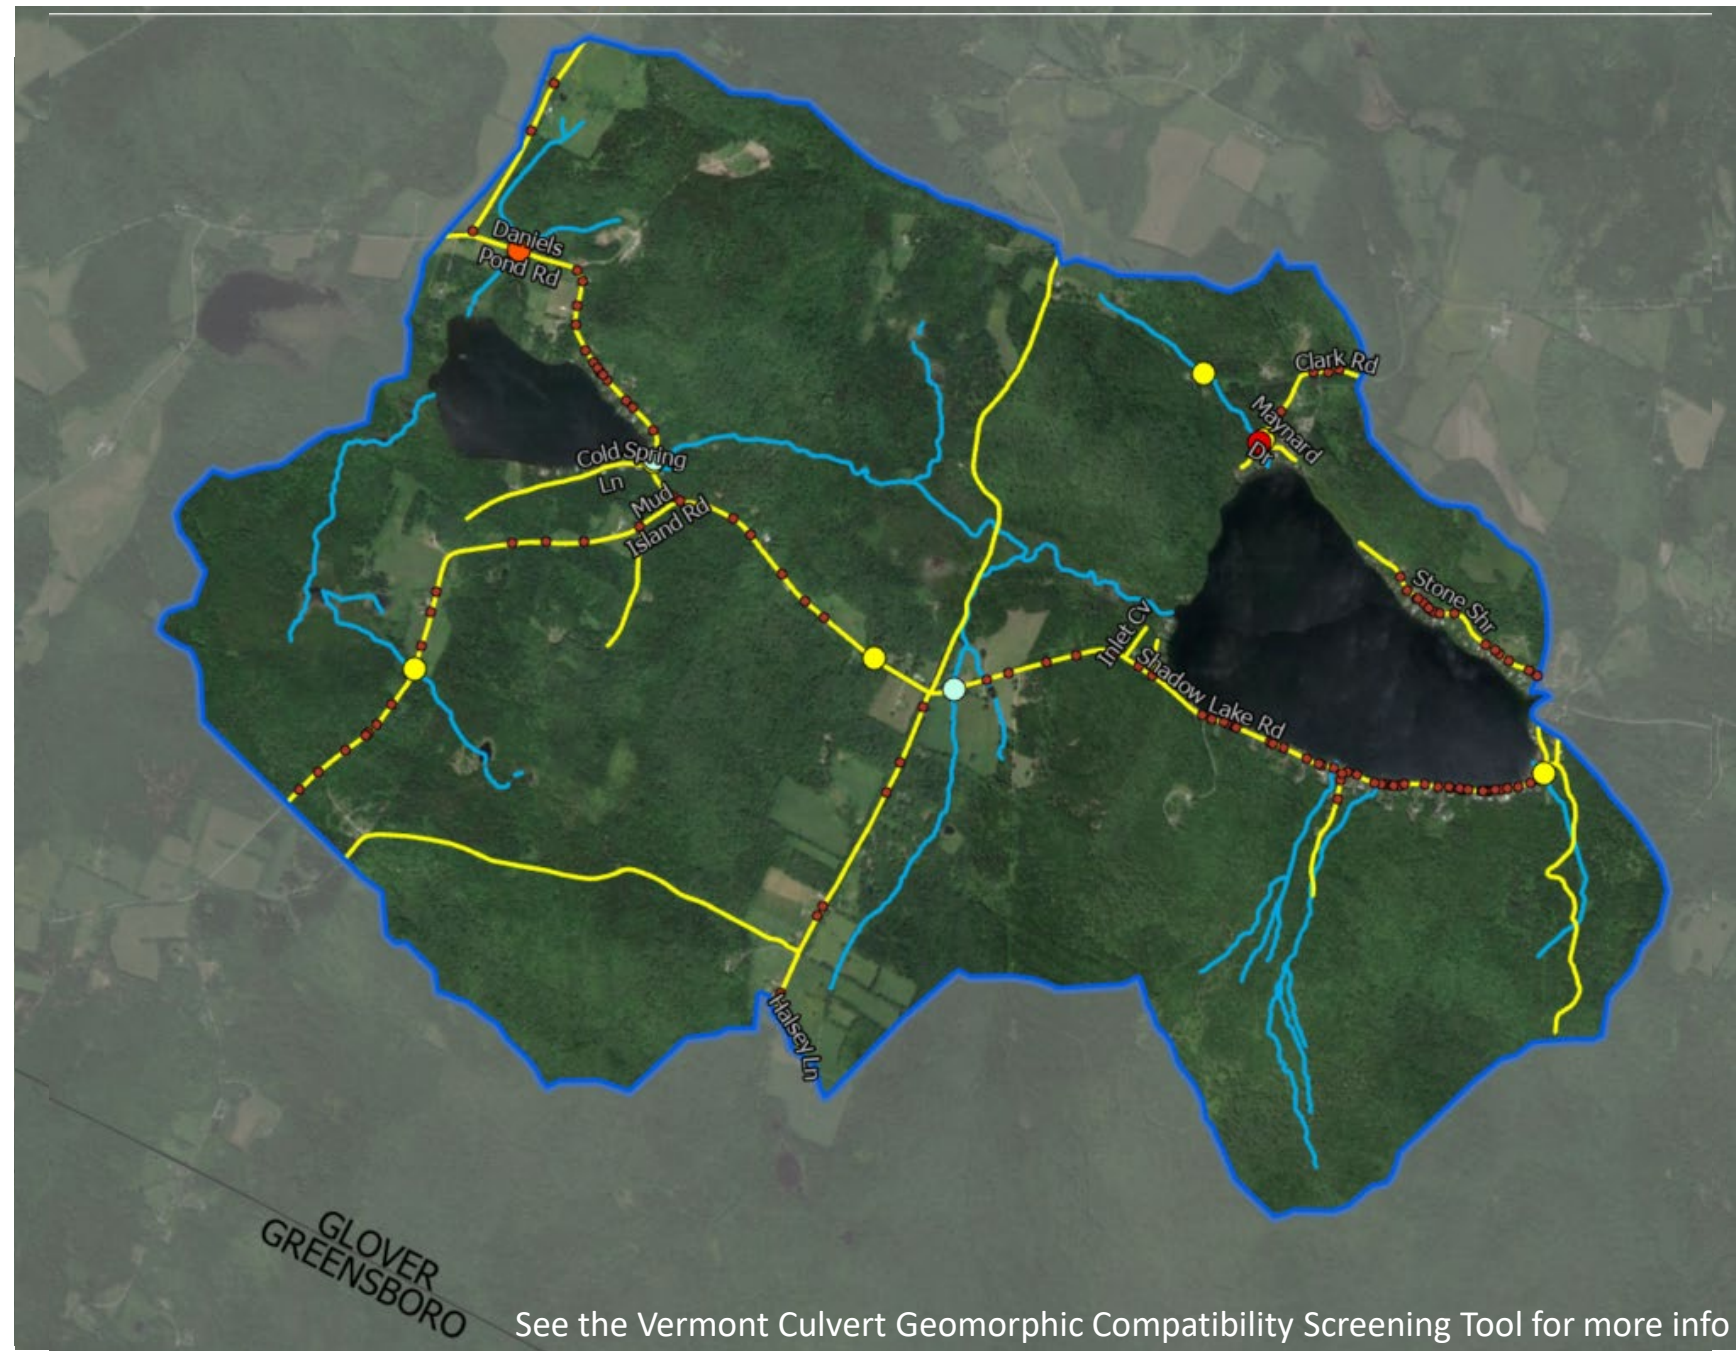
10 mapped stream crossing culverts, scored for
Geomorphic Compatibility

Teal = Mostly Compatible

Yellow = Partially Compatible

Orange = Mostly Incompatible

Red = Fully Incompatible

- Structure fully incompatible with channel and high risk of failure.
- Re-design and replacement performed ASAP

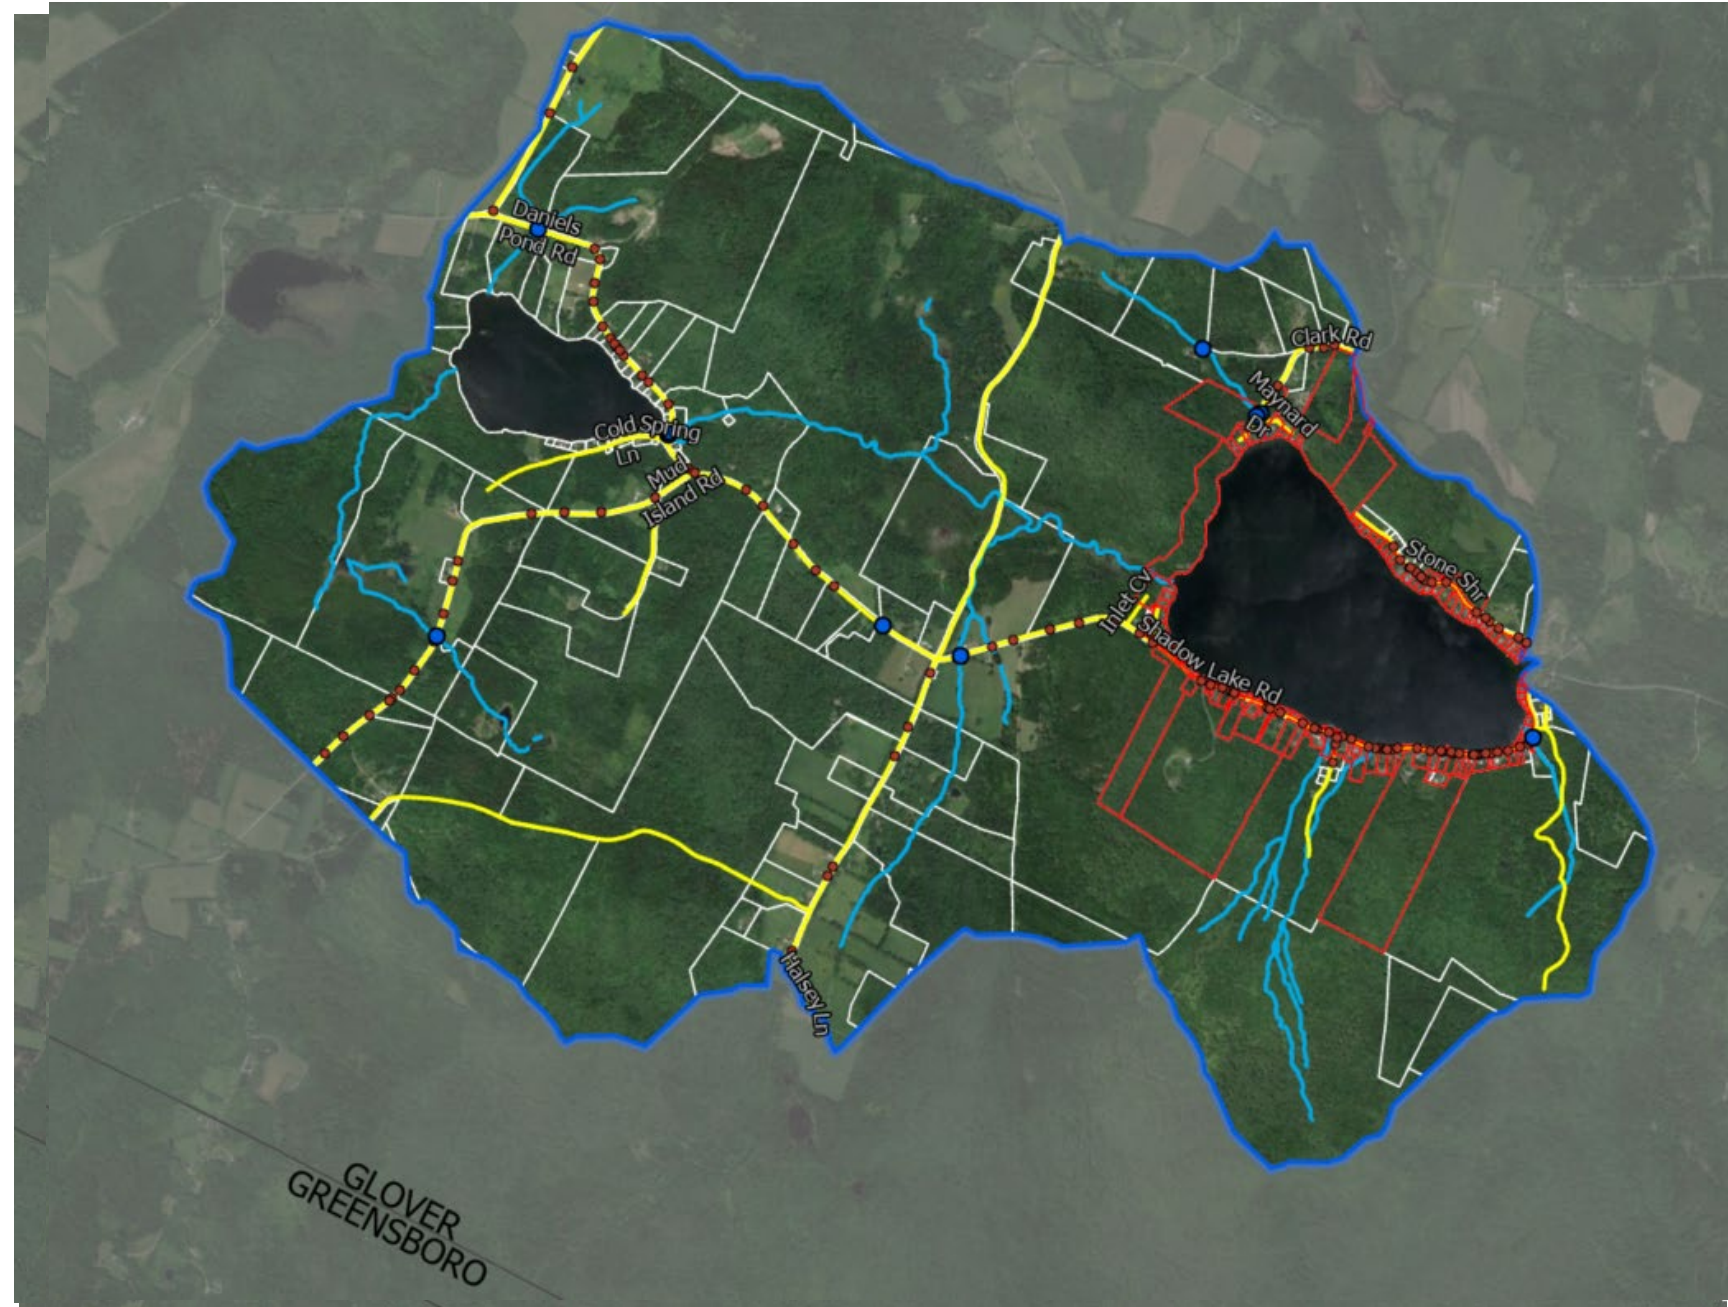
Parcel boundaries in white

106 lakeshore properties (red
property boundary lines)

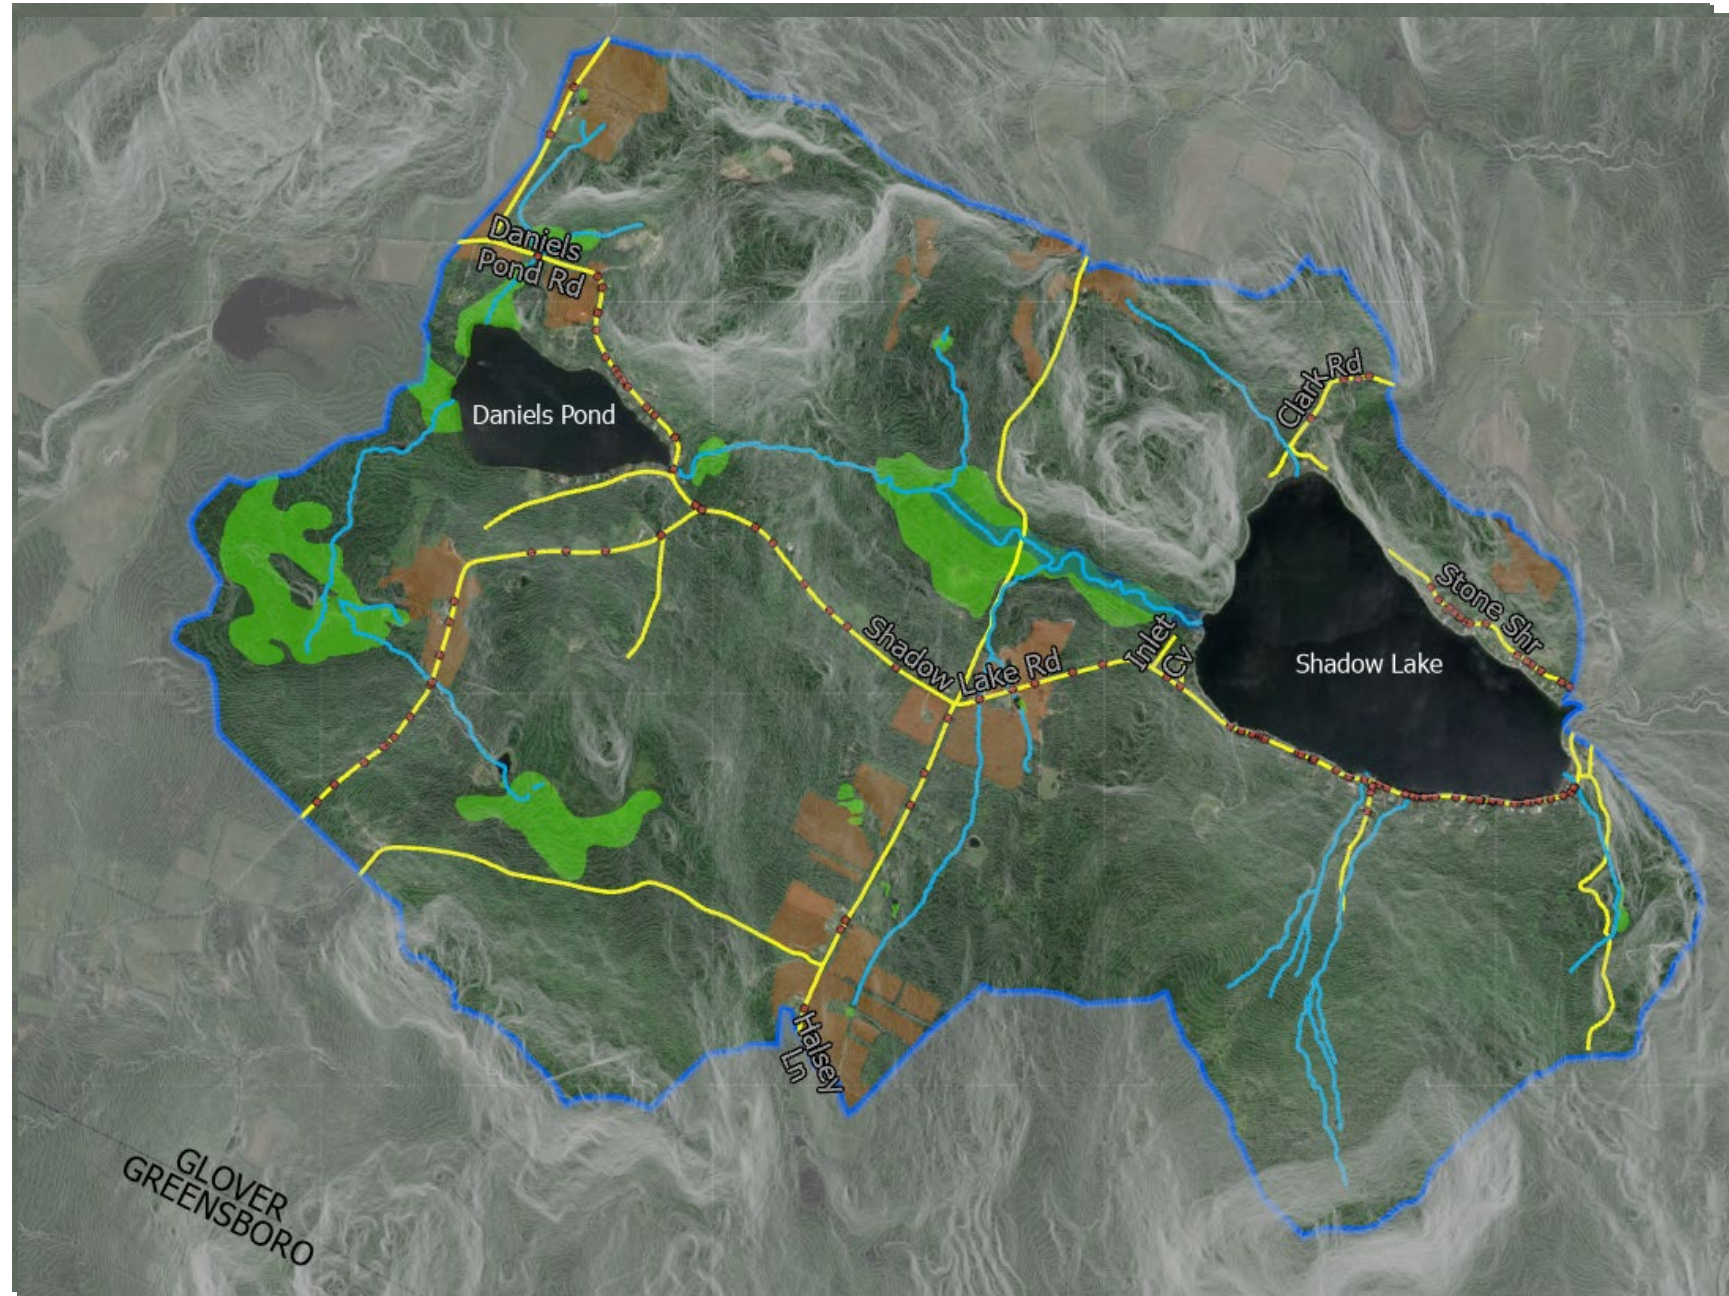
Shadow Lake is in a low point,
steeper to the northwest

Grey lines show contours

Closer together = steeper
slopes

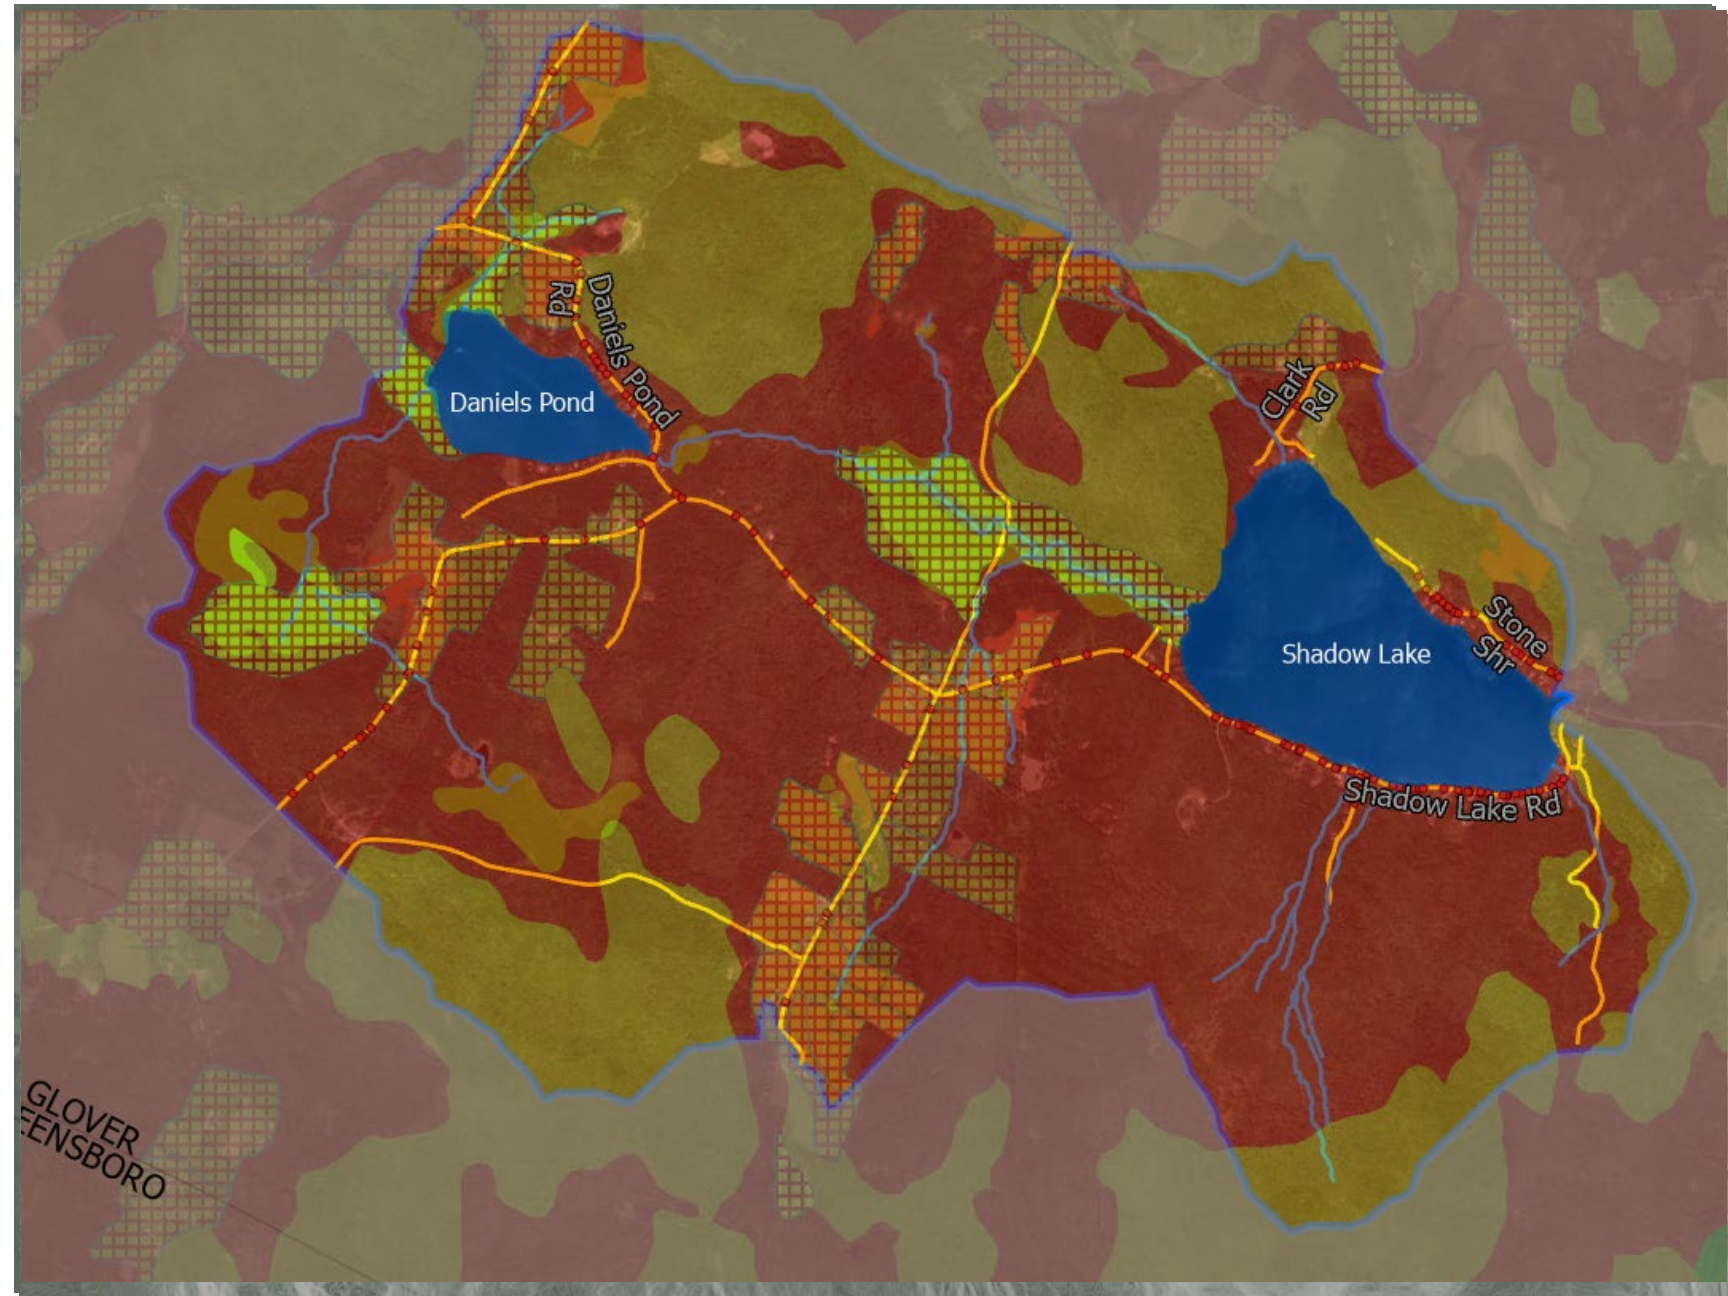
More D (Clay Soil) = more runoff
