Shadow Lake

Phase 1 Lake Watershed Action Plan

Data Library Summary

Glover, VT

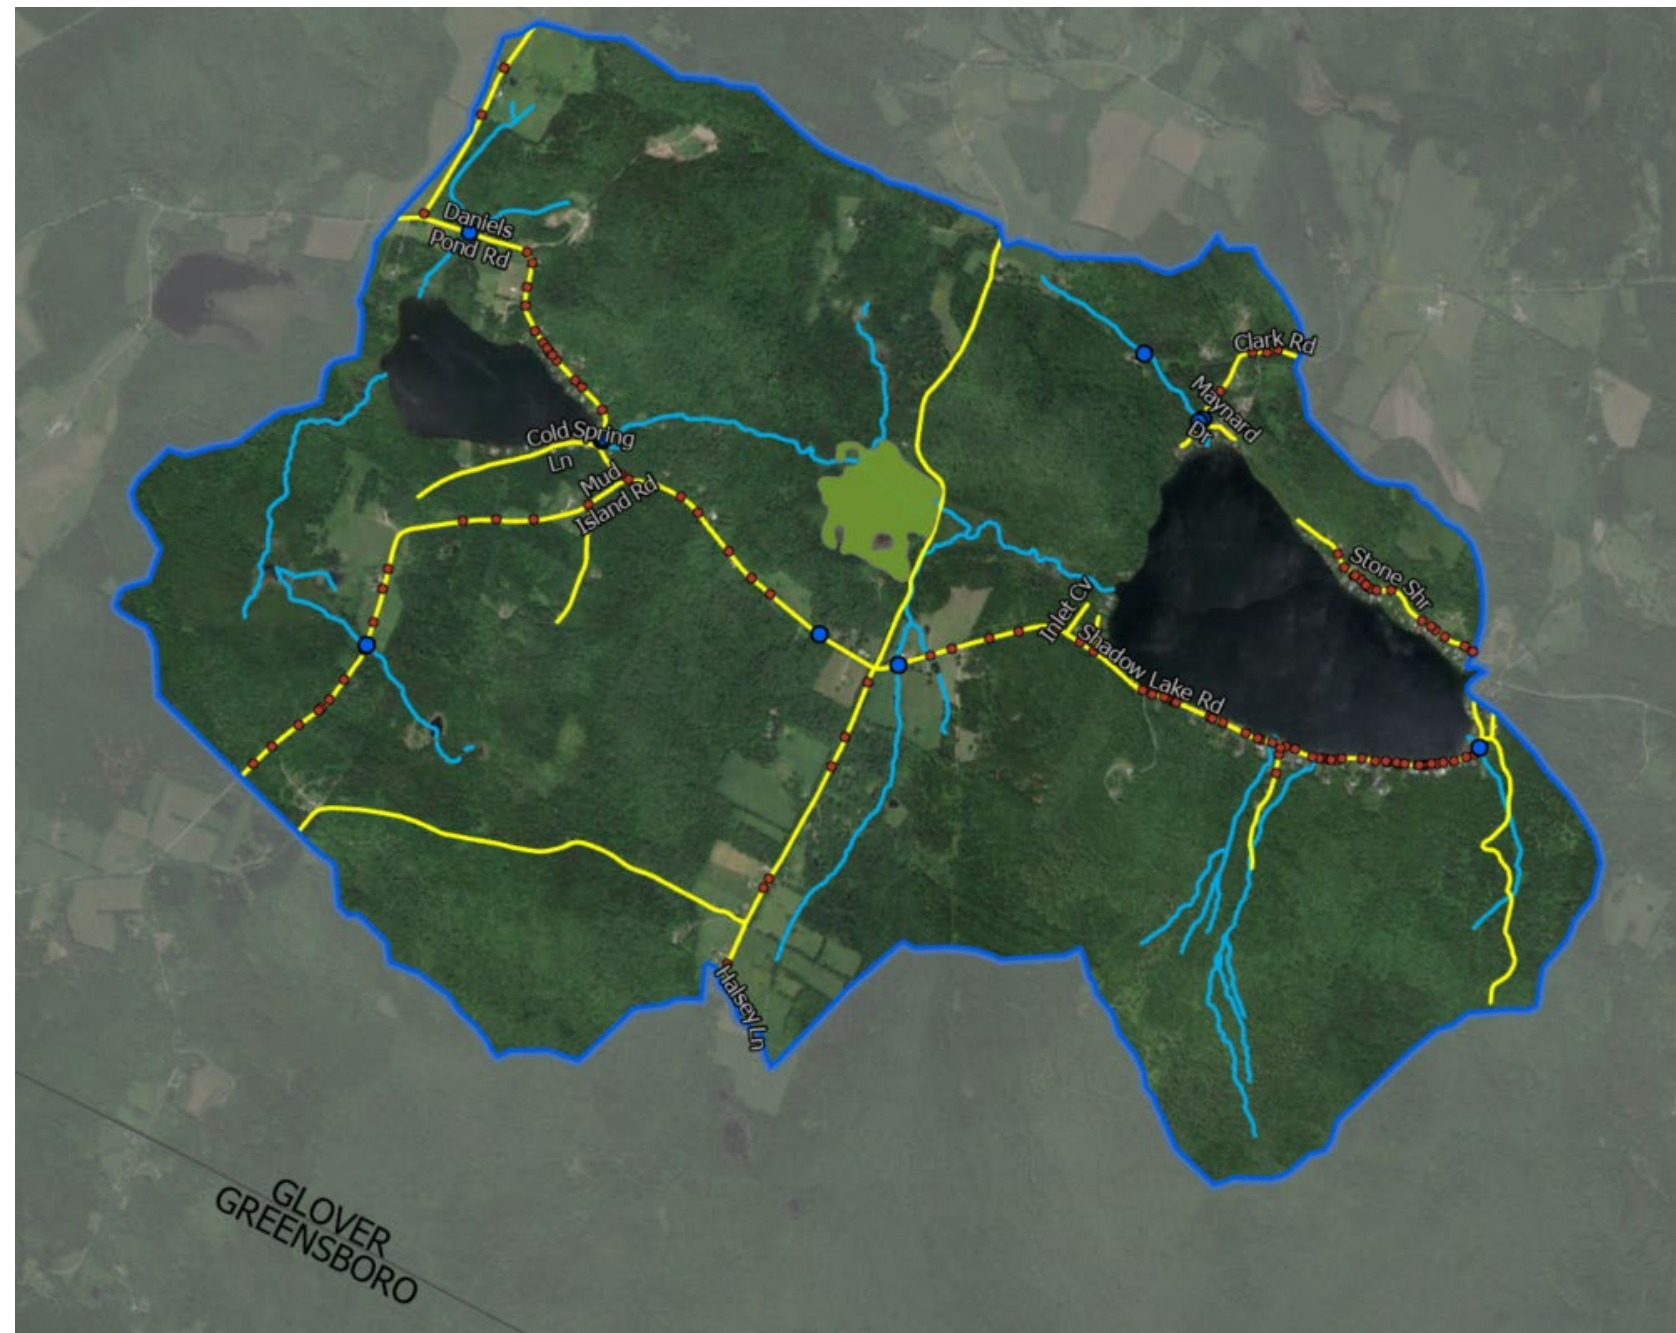
34.8-acre Significant Natural Community (green)

- Northern White Cedar Swamp

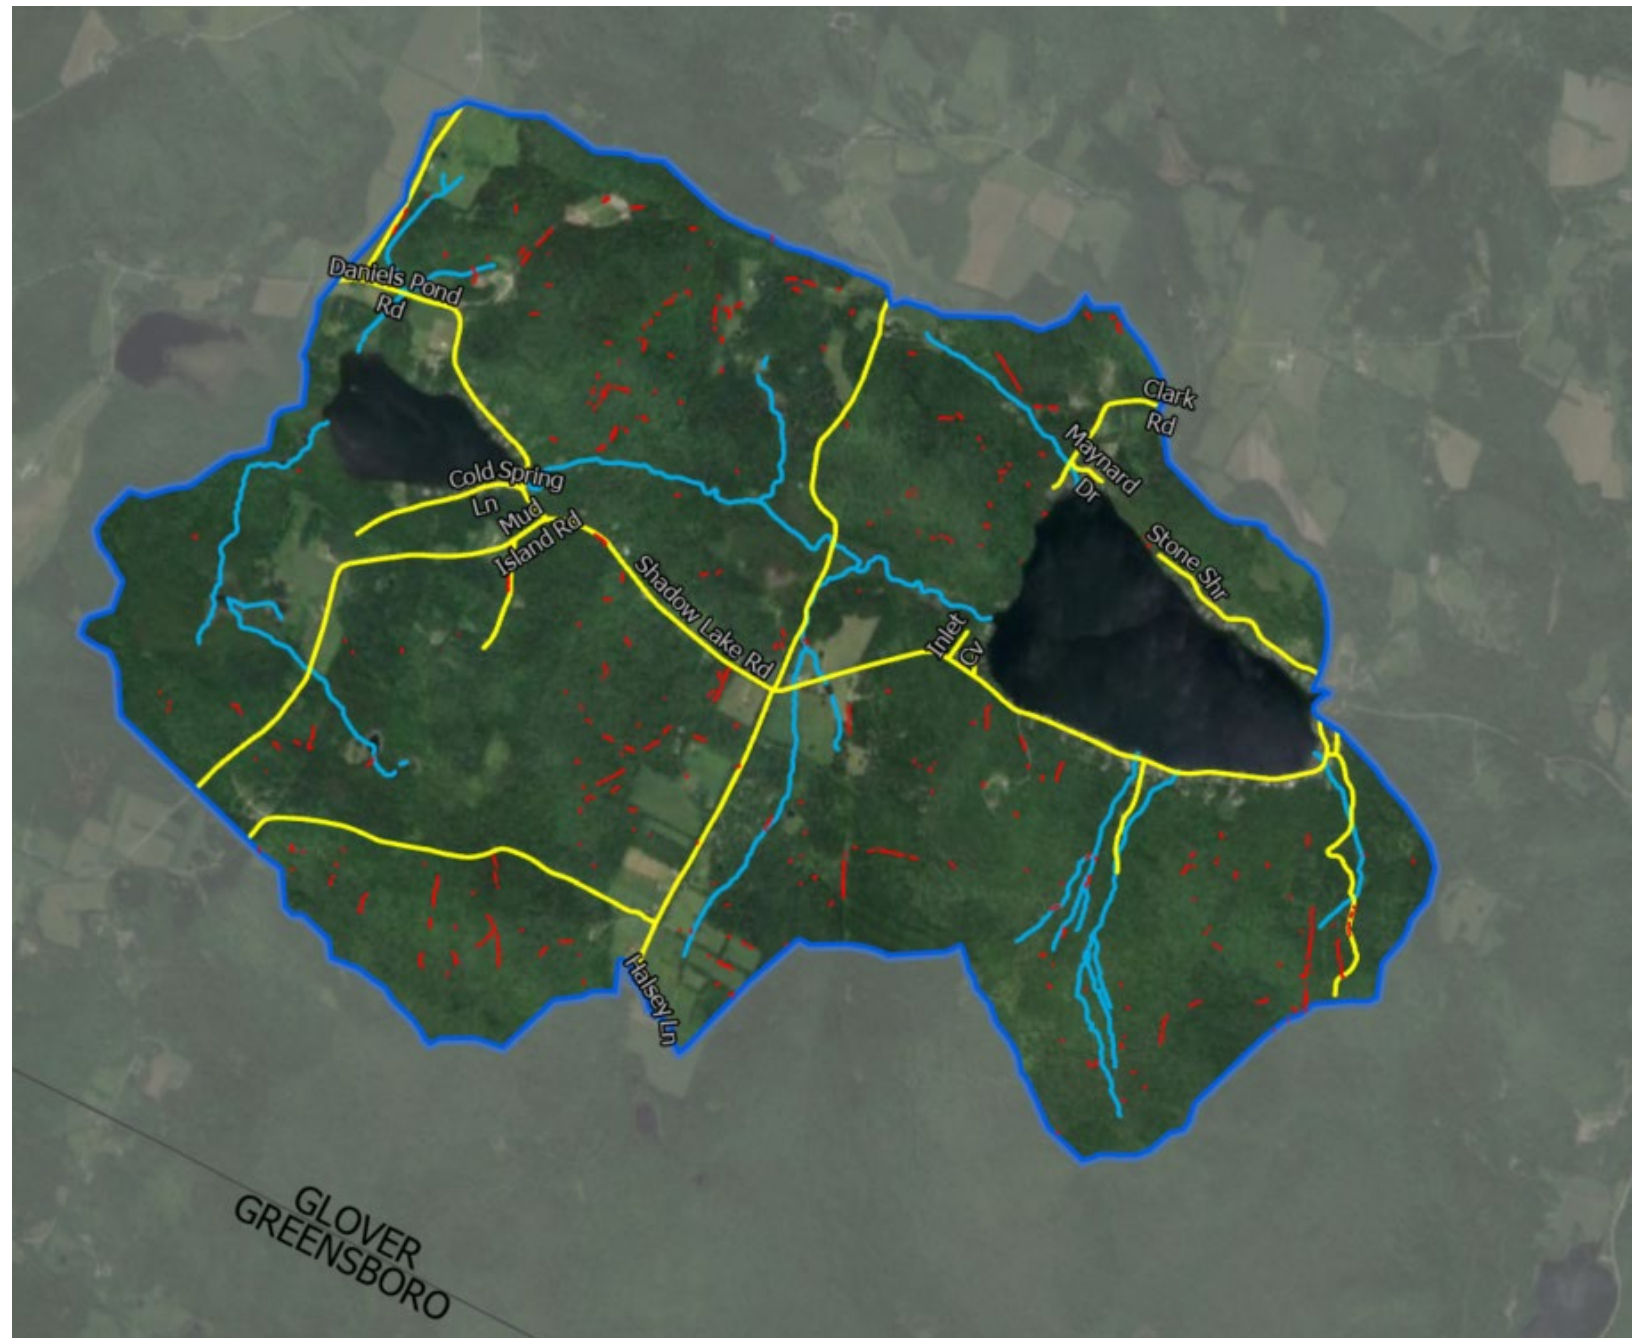
393 Potentially Erosive Features
(red)

5.99 acres

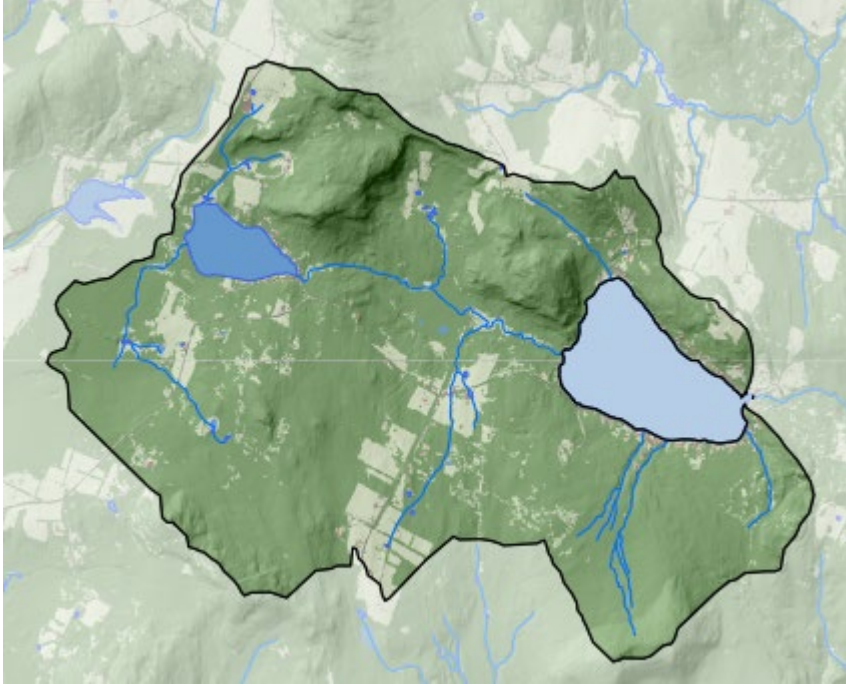
Land Cover: Watershed

- 85% of the watershed is forested
- 15% is wetlands
- 1.5% impervious
- Agriculture is 6.3%
- See UVM SAL High-Resolution Land Cover 2016 Report for more detailed explanation of methodologies

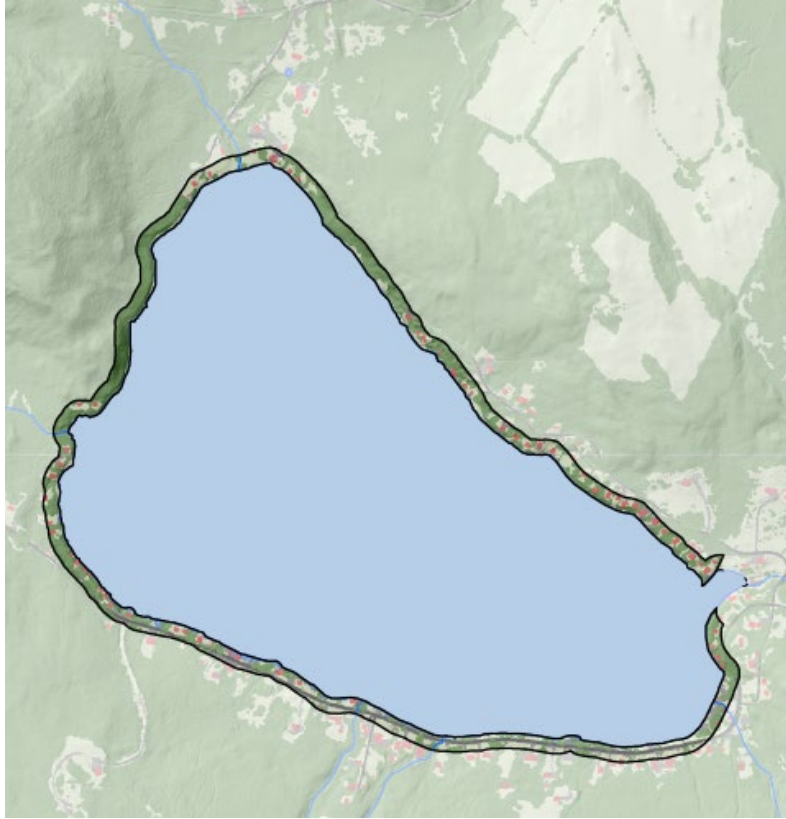
Land Cover: Lake 100ft buffer

Greater percentage of impervious surface within the 100 ft buffer than in the entire watershed

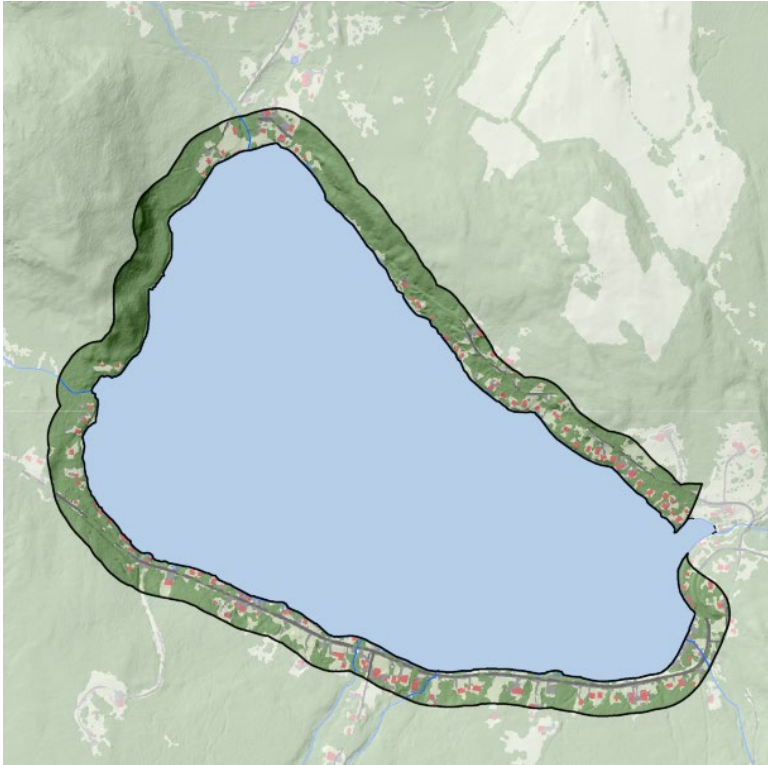
Land Cover: Lake 250ft buffer

More forested percentage of land cover within 250 ft of Shadow Lake than 100 ft, but still much higher percent impervious than overall watershed

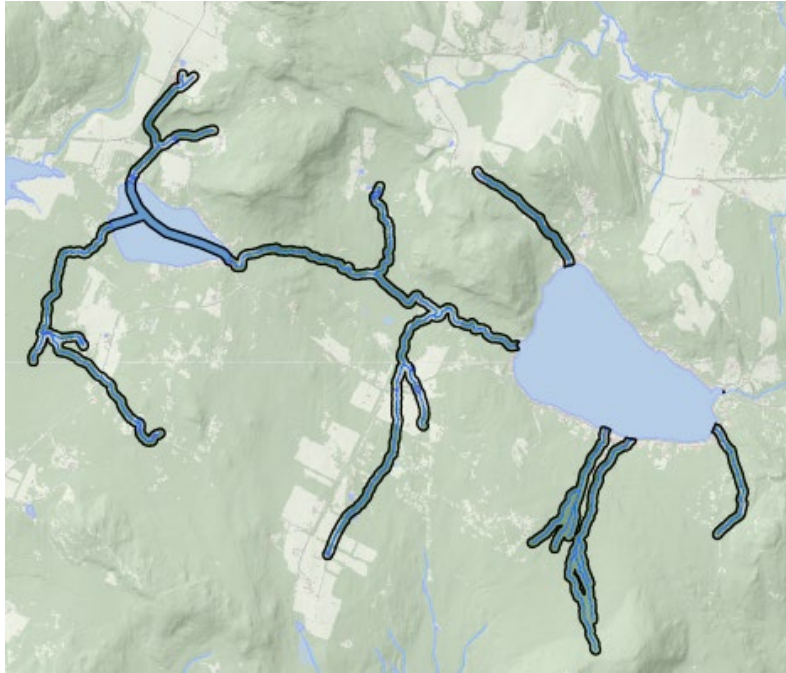
Land Cover: Tributary 100ft buffer

The impervious and agricultural percentages are slightly higher within 100ft of the tributaries than in the overall lake's watershed

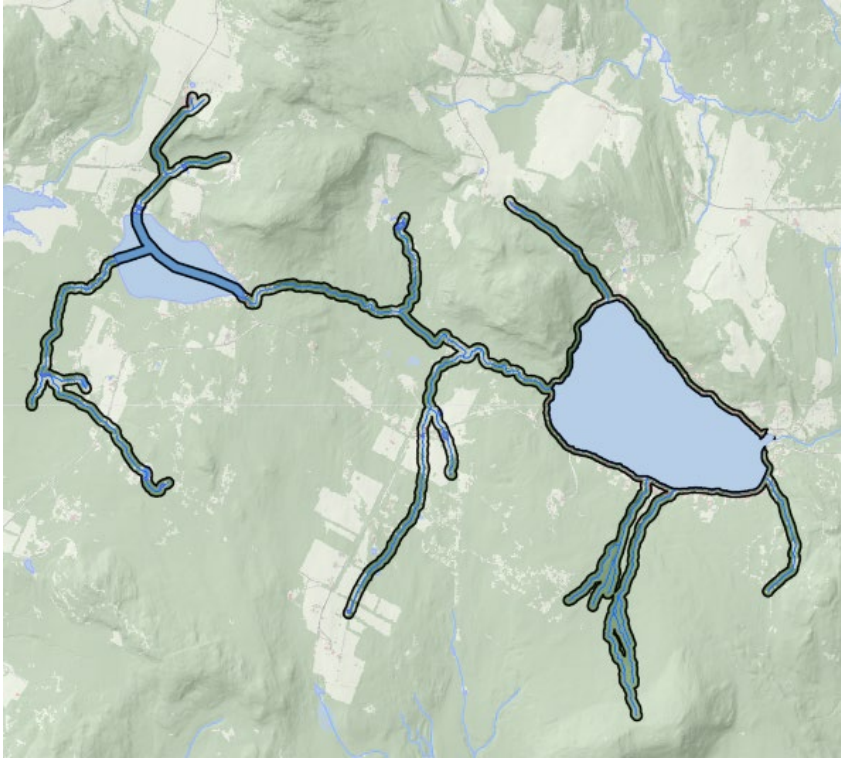
Land Cover: Lake and Tributary 100ft buffer

The impervious percentages are higher within 100ft of the tributaries and lake than in the overall lake's watershed

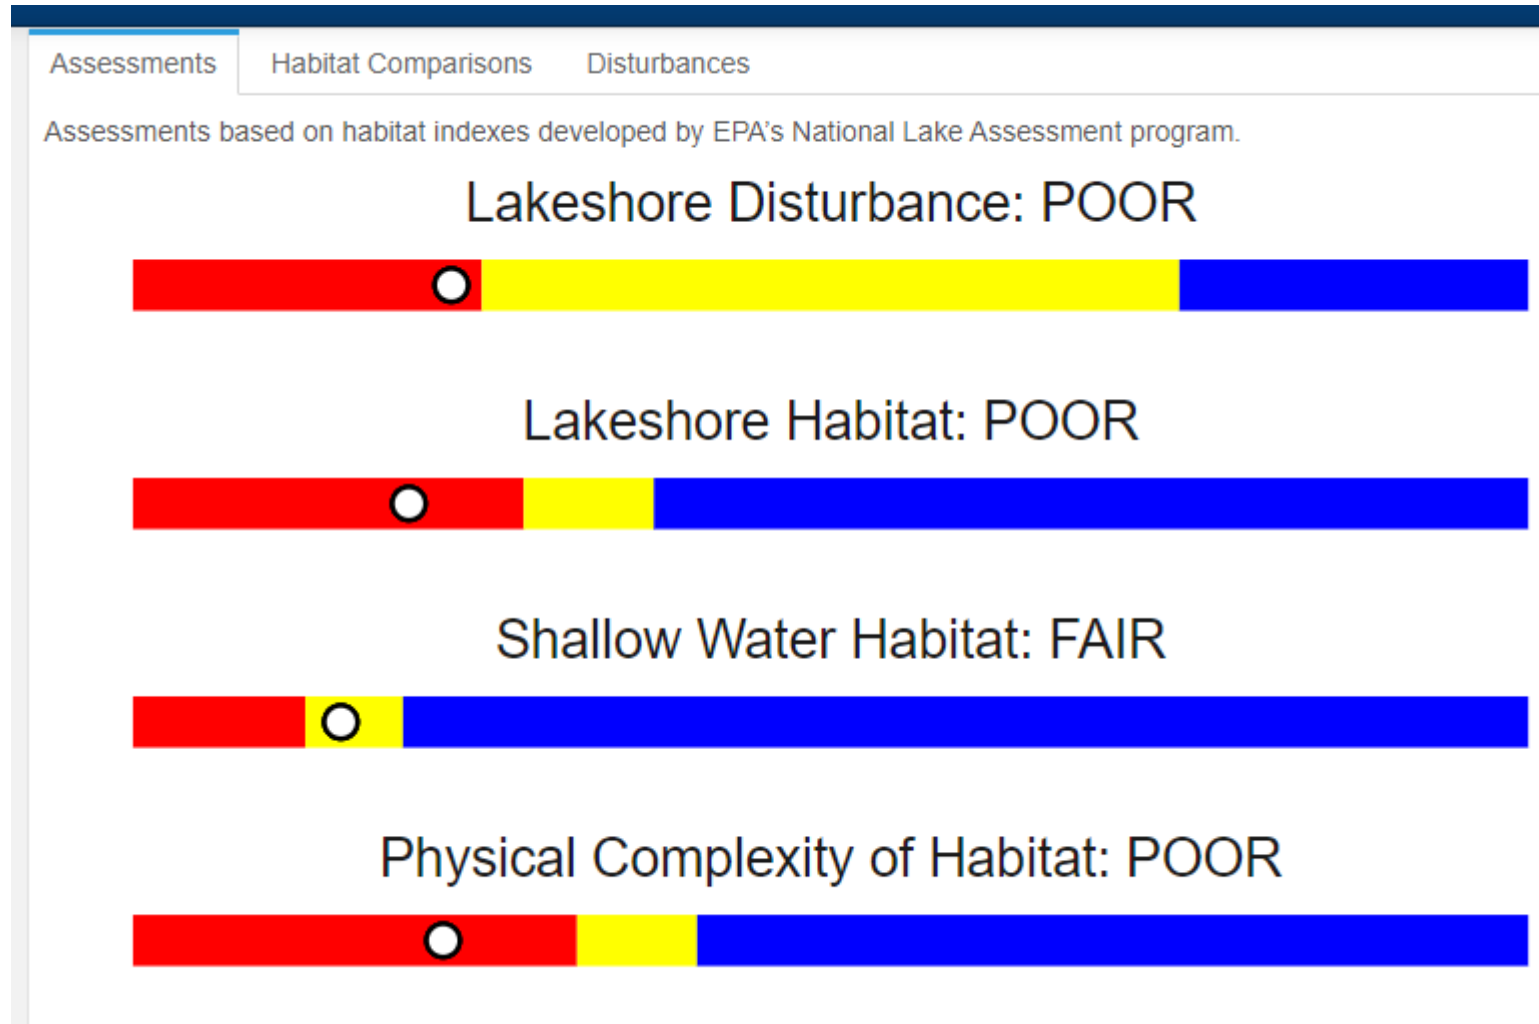
Other parameters were classified as fair (yellow) or poor (red)

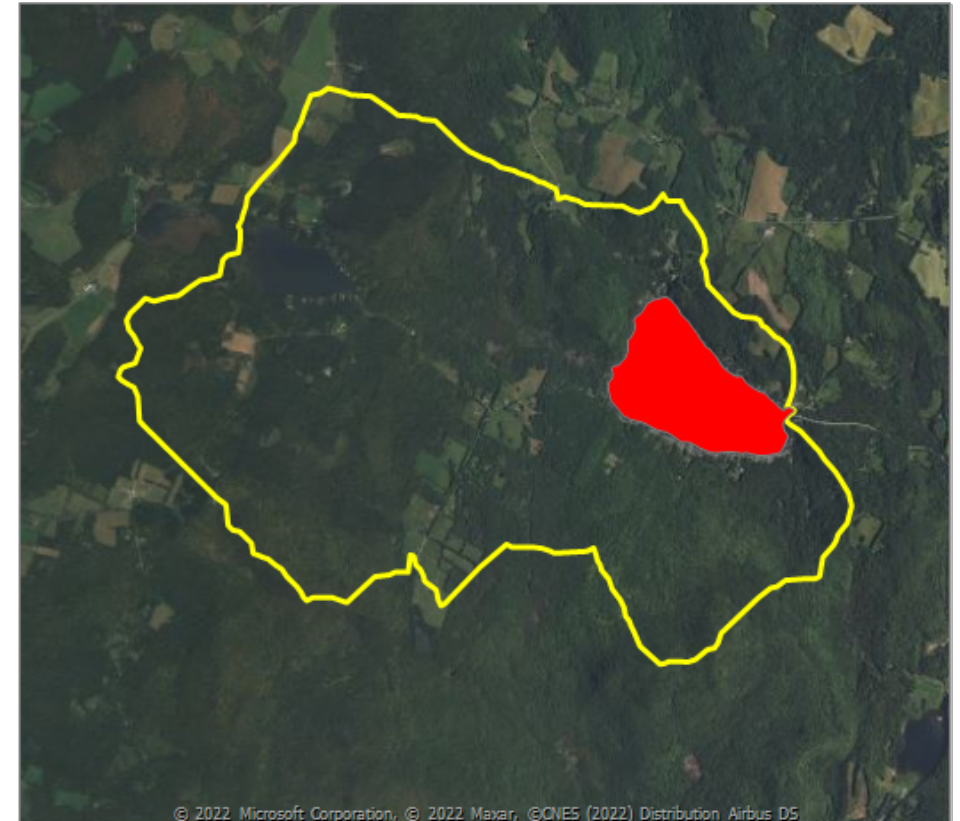
Spring TP Trend: $p = 0.0024$ | $CV = 27$
Highly significantly increasing

Summer TP Trend: $p = 0.0015$ | $CV = 19$
Highly significantly increasing

Summer Secchi Trend: $p = 0$ | $CV = 13$
Highly significantly increasing

Summer Chla Trend: $p = 0.0717$ | $CV = 39$
Stable

Trend Score: **Poor**

WQ Standards Status: **Altered**

Watershed Score: **Moderately Disturbed**

While TP is still classified as good, the trends are showing increasing TP for annual means for spring and summer. These trends are pushing the lake out of oligotrophic status and into mesotrophic conditions.

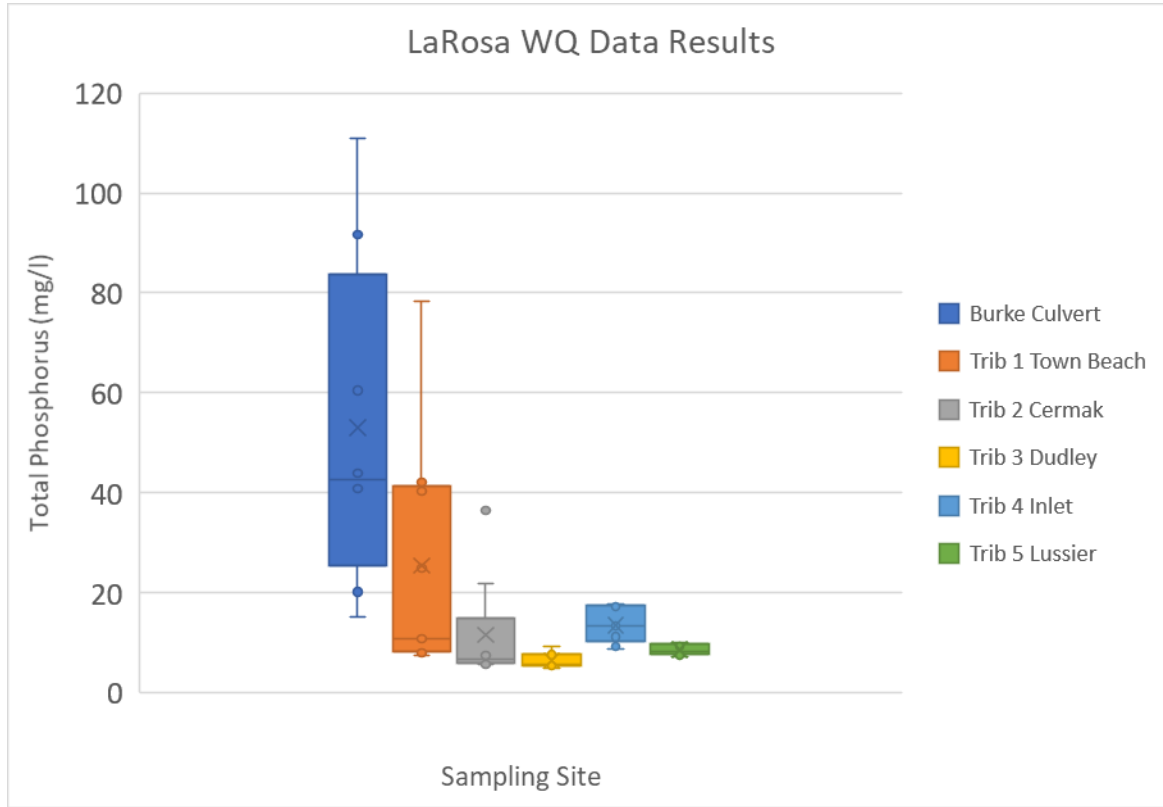
Water Quality Data

The Burke culvert and the Trib 1 Town beach will be areas of focus for this LWAP due to higher nutrient concentrations

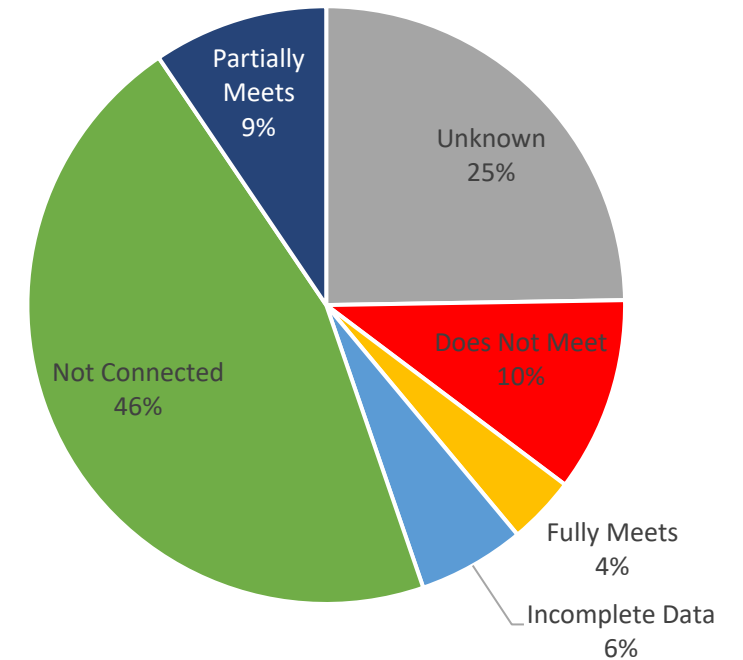
Road Segments Meeting Standards

Number of segments:

- 87 Not Connected
- 20 Does Not Meet
- 18 Partially Meeting
- 7 Fully Meets
- 11 Incomplete Data

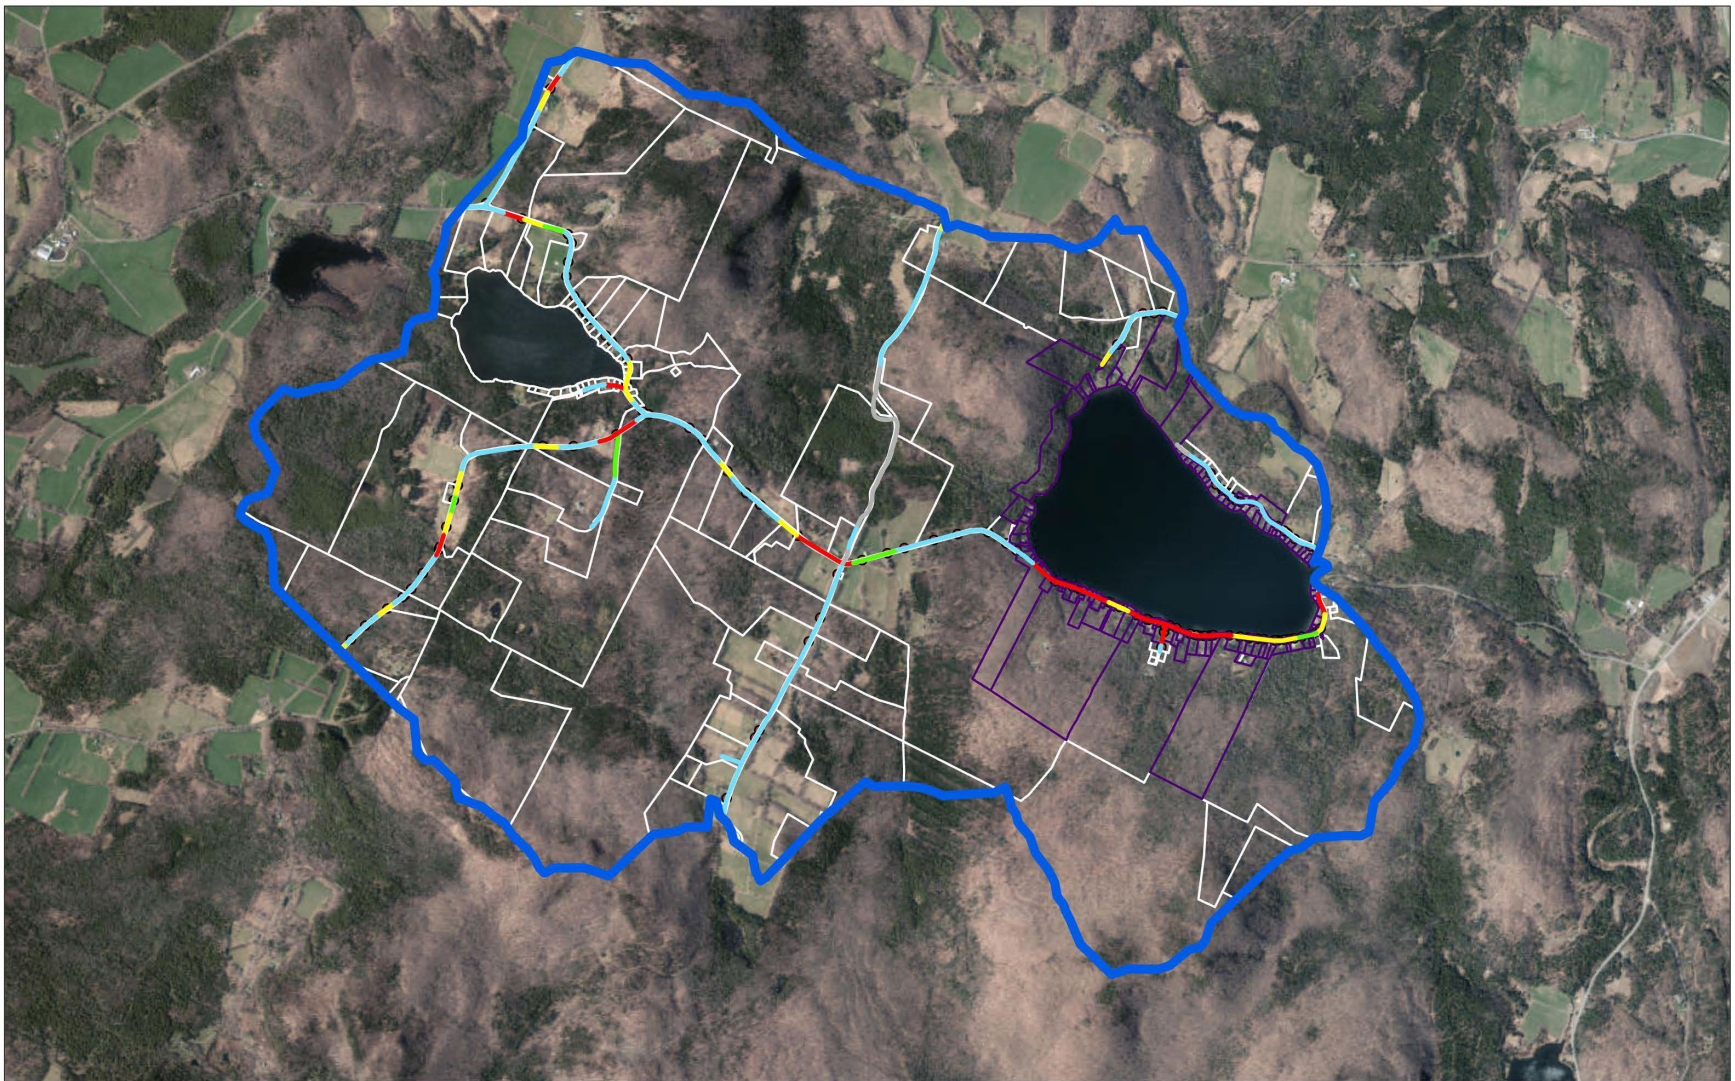
Shadow Lake Road Erosion Inventory

190 road segments in the watershed

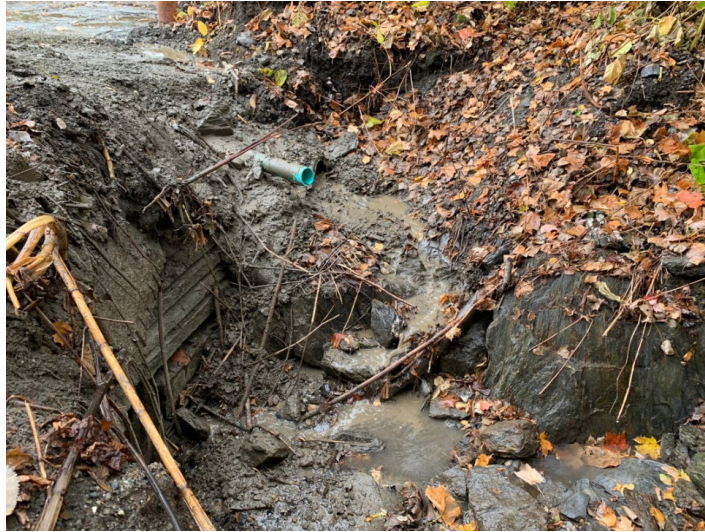
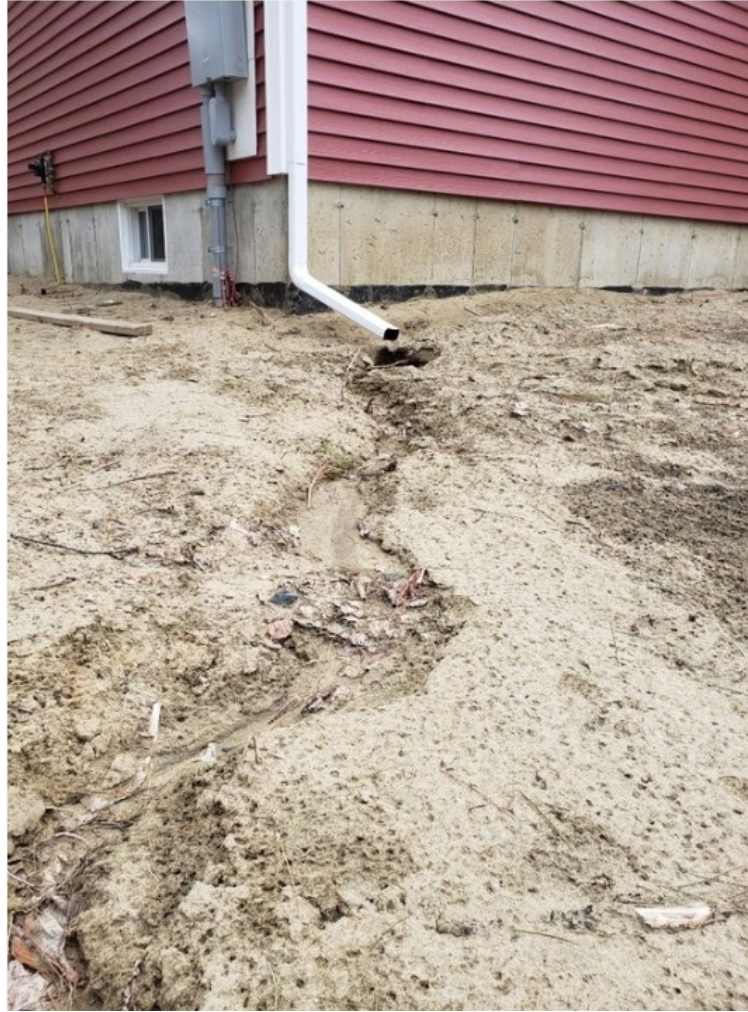
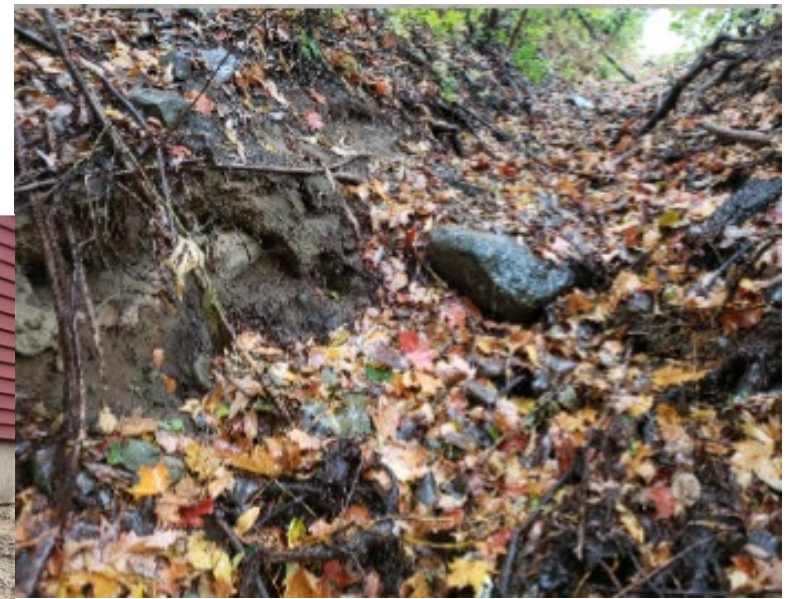
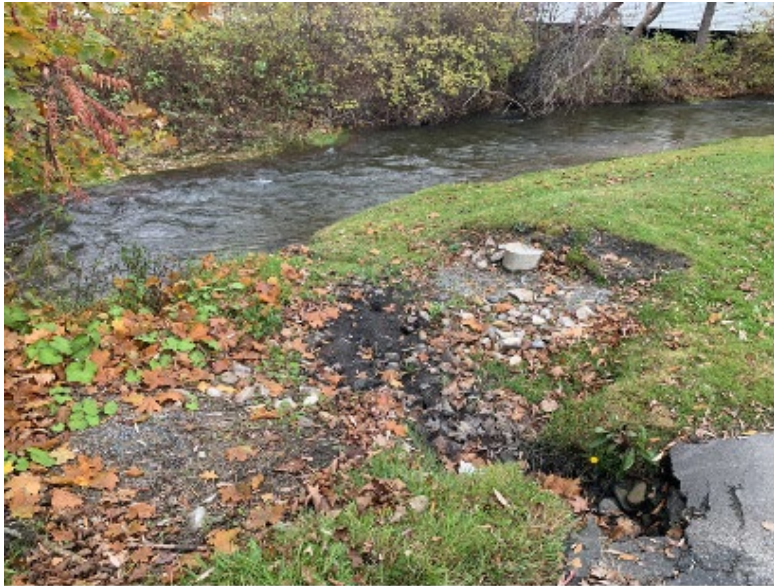
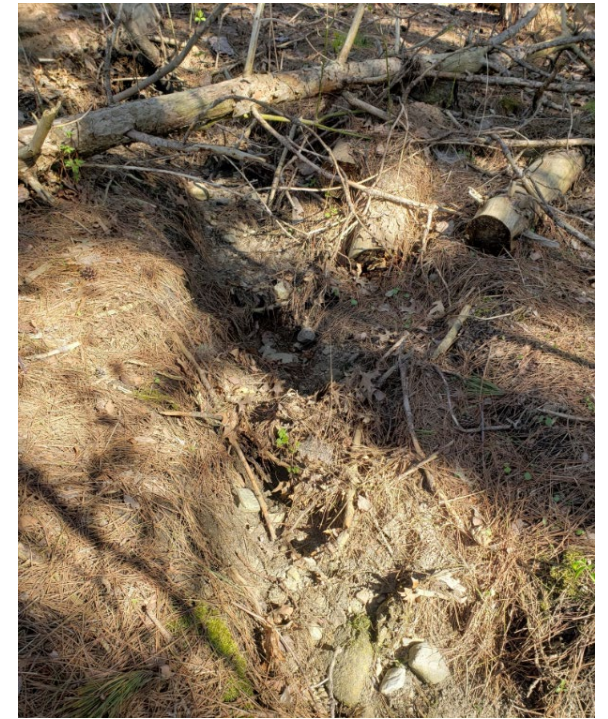
Erosion: Outfalls and Downspouts

- Erosion
 - Turbidity
 - Nutrient loading
-
- The following slides show examples of these types of issues from other areas

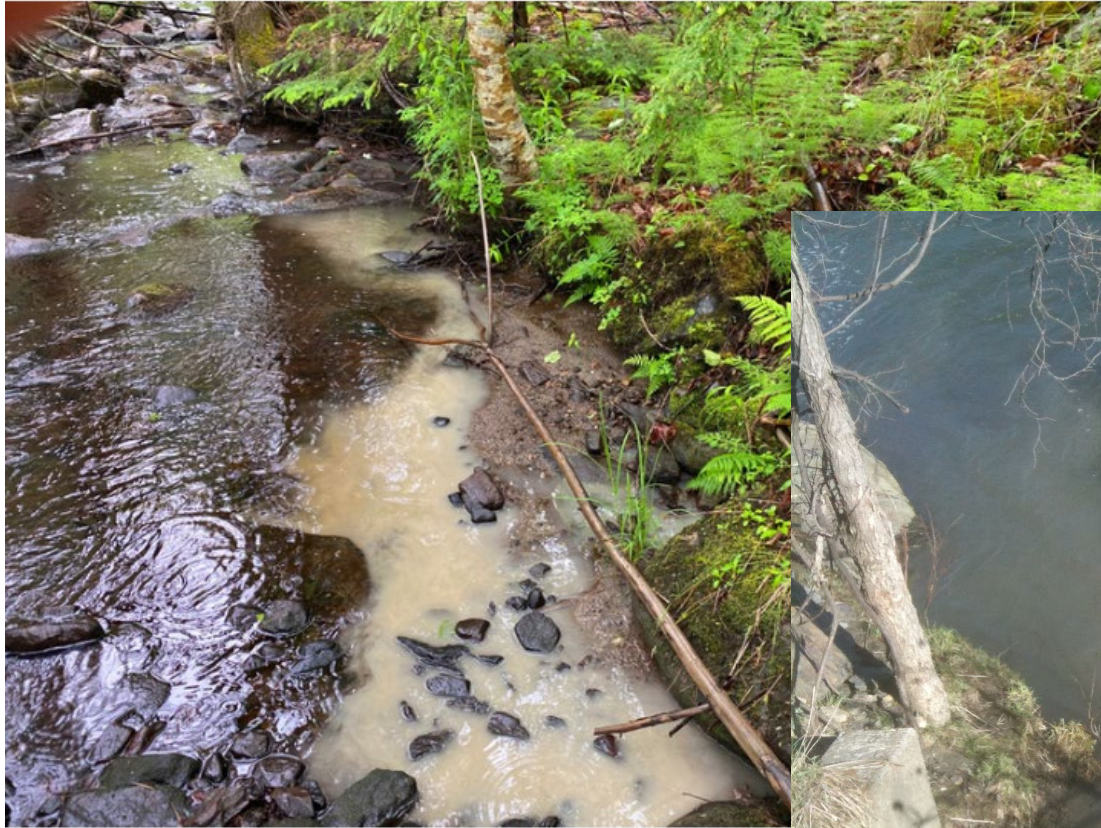
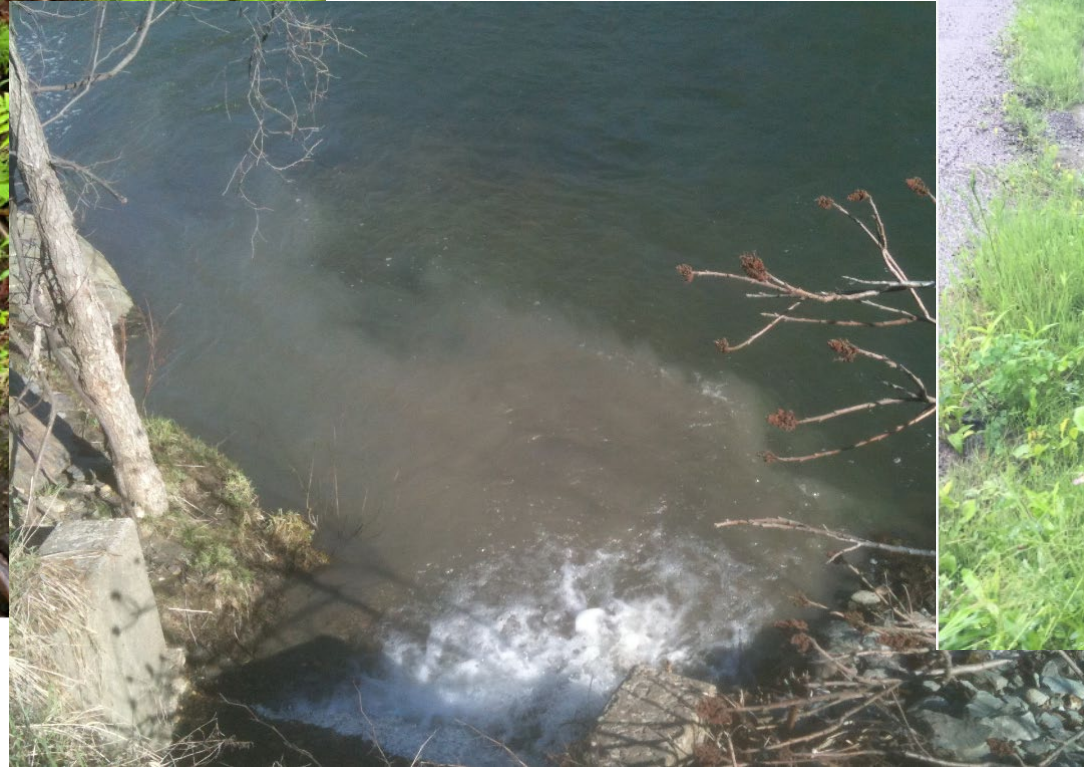
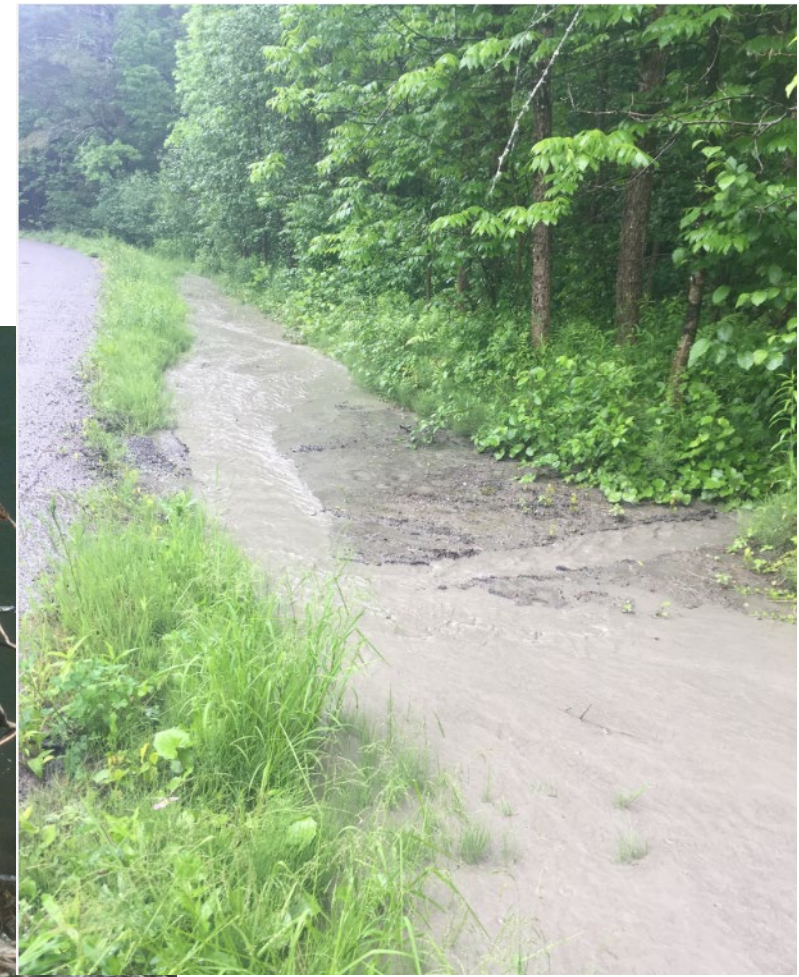
Turbidity

Stormwater can carry sediment from roadways and eroded areas into tributaries to Shadow Lake. These contribute to increased turbidity

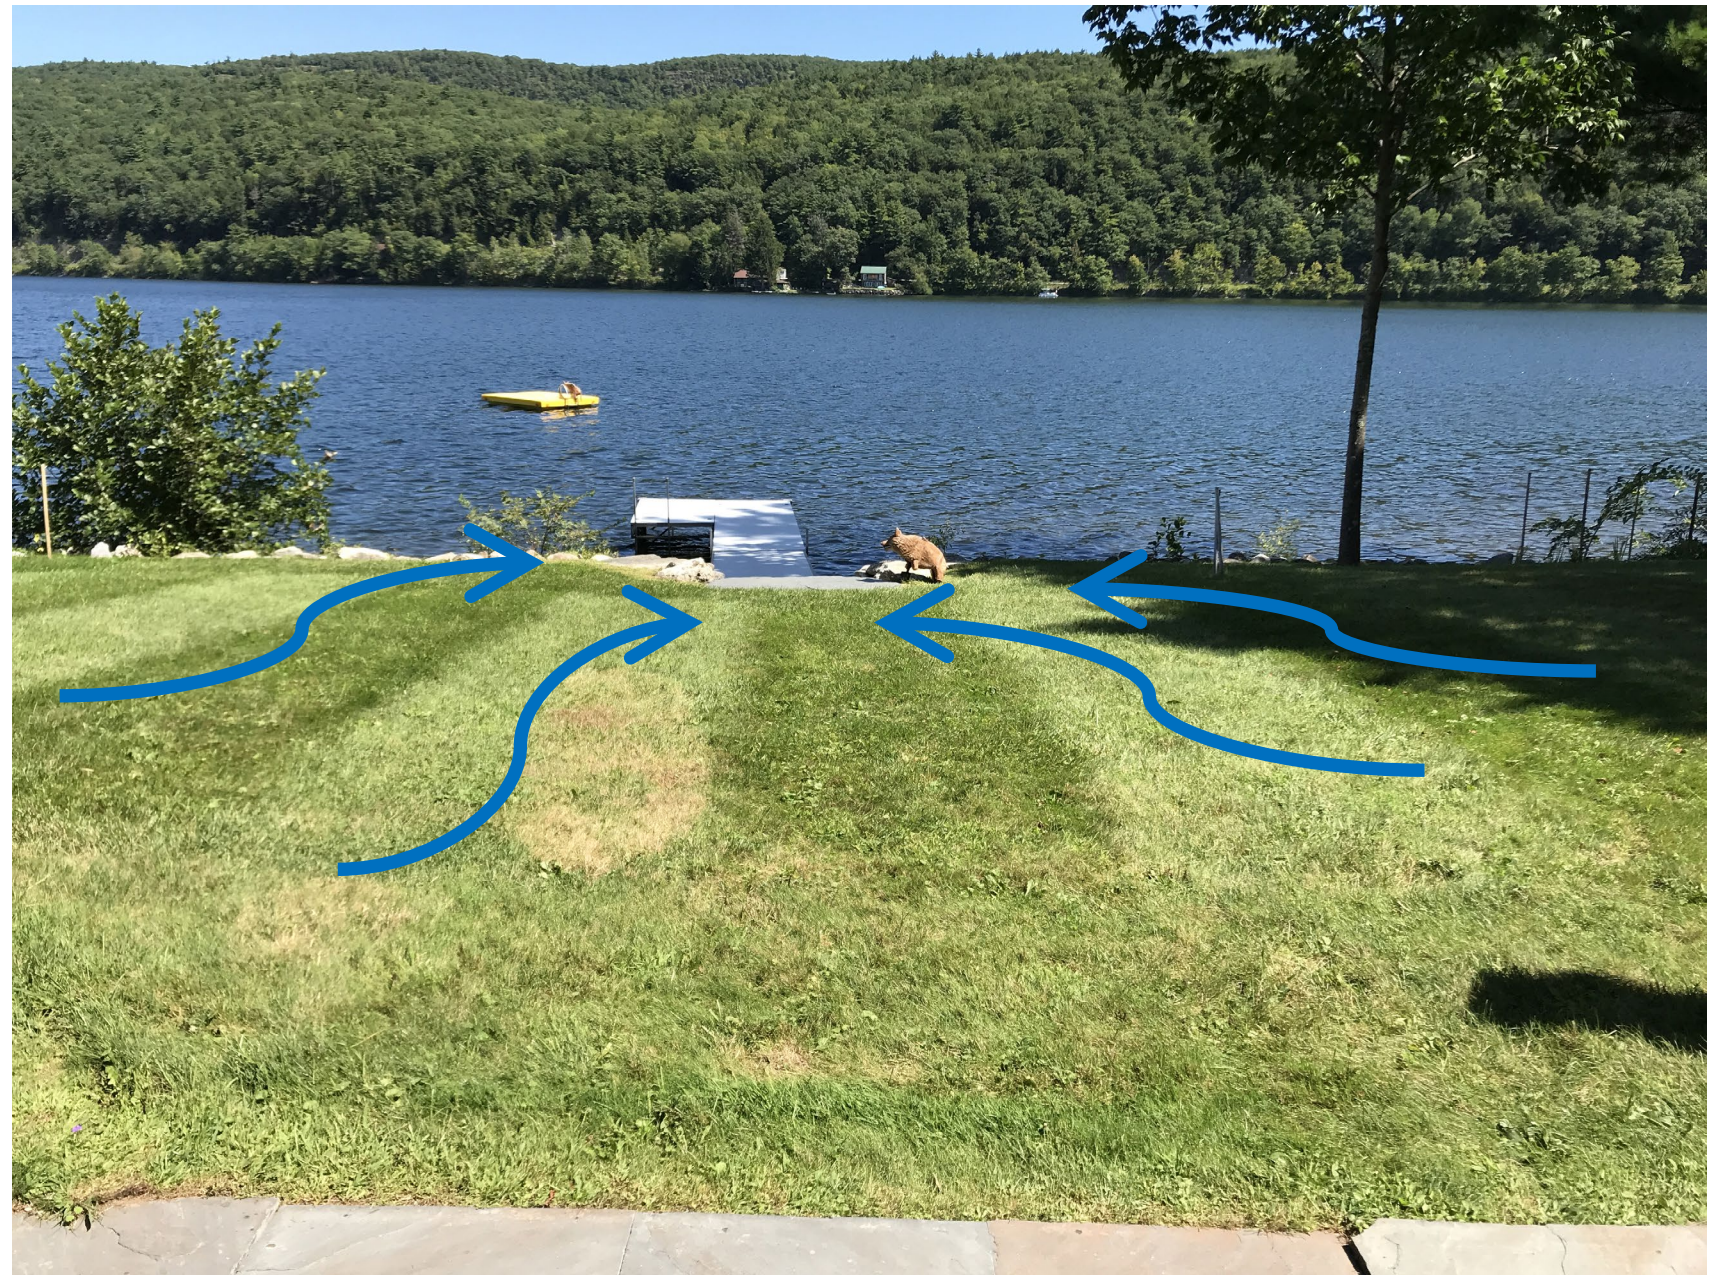
Lacking Buffers

Lakeshores lacking robust native buffers can contribute higher nutrient loads. Shorelines can become unstable.

Turf grass has very shallow roots that does not stabilize the shoreline.
