Shadow Lake

Phase 1 Lake Watershed Action Plan

March 12, 2024

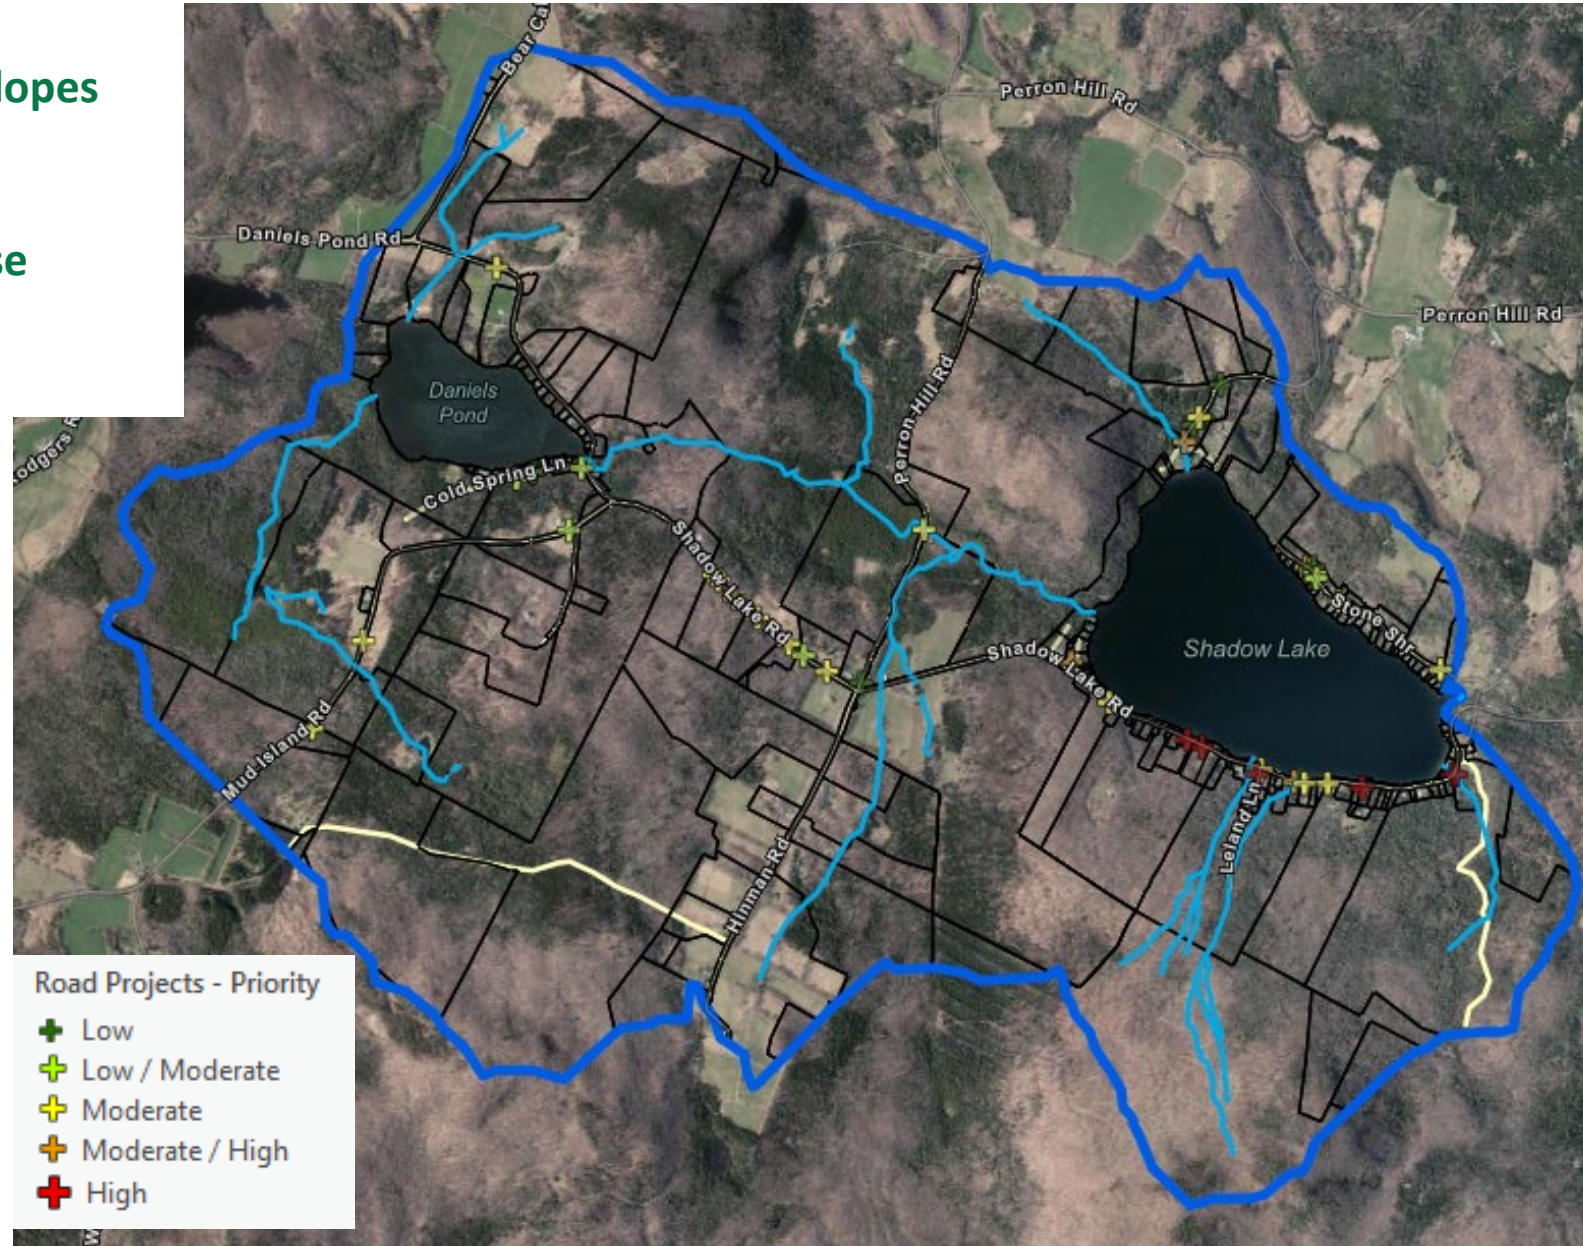
Issues observed:

- Unstable ditches and uncompacted ditch slopes leading to sediment transport
- Undersized, absent, or clogged culverts
- Improper grading, grader berms, piled loose materials near culverts and streams
- Off-road vehicle-related erosion

40 projects identified

- 7 high priority
- 5 moderate / high priority
- 18 moderate priority
- 5 moderate / low priority
- 5 low priority

Project types:

- Slow and filter stormwater runoff with best management practices (BMPs)
- Improve grading
- Ditch stabilization
- Culvert improvements

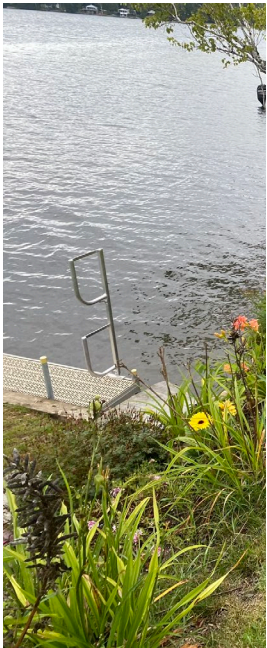
Shoreland - Lacking Buffers

Lakeshores lack buffers can con loads. Shoreline unstable.

Turf grass has v does not stabili

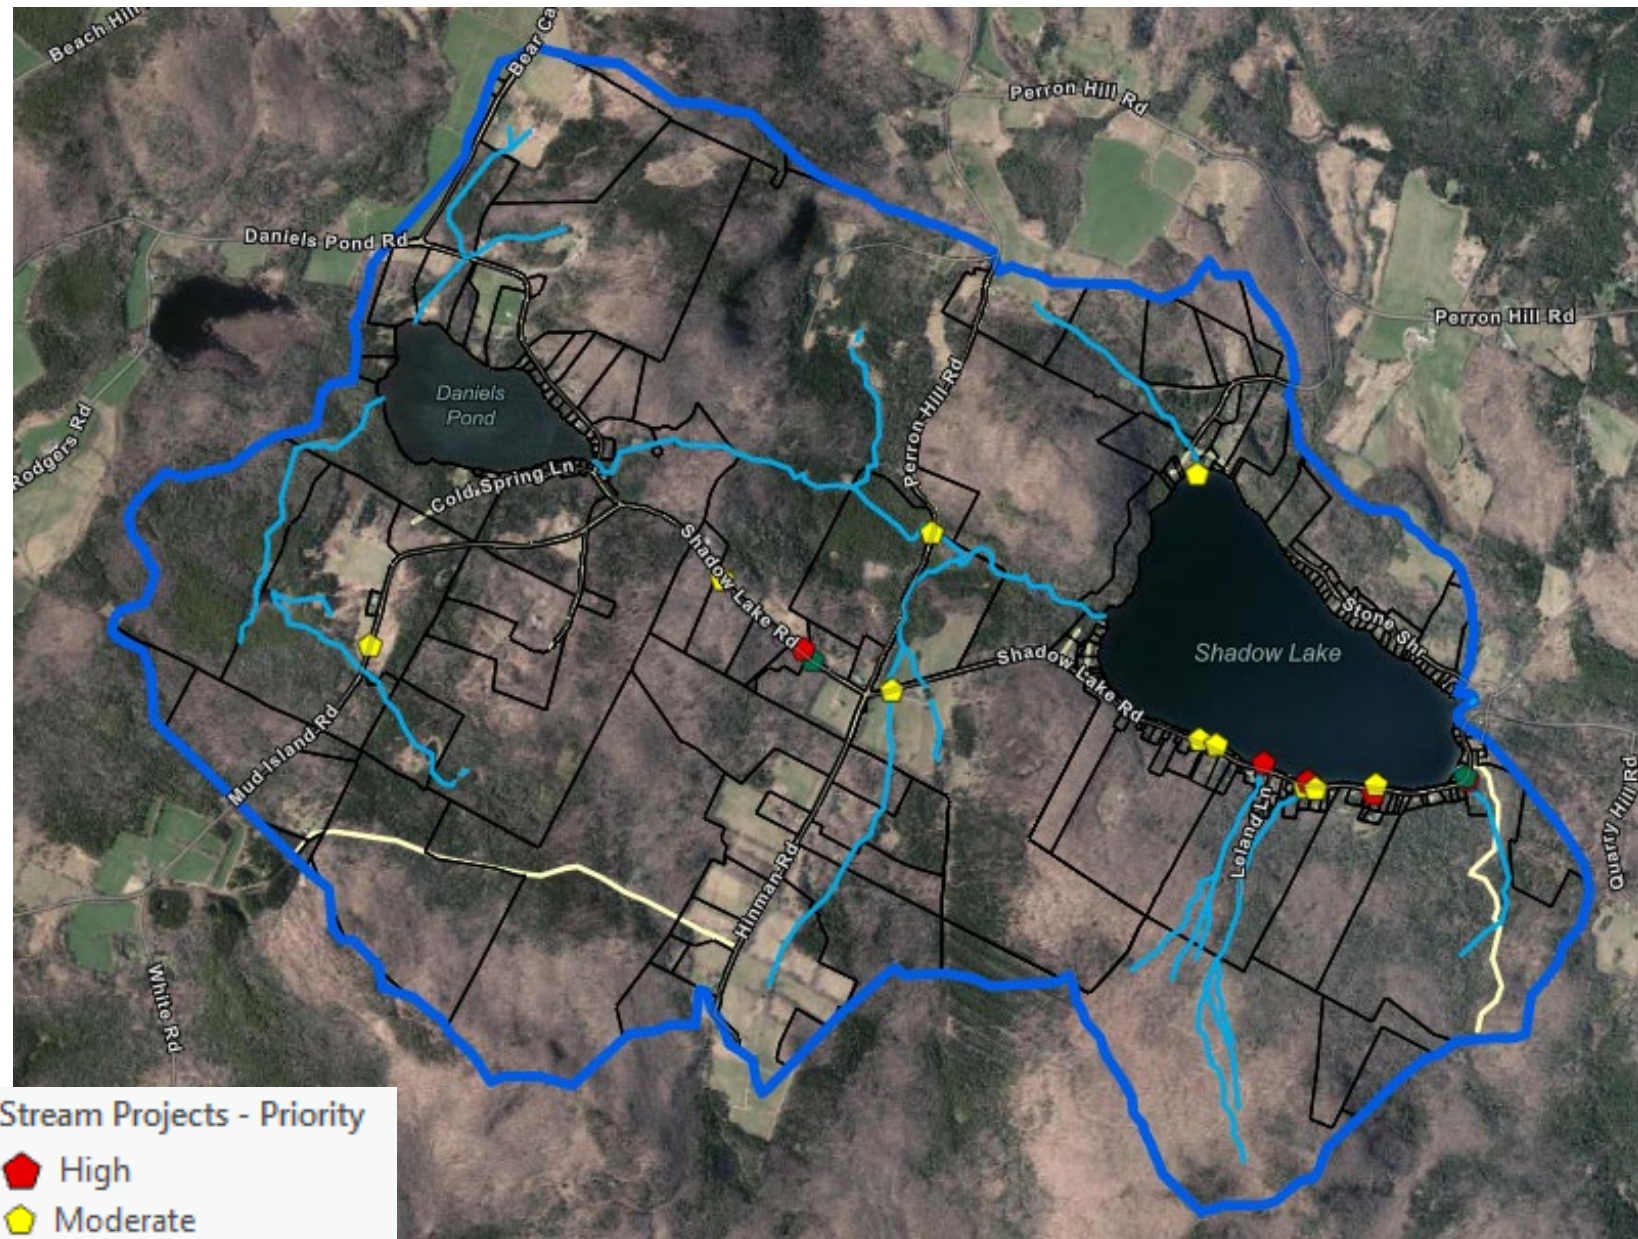
Issues observed:

- Unstable streambanks
- Scour / erosion near stream culverts
- Lack of robust vegetated buffer
- Unfiltered channelized stormwater inputs into streams

17 projects identified

- 5 high priority
- 10 moderate priority
- 2 low priority

Project types:

- Floodplain restoration
- Buffering and stabilization
- Slow and filter stormwater runoff to streams

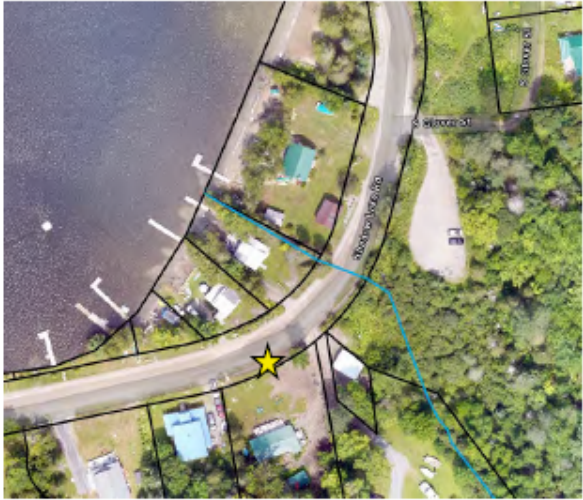
Shadow Lake LWAP Phase 1 – Public Roads Summary Sheet		Project rank by sector: 1																										
Site name:	Ditches by Public Beach																											
Approximate address:	1189 Shadow Lake Rd, Glover, VT 05839																											
Sector type(s):	Public Areas including Roads																											
Proposed BMP Description:

Proposed BMP details		Current site type	Public road	Drainage area size	High	Water Quality Concern	High	Pollutant reduction potential	High	Design required	Medium	Hydrologic soil group	D	Hydrologic connectivity	Yes	Ownership of Site	Public	Relative project cost	Medium	Auxiliary Benefits	Lower repair and cleanout frequency	Landowner Participation:	Public	Retrofit Priority	High
Proposed BMP details																												
Current site type	Public road																											
Drainage area size	High																											
Water Quality Concern	High																											
Pollutant reduction potential	High																											
Design required	Medium																											
Hydrologic soil group	D																											
Hydrologic connectivity	Yes																											
Ownership of Site	Public																											
Relative project cost	Medium																											
Auxiliary Benefits	Lower repair and cleanout frequency																											
Landowner Participation:	Public																											
Retrofit Priority	High																											
Site Description It is recommended that the ditches in this area are stabilized, road edges compacted, excess sediment removed, culverts cleaned out, and check dams installed in ditches where slope allows. The remainder of ditches should be well vegetated to prevent further erosion. Floodplain restoration project also recommended in this area.																												
Feasibility concerns: Constrained area																												
Site map		Site photo
