Livestock Exclusion

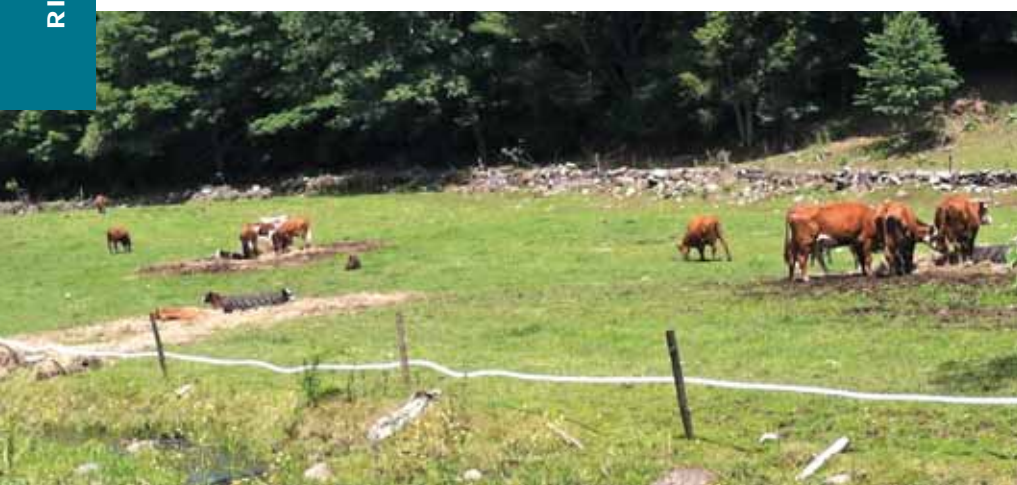
Permanent fencing runs the length of the brook along this pasture. Keeping livestock out of waterways helps to protect water quality and herd health.

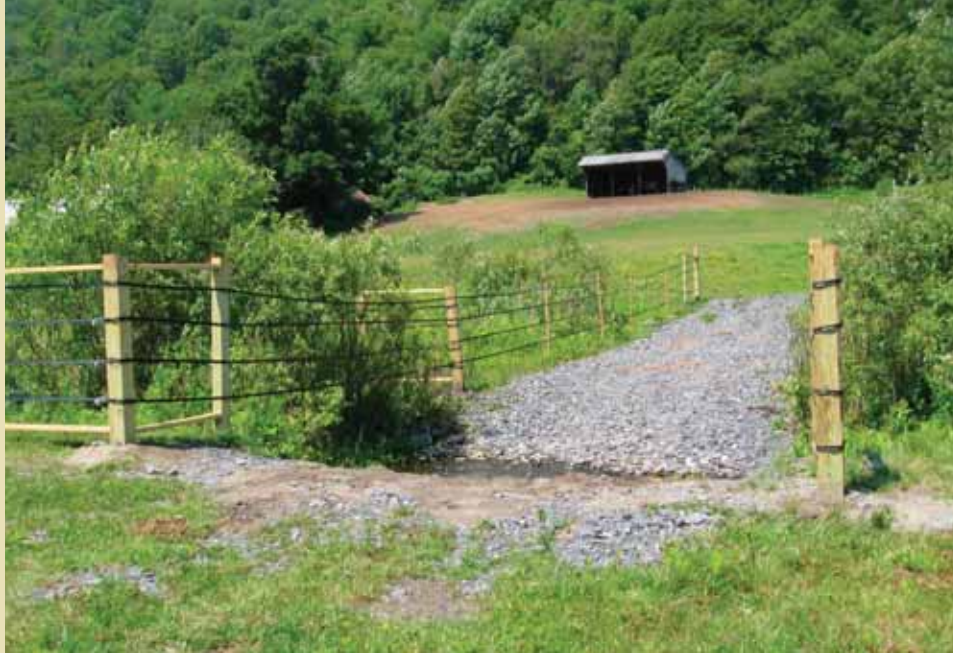
Livestock exclusion fencing and an armored stream crossing on Highbrook Farm, S. Woodstock, VT.

The main concern was the type of fencing that could be safely used for mares and foals. With research, a high tensile wire encased in a one inch polymer fence was found to be acceptable. Four strands were used. Due to the wet soils where the fencing had to be installed, a composite post was used for support with treated posts at corners. The composite posts were predrilled to accommodate the fence and then pounded in.

Grant funds were secured to help the owners install two livestock crossings through the stream and for the fencing materials. The Spittles supplied the labor and machinery. Not only did the fencing project look great, it was safe for the horses and the stream was protected.
